UNITED STATES AIR FORCE
GROUND ACCIDENT INVESTIGATION
BOARD REPORT

CONFINED SPACE MISHAP, SEWAGE CLEARING PROJECT

**380th EXPEDITIONARY CIVIL ENGINEER SQUADRON,
380th AIR EXPEDITIONARY WING**

DATE OF ACCIDENT: 8 JULY 2018

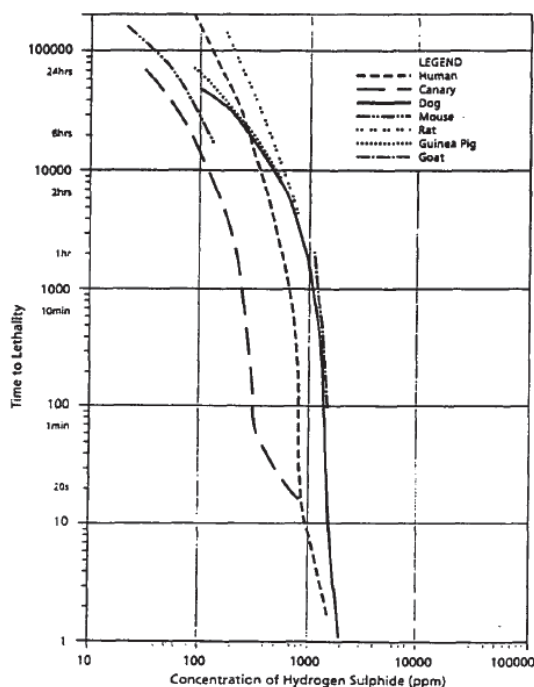
Figure 1 (Tab DD-60)
Graph depicting time to lethality at various concentrations of H₂S

Similar to other toxic occupational events, H₂S exposures are sporadic, unpredictable, and less common than traumatic injuries (Tab DD-12). This means that clinical information must be obtained from individual case reports and animal studies (Tab DD-12, DD-30 to DD-58, and DD-71 to DD-75). These case reports all present multiple characteristic symptoms of H₂S toxicity (Tab DD-13 and DD-30 to DD-60). Clinical outcomes vary, depending primarily on the concentration of H₂S the individual was exposed to rather than duration of exposure (Figure 1) (Tab DD-13 and DD-30 to DD-58).

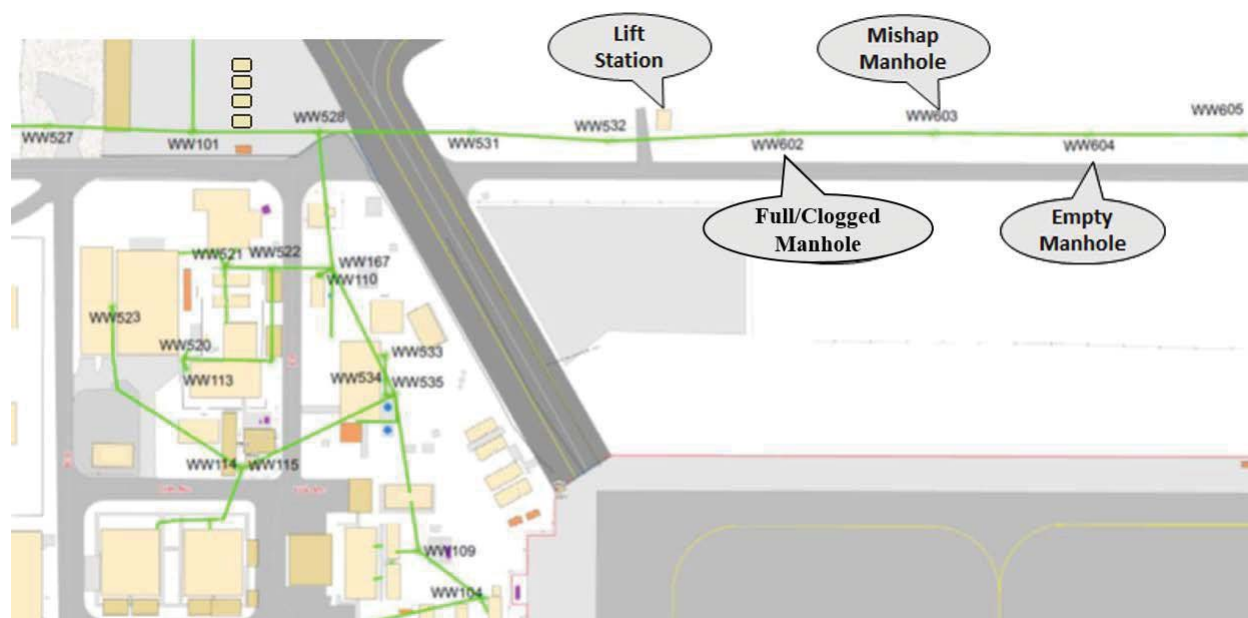
Figure 3 (Tab Z-3)
Partial overview of wastewater line

On 8 July 2018, 380 ECES personnel were continuing a project that had been ongoing for a few days (Tab R-5 and R-89). The task was to clear a sewage line by jetting out (clearing using high- pressure water) the clogged line via manhole access to ensure unimpeded wastewater flow (Figure 3) (Tab R-13, R-28, and R-89). The sewage line in question had a history of clogging (Tabs R-89 and V-7.2). The project did not require any member to enter a manhole, as they could lower their equipment into each manhole from the surface above (Tabs R-90 and V-7.2). Supervision provided no specific guidance on confined space entry for this project since entry into a manhole was not required (Tab V-7.2).

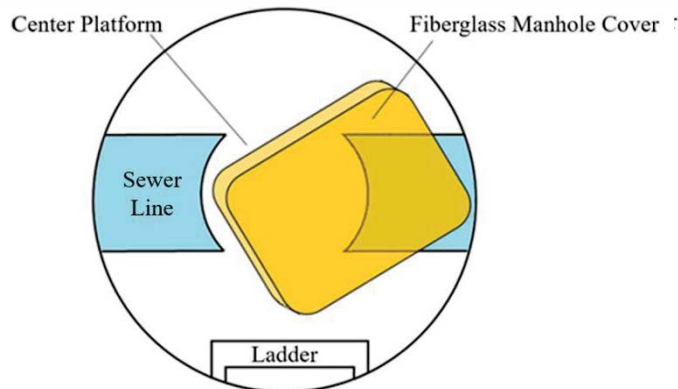
Figure 8 (Tab Z-5)
Notional diagram of manhole from above prior to entry of the MA. Not to scale. Side on which fiberglass manhole cover rested is unknown.

At approximately 1330L, the 4-person WFSM team arrived at the jobsite to continue sewage line clearing efforts (Tab R-5 and R-68). The MA and MW2 removed a metal outer cover (Figure 6) from the manhole and discovered there was a second square manhole cover made of fiberglass (Figure 7), designed to prevent sand and dirt from getting into the manhole (Tab R-5 and R-28). The WFSM team attempted to remove the fiberglass cover unsuccessfully and eventually had MW4 use the small bucket on the backhoe to remove it (Tab R-62). MW4 broke a handle off the cover on his first attempt to remove it and then used the small bucket to push the cover (Tab R-62 and R-78). MW4 was able to dislodge the cover; however, it fell to the bottom of the manhole (Figures 8 and 9) (Tab R-41 and R-62). There was a noticeable smell when the cover was removed (Tab R-14, R-63, and R-80).

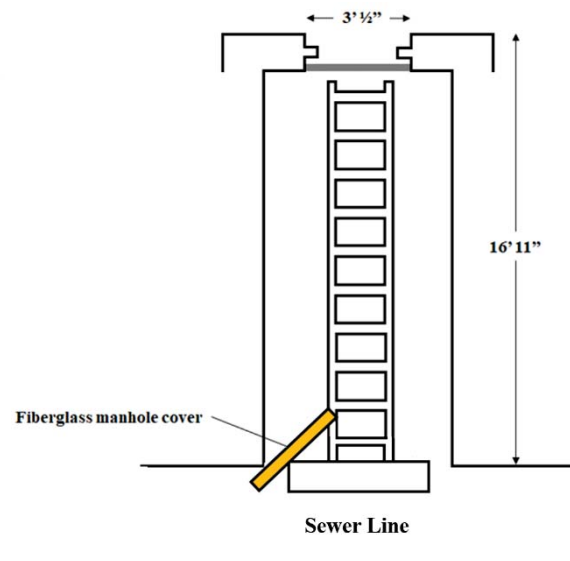
Figure 9 (Tab Z-6)
Notional diagram of manhole cross-section prior to entry of the MA. Not to scale. Side on which fiberglass manhole cover rested is unknown. Measurements reflect those of manhole in which mishap occurred.

The MA descended the rungs of the manhole ladder to retrieve the cover (Figures 9 and 10) (Tab R-34 and R-79). At the bottom of the manhole, the MA grabbed the cover and began his ascent (Tab R-79). Approximately one third of the way up the ladder, he dropped the cover, appeared to lose consciousness, and fell to the bottom of the manhole (Tab R-20, R-34, R-62, and R-69). At this point, the MA had been in the manhole for less than one minute (Tab R-5, R-63).

H₂S is 20% heavier than air, meaning higher concentrations are expected at increasing depths (Tab BB-92). The air samples taken on 22 July and 30 July 2018 indicated that H₂S concentrations in the middle third and bottom third of the manhole were at least 99.9 ppm (Tab S-21). More accurate measurements were later taken within the manhole using a Chip Measurement System (CMS) kit once a required attachment was obtained (Tabs S-21 and V-19.3). CMS measurements were taken at a depth of 16 feet, which was 11 inches above the bottom of the manhole (Tab S-9 and S-21). The reported H₂S concentration on 30 July, 22 days following the mishap, was 282 ppm (Tab S-21). It is likely that the H₂S concentration at the time of the mishap was significantly higher, as the MA went unconscious after less than a minute in the manhole (Tab R-5 and R-63). Symptoms of exposure to H₂S at concentrations of 700-1000 ppm include rapid unconsciousness and immediate collapse within one to two breaths (Tabs BB-54 to BB-55).
