AUGUST 1961

TAC Attack August 1961 The Investigation

TACTICAL AIR COMMAND ATTACK

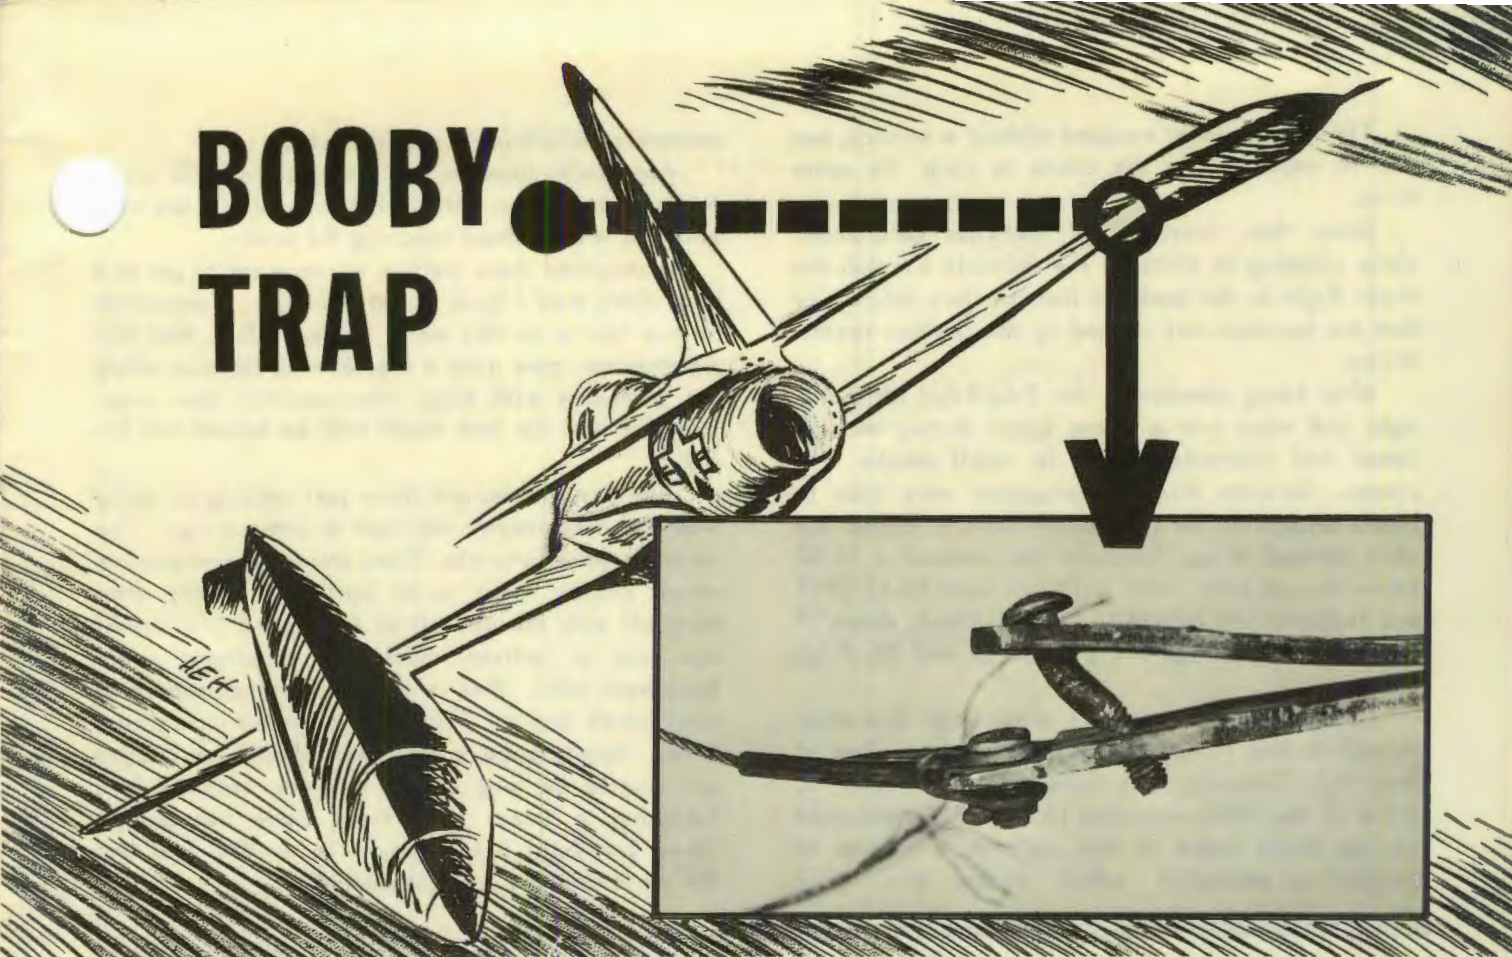
BOOBY TRAP

TWO FULL COLONELS from another command had T-bird difficulties which were compounded by a maintenance goof to the point where they had to abandon the machine.

tanks. They did, and the colonel in front pressed the jettison button. The left tank departed no sweat, but the right one stayed on. The colonel pressed the button again but nothing happened. He pulled the manual release and again, nothing happened. Enroute to the airbase the colonels explained their problem to the tower and three well-qualified T-33 pilots were made available. Using the dash one, they advised the colonels on what to try, but all efforts were unsuccessful and the tank stayed on. The colonels checked and found that they could not slow to 150 knots without losing aileron control, so they jettisoned the canopy and punched out.

Other than leaving fuel switches gangloaded while climbing to altitude, the colonels handled the whole flight by the book, so investigators determined that the accident was caused by the jettison system failure.

Curious, the investigators shook down four other aircraft to see if they too had these holes. Two of them did. Checking, they found that TO 1T-33A-95, dated 16 May 1955, rescinded 16 May 1957, authorized drilling these holes in the indicator and lever to provide a secondary safety feature when door

assembly 207038-6L/R was removed.

The screw remained there just waiting to booby trap the first aircrew who had to jettison tips. The colonels were fortunate. There are many emergencies which require tanks to be jettisoned shortly after take off with the aircraft at low speed. Failure of one tank to jettison under such conditions would have been fatal. This is why maintenance personnel must insure that the T-33 jettison system is in proper order. Maintenance safety pins should be flagged and should be long enough to keep someone from buttoning a panel over them. More appropriate, these particular holes should be welded over and the parts properly straightened. ●

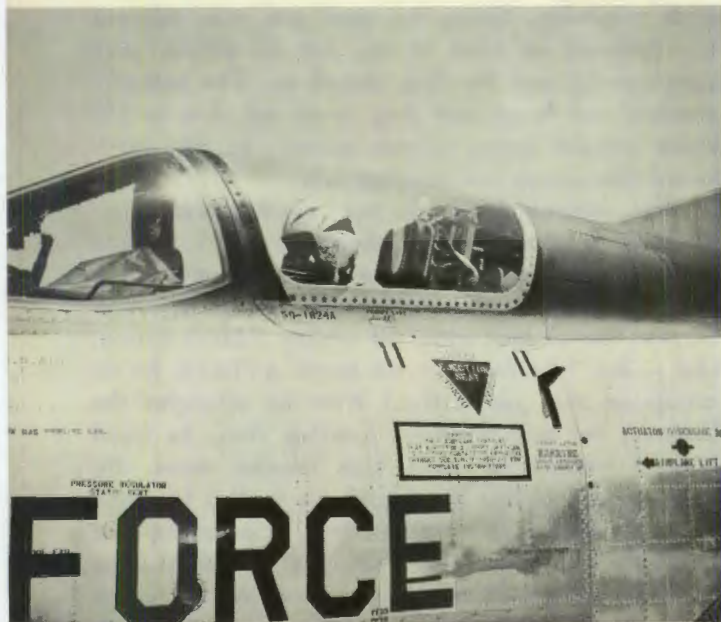
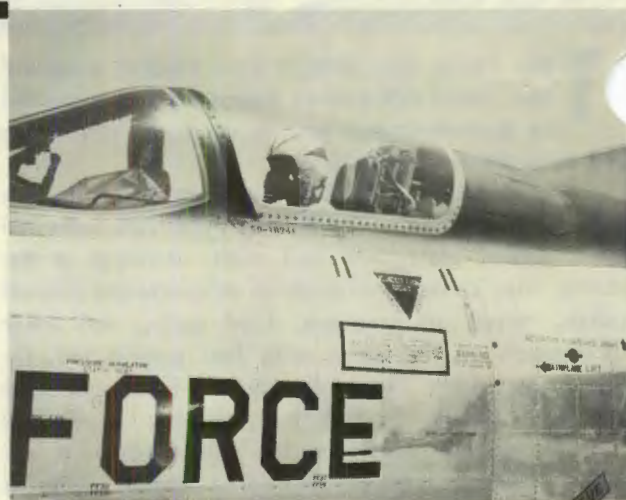
CANOPY

All pilots pulling mobile control should glance at these photographs of the F-105. In the picture on the left the canopy is unlocked and will come off in flight unless someone . . . you . . . calls it to the pilot's attention. On the right, the aircraft is clear and ready to go. We deliberately failed to include the usual set of arrows pointing out the difference, since they won't be there if the real thing comes your way.

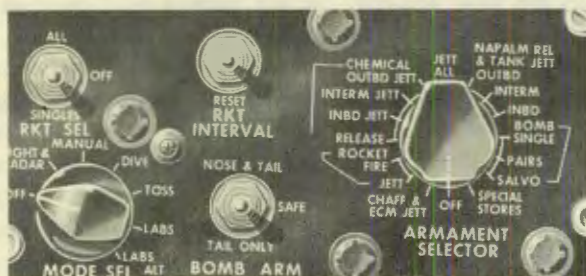
SAFE OR SALVO. The pilot of an F-100D inadvertently dropped two 450-gallon tanks and two Type VIII pylons while making a LABS system check. One of the pylons dropped through the roof of a house and caused substantial damage. The pilot checked the armament selector switch, but did not notice that it was 180° out of phase and was in the JETTISON ALL position rather than the OFF position. He had also checked the armament panel during preflight but had not noticed the discrepancy then either. The investigating officer determined that the shape and location of the selector switch was a related factor to the incident. (See photo.)

The square shape and location in the cockpit requires that the pilot scrutinize the switch closely to insure its correct position. Action has been initiated to replace the square type switches, but in the meantime double check before you press the button.

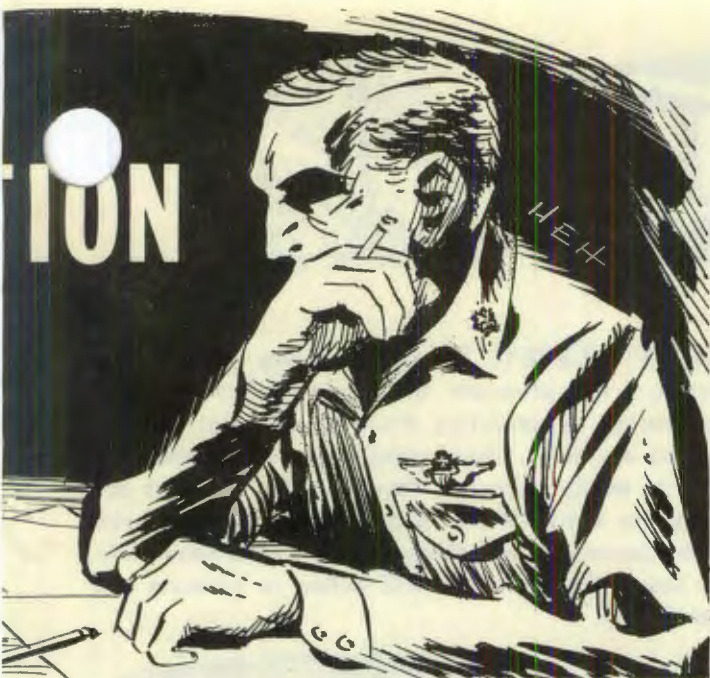
Why did he lose control? A check of aircraft records gives some clue. The attitude gyro had been written up as unreliable on a recent test hop. The K4B control was subsequently removed, ben-

checked and put back in the airplane. The attitude indicator was also removed, bench checked and put back in the airplane. No difficulties were reported on the next test flight or the air-to-ground mission which followed. The third flight was the one which ended in the accident.

The attitude gyro system malfunctioned, else the pilot would not have written it up. Obviously, the process of removing, bench checking, and reinstalling this equipment is not going to correct the cause of malfunction . . . why then, did it bench check o.k.? A few well-directed questions, and you learn that the present testing equipment doesn't do the job. The instrument technicians apparently were aware of this because they borrowed test equipment from a sister wing which had adequate equipment . . . and claimed to have done so in this instance.

Maintenance men committed an all too common error when they reinstalled the flight instrument with no corrective action other than a ground check of the instrument and K4B control. Maintenance supervisors were right in there with them for not insisting on a thorough checkout of the entire system and for failing to see that proper test equipment was secured. It stands to reason that every technician isn't going to take the time and effort to run over to another shop to make such tests . . . and for that matter, he shouldn't have to!

So you nail the poor guy with pilot factor for failing to cross-check all available flight references and then make a mental note to have increased emphasis placed on partial panel work in the simulator training program. ●

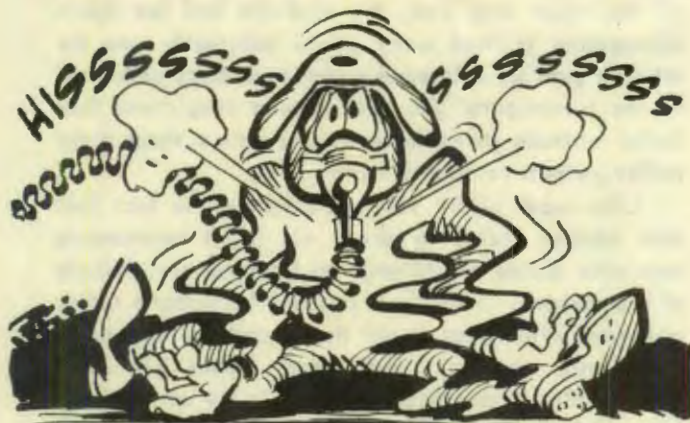
SLOW LEAK. The small Webb retainer strap on the oxygen hose connector is held in place by a screw which goes all the way through the connector. A pilot noticed his strap was missing, but didn't realize the missing screw left a nice hole in his oxygen line. Fortunately, the PE man discovered it before the pilot made a high flight of long duration.

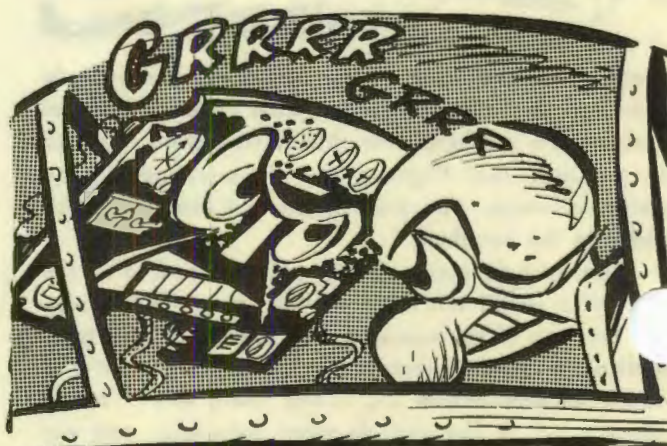
F-101B HEADWORK. Shortly after takeoff while on the gauges in weather, the pilot of an F-101B found the instrument panel in his lap. He maintained a climb attitude by referring to the radar horizon and by having the RO monitor airspeed in the aft cockpit. After gaining altitude the pilot used both hands and released the mechanical stops that lock the panel down. He then pushed it up with his head, locking it in place. The instrument panel was checked for security prior to takeoff but the pilot apparently wasn't familiar with the locks. All pilots flying F-101B's should raise and lower this panel to see how the thing works. The linkage must be inspected before strapping in . . . and safety pins can be installed in one of the linkages to prevent recurrence.

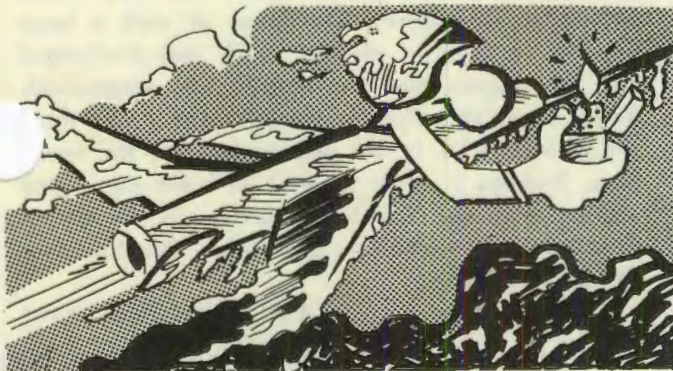
PITOT SYSTEM ICING – F-100. Both aircraft in a flight of two F-100's lost airspeed indications during a weather penetration. Full defrost heat did not open the pitot system until the aircraft descended below the freezing level. All correct operating procedures were followed. Another flight of F-100's that penetrated immediately following this flight had similar problems. Twenty-twenty hindsight indicates that engagement of the windshield anti-icing or defrosting system prior to penetration would have increased the temperature in the mixing chamber and probably would have given positive pitot system anti-icing. With the winter months comes lower freezing levels and the increased possibility of icing conditions. From all indications, F-100 pilots will have to anticipate icing during penetrations and use the defrosting system a few minutes before starting down the slide.

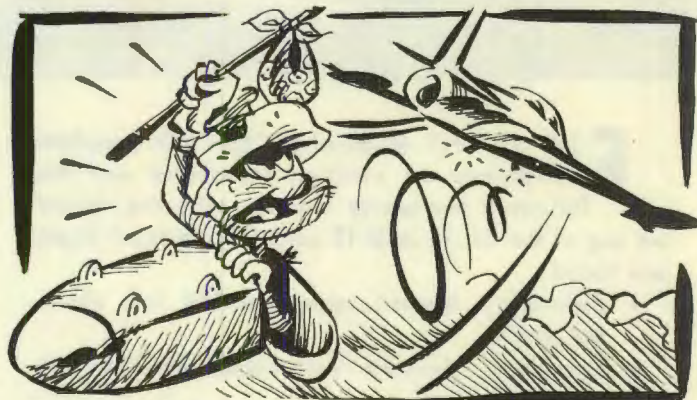
T-33 TRAVEL PODS. Travel pods are still falling off of T-33's at regular and inconvenient intervals. Therefore, T.O. 1T-33A-491, dated 2 September 1960, was published, requiring the installation of new improved forward attaching brackets on all existing pods. Stock numbers for these brackets are 1ALC-1560-787-6758 and . . . 59. In addition, this T.O. reworks the aircraft JATO latching mechanism to make the pod non-jettisonable. This is done by drilling a .07 inch hole with a number 70 drill through the lower mid-section of the protruding trigger, as close as possible to plate, part number 178165-2. A 1/16 inch cotter pin through this hole keeps the manual release from operating. Both pilots and ground crews should make sure that this pin is in properly. If you do not know how it should be installed, ask the engineering officer... don't be one of the T-bird travel pod bombers!

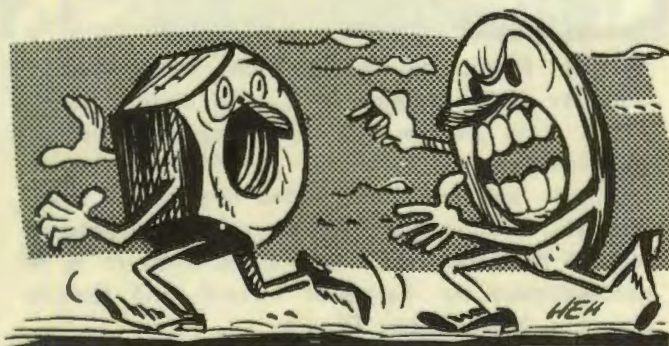
MN-1A DISPENSER. When the MN-1A is installed on either the Type VII or Type VIII pylon, the actuating pylon pin, P/N 58C45117, must be installed in the 1/2-inch threaded hole located on top of the dispenser. The pin actuates a micro switch plunger in the pylon, which re-routes the release signal in the aircraft from the pylon to the dispenser. This is how the pilot is able to release the miniature bombs. To keep the actuating pylon pin from vibrating loose and damaging the micro switch, a tooth lock washer,

P/N AN936B816, should be installed under the head of the pin. Proper installation of the pin can help prevent an inadvertent release of the dispenser.

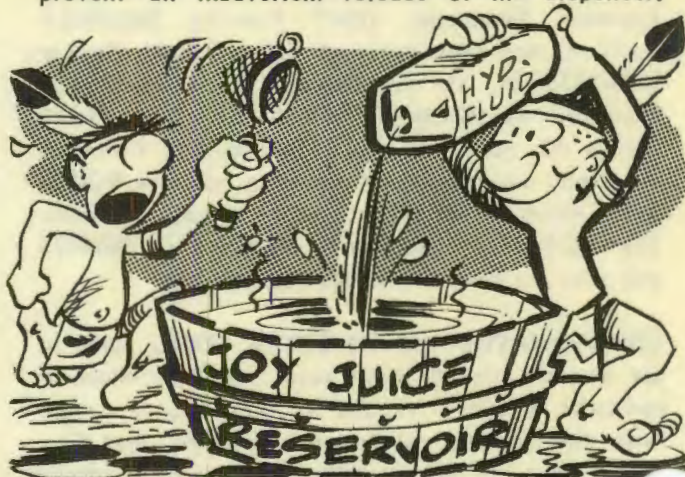
MF-1 TRAILER. SAAMA has found sand and oil foreign stuff in the hydraulic systems of several MF-1 trailers. SAAMA repairmen had to replace all of the vital parts in these trailers in order to make their hydraulic systems serviceable. This was expensive. Please help cut repair cost. Add only clean fluid to the reservoir and keep the breather cap on the filler tube. You pay taxes too!
