**UNITED STATES AIR FORCE**  
**AIRCRAFT ACCIDENT INVESTIGATION**  
**BOARD REPORT**

**E-11A, T/N 11-9358**

**DATE OF ACCIDENT: 27 JANUARY 2020**

**SUMMARY OF FACTS AND STATEMENT OF OPINION  
E-11A, T/N 11-9358  
27 JANUARY 2020**

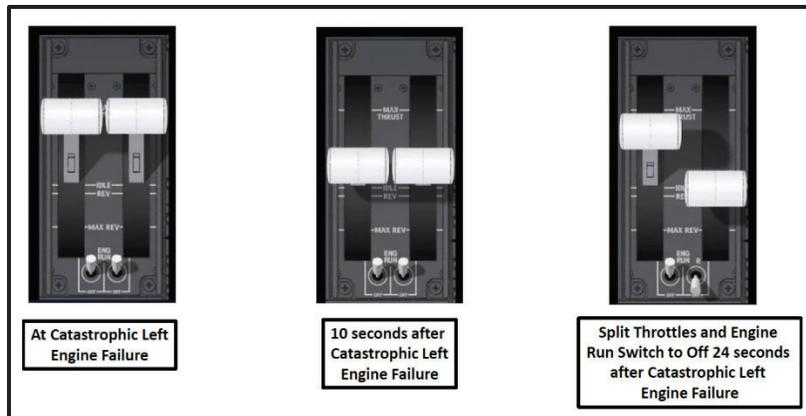
**Tab Z-12 (Simulated)**

Ten seconds after the catastrophic left engine failure, the MC retarded both throttles to just less than halfway (14 degrees; total throttle range is from 0 – 40 degrees) for one second, then slightly advancing the left throttle separately (26 degrees) for one second, then retarding it to align with the right throttle (both at 16 degrees) for one second, and finally splitting the throttles to advance the left throttle (to 31 degrees) while retarding the right to idle (0 degrees) (Tab DD-13 to DD-14). Nine seconds after moving the right throttle to idle, the MC placed the right engine run switch to off, shutting down the right engine (Tab DD-15). Finally, at 1251:19L, the left throttle was advanced to full power (40 degrees), briefly cycled then brought to idle (Tab DD-15). At 1251:23L, both throttles were advanced from idle to full power (Tab DD-15).

The first throttle movements may represent an attempt to first reduce vibration by reducing power, then to isolate the affected engine by moving the left throttle separately. Airframe vibrations did dampen slightly, but then resumed, roughly coincident with the power reduction and the advancement of the left throttle at 1251:08 (Tab DD-12 to DD-13). However, the moves were very brief and the vibrations in the left and right and up and down directions were cyclical but not regular (Tab DD-13). In any case, the left engine did not respond – the engine N1 ( fan RPM) had spiked to a maximum value, but other engine instruments continued to roll back consistent with an engine shutdown (Tab DD-13).

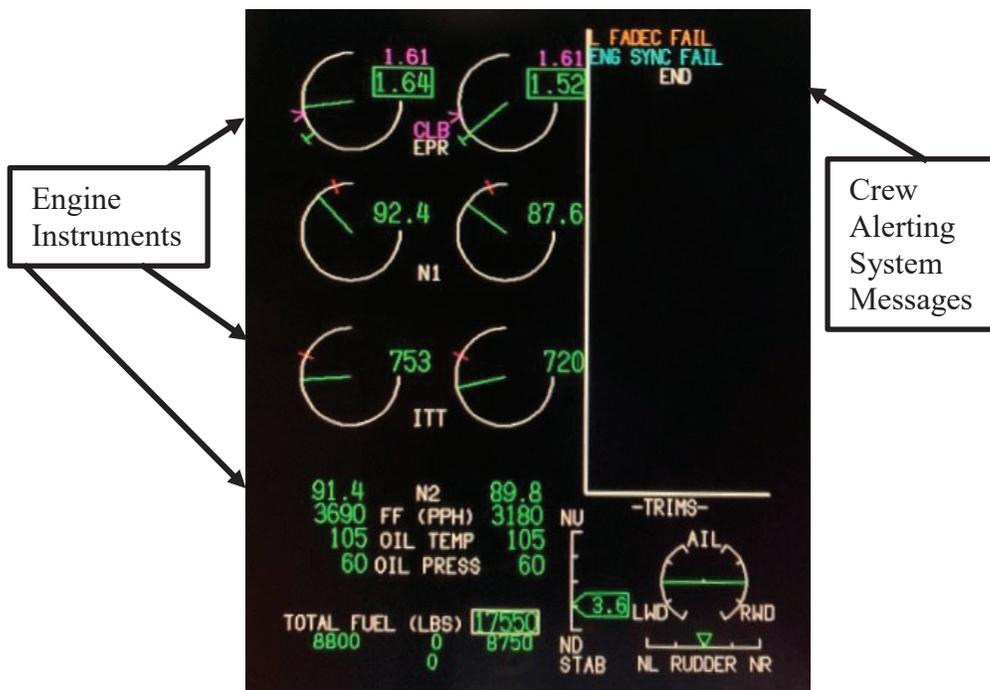
Tab Z-13 (Simulated)

The design of the MA's crew alerting system display and supporting inputs displayed an amber "**L (Left) FADEC FAIL**" caution crew alerting system message, accompanied by the amber Master Caution light at MC eye level (on the cockpit glareshield), derived from the software-directed shutdown of the left engine at 1250:52L (Tab J-179). A large majority of squadron E-11A pilots interviewed understood this message to indicate a failure of the software, but not necessarily to affect the engine in the short term (Tabs V-2.4 to V-2.6, V-3.4, V-7.4 to V-7.5, V-11.5 and V-22.3 to V-22.5). The checklist for "**L FADEC FAIL**" lists three possible consequences of the failure, one of which is eventual engine shutdown (Tab AA-20). The disengagement of the auto-throttles would have caused an audible warning, though the throttles would be expected to, and did, remain in place (Tab J-116 and J-136). Finally, a cyan "**ENG (Engine) SYNC FAIL**" advisory crew alerting system message was displayed (Tab J-179). Collectively, in the first moments, the crew alerting system did not directly indicate the left engine failure (Tab Z-13).

**EICAS Display #1:** A representative image of the crew alerting system messages within 1-2 seconds of the initial event and the left engine's FADEC-directed shutdown (Tab DD-6)

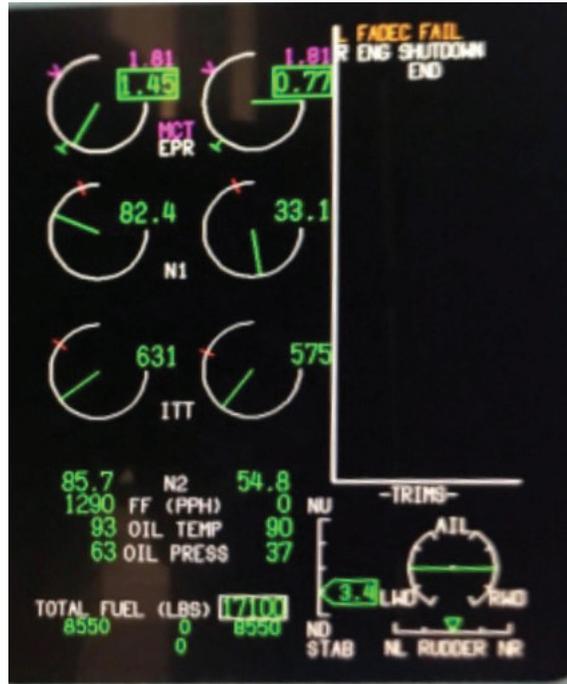
**Tab Z-17 (Simulated)**

When the right engine was shut down at 1251:16L, the crew alerting system would have posted a status crew alerting system message of "**R (Right) ENG SHUTDOWN**," displayed in white and below the other crew alerting system messages (Tabs J-180 and Z-17).

**EICAS Display #2:** A representative image of the crew alerting system messages just after the right engine shutdown.

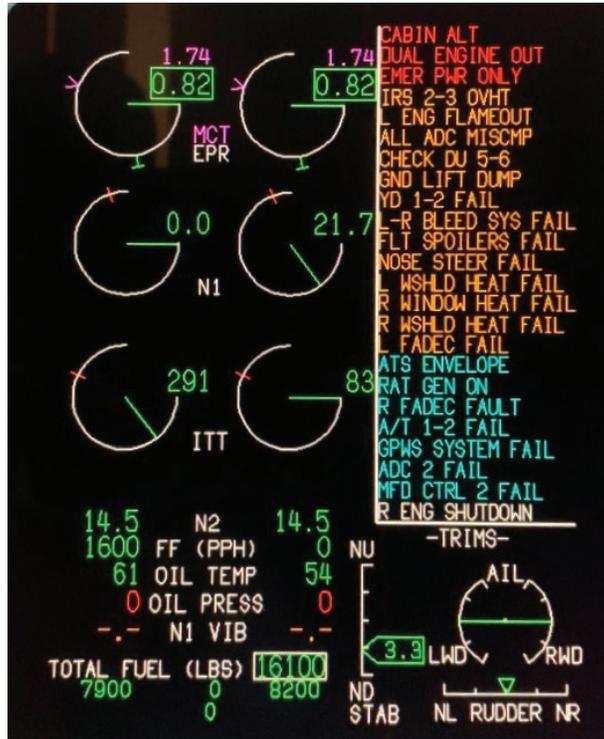
Tab Z-16 (Simulated)

Dual engine failure indications from the crew alerting system occurred later, estimated at 1252L (Tab J-180). The red **“DUAL ENGINE OUT”** warning crew alerting system message indicates that both engines have failed/been shutdown (Tab AA-3). This message is designed to display when both the left and right engines indicate either an amber **“ENG FLAMEOUT”** caution crew alerting system message or white **“ENG SHUTDOWN”** status crew alerting system message (Tab J-180). Thus, rather than displaying immediately when the right engine run switch was placed to off and the left engine had been shut down by the FADEC, the red **“DUAL ENGINE OUT”** warning crew alerting system message and an associated red Master Warning light on the glareshield did not appear until the **“L. ENG FLAMEOUT”** was triggered as that engine’s internal RPM dropped below 35%, estimated some 30-45 seconds later (in accordance with system logic (Tab J-180 and Z-16)). Note that the flameout caution and dual engine warning would have preceded the red **“CABIN ALT”** (altitude) warning crew alerting system message, and several other systems messages (Tab Z-16 to Z-17).

**EICAS Display #3:** A representative image of cockpit indications following the amber “**L ENG FLAMEOUT**” caution, red “**DUAL ENGINE OUT**” warning, and red “**CABIN ALT**” warning crew alerting system messages with associated systems messages.

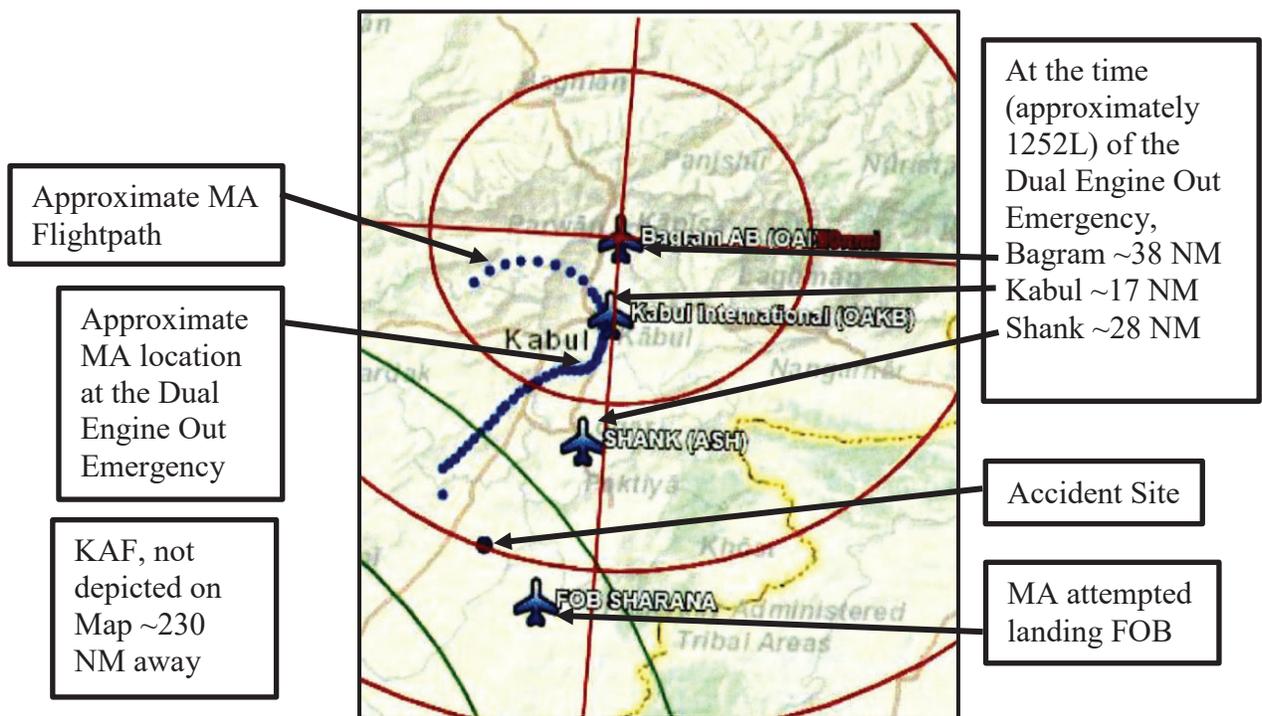
Tab Z-4

Even with the loss of both engines, backup E-11A systems would have allowed the MA to be controlled through an emergency landing. Additionally, both performance data and flight simulation profiles suggest that a divert to another airfield was still possible after the dual engine emergency (Tabs DD-6 to DD-7). However, the probability of a successful dual engine out landing cannot be determined, since it has never happened, and the MC would have had to accomplish a divert procedure not executed for at least several months prior to the mishap (Tab V-26.14). The MC would need to alter the flight plan, accomplish normal, emergency and divert checklists,

initiate communications, and manage their descent and routing to arrive at the divert airfield in a position to land without thrust to correct any miscalculations (Tab AA-37 to AA-42) .

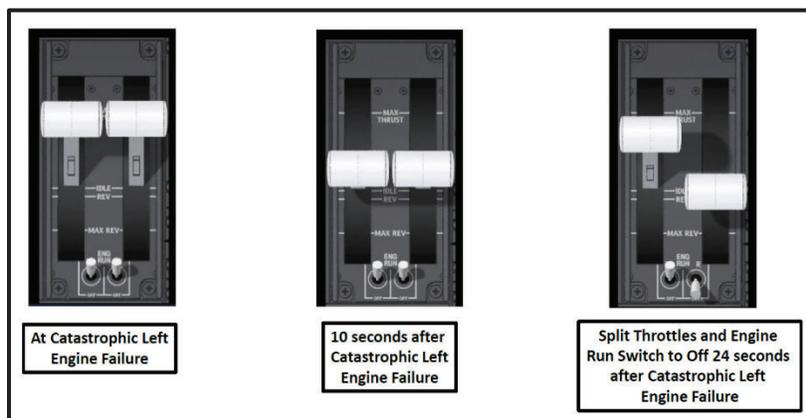
Tab Z-12 (Simulated)

Ten seconds after the catastrophic left engine failure, the MC retarded both throttles to just less than half way (14 degrees; total throttle range is from 0 – 40 degrees) for one second, then slightly advancing the left throttle separately (26 degrees) for one second, then retarding it to align with the right throttle (both at 16 degrees) for one second, and finally splitting the throttles to advance the left throttle (to 31 degrees) while retarding the right to idle (0 degrees). Nine seconds after moving the right throttle to idle, the MC placed the right engine run switch to off (moving the throttle to idle before switching the engine run switch to off is a FCOM checklist procedure when it is a crew initiated engine shutdown), effectively shutting down the right engine. See Figure **Tab Z-12**, which is a representative image of the throttles and engine run switch panel. Because of the minimal time spent in each throttle position, the above throttle movements could not be used reliably to assess engine response.

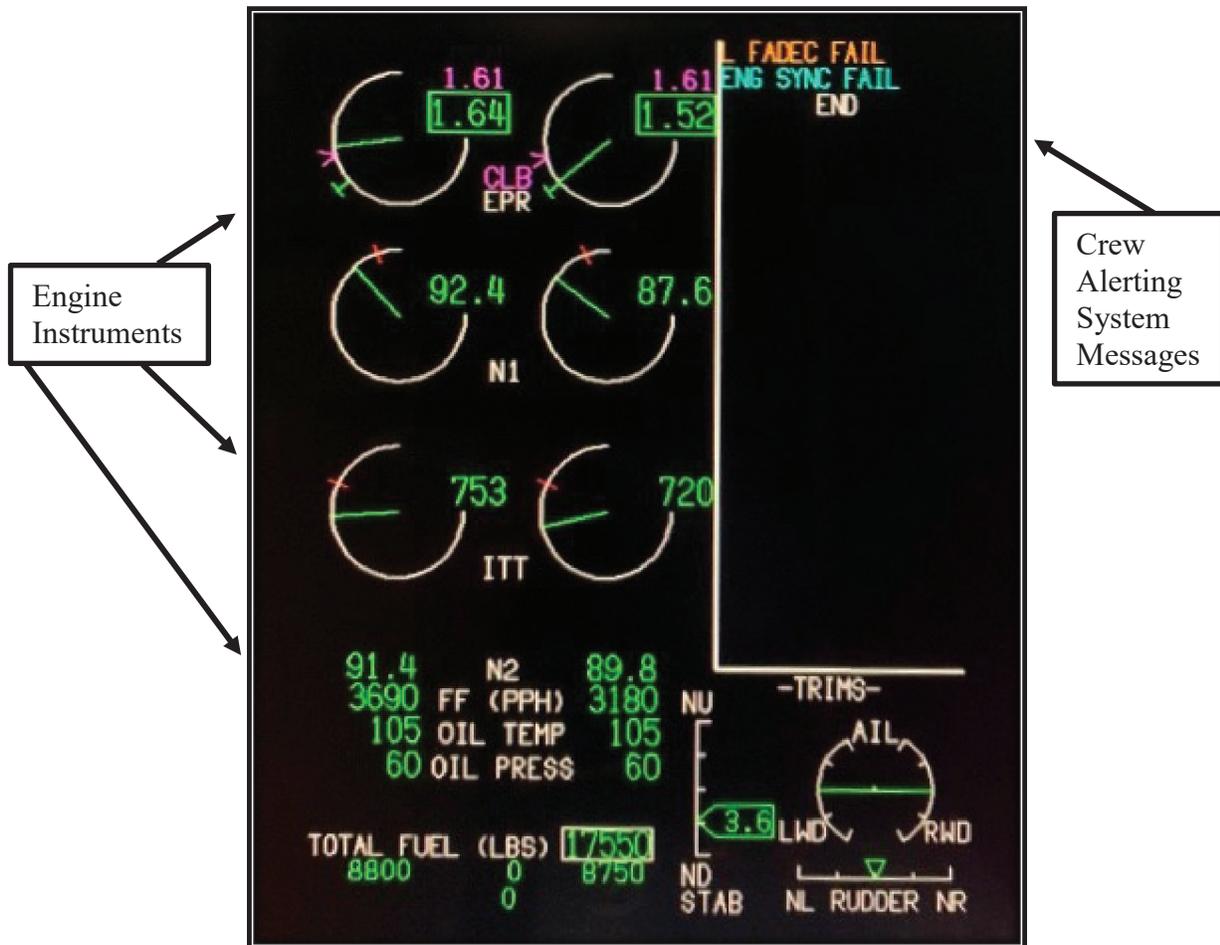
Tab Z-13 (Simulated)

The E-11A's EICAS displayed an amber "**L FADEC FAIL**" caution crew alerting system message with an amber Master Caution light on the glareshield concurrent with the FADEC shutdown of the left engine (a consequence of the L FADEC FAIL message). Figure **Tab Z-13** depicts a representative image of the EICAS display and shows crew alerting system messages 1-2 seconds after the catastrophic left engine failure and the FADEC-directed engine shutdown. Importantly, the engine instruments do not reflect those of the MA and may differ.

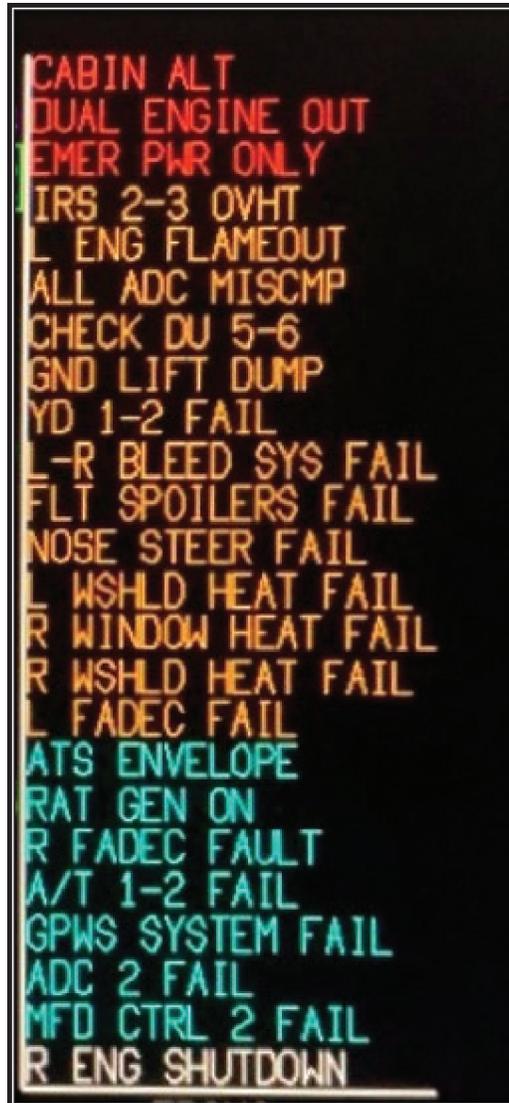
Tab Z-16 (Simulated)

In the first 24 seconds after the catastrophic left engine failure, the EICAS crew alerting system display did not necessarily suggest an engine failure. However, when the MC initiated shutdown of the right engine, it would have triggered an immediate white “**R ENG SHUTDOWN**” status crew alerting system message. Then, once the left engine RPM decreased below 35% (approximately 30 seconds after the right engine shutdown), an amber “**L ENG FLAMEOUT**” caution crew alerting system message would have been displayed followed by a red “**DUAL ENGINE OUT**” warning crew alerting system message, and a red Master Warning light (approximately 1252L). Of note, other EICAS crew alerting system messages would have been displayed, but are not important in this analysis of determining the affected engine. Figure **Tab Z-16** depicts a representative image of the crew alerting system part of the EICAS display and the crew alerting system messages showing the right engine shutdown, dual engine out, and left engine flameout messages indicating a dual engine out emergency.

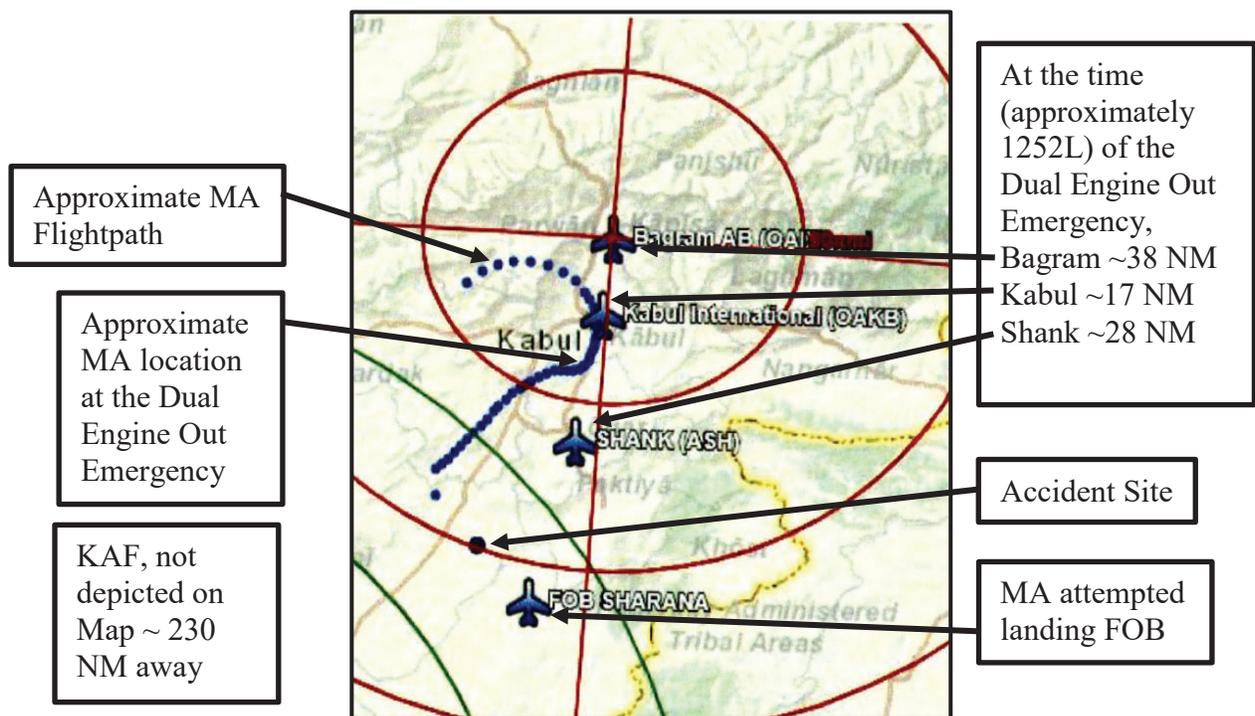
Tab Z-4

Even with the loss of both engines, backup E-11A systems allow the aircraft to be controlled through an emergency landing, and both performance data and flight simulation profiles suggest that a divert to another airfield was still possible even after the dual engine emergency. However, the exact probability of a successful dual engine out landing, since it has never happened, cannot be determined. In fact, the MC would have had to accomplish a procedure only considered hypothetically. During the mishap, the MC would need to alter the flight plan, accomplish checklists, initiate communications, and manage their descent and routing to arrive at the divert airfield in a position to land without the ability to correct any miscalculations.
