# TAC ATTACK

MAY 1969  
Vol. 9 No. 5

Lightning strike

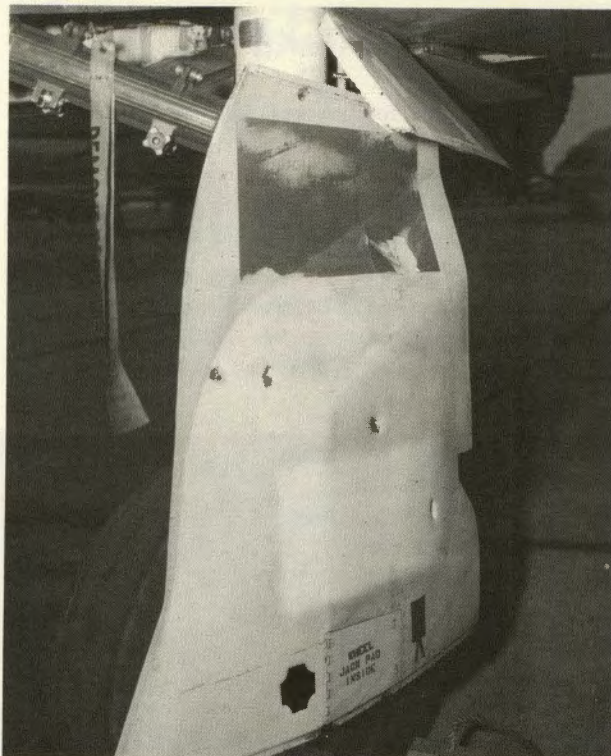
Damage to the aircraft was quite extensive. The lightning strike caused the left external tank to jettison, and then explode while still very close to the aircraft. There was no evidence of forceful separation of the external tank. The damage report included: left center leading edge flap dented and 6-inch hole torn in it; left aileron flap dented and torn; left wing-fold strips torn; left inboard landing gear door dented and punctured; left cartridge starter door punctured; left engine bay door punctured; left wing skin punctured; left pneumatic starter door torn; panel 48 and adjacent skin punctured and torn; skin below ram air turbine punctured and three adjacent ribs cracked; skin aft of panel 47 punctured and torn; right external tank punctured and hole blown in aft end; and casting and hinge adjacent to doors 78 and 138 cracked. Four bolts from the left external tank seam joint were found imbedded in the left gear door and a piece from the seam flange of the left external tank was found imbedded in the left engine starter access door. Including 350 man-hours, all of this came to a hair over nine grand. We were lucky — it only cost us money this time.

**Left main gear door. Note bolts from left drop imbedded in skin.**

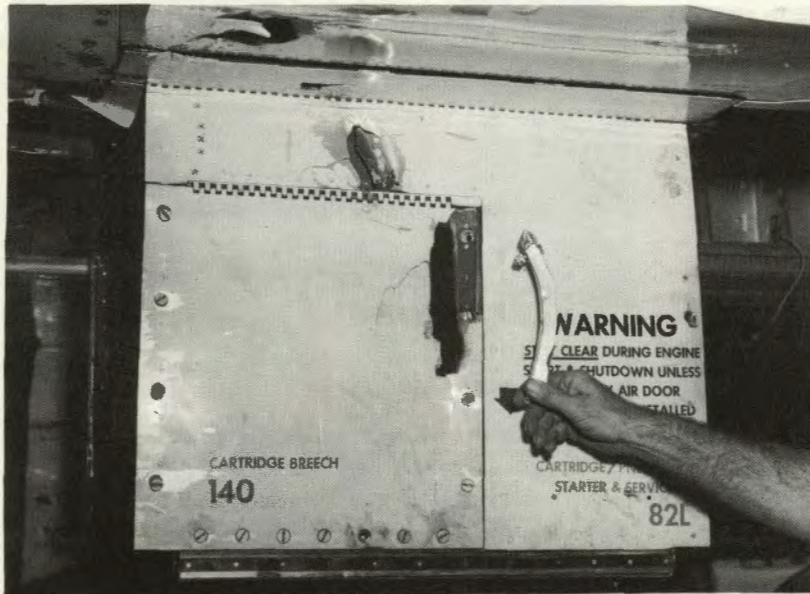
**Door 140. Seam flange from left drop tank was found in hole to left.**

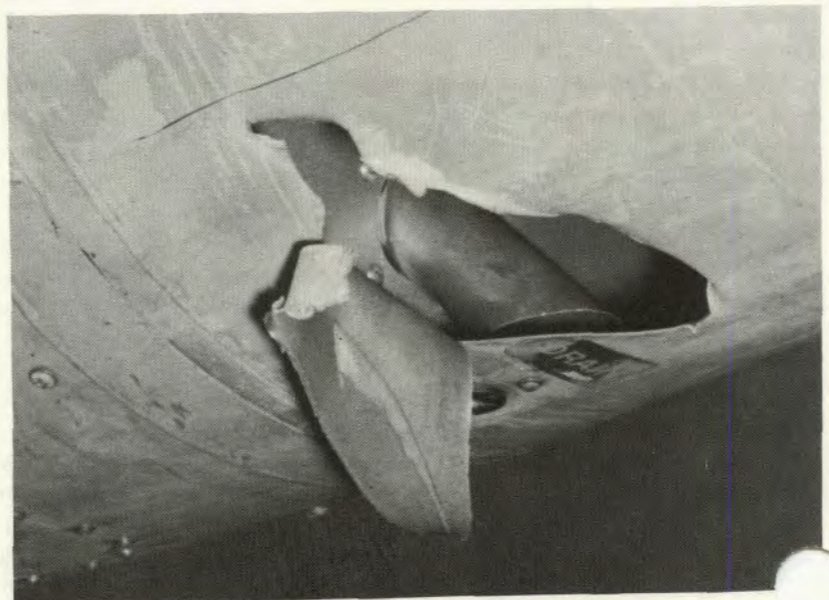
**Damage to right drop.**

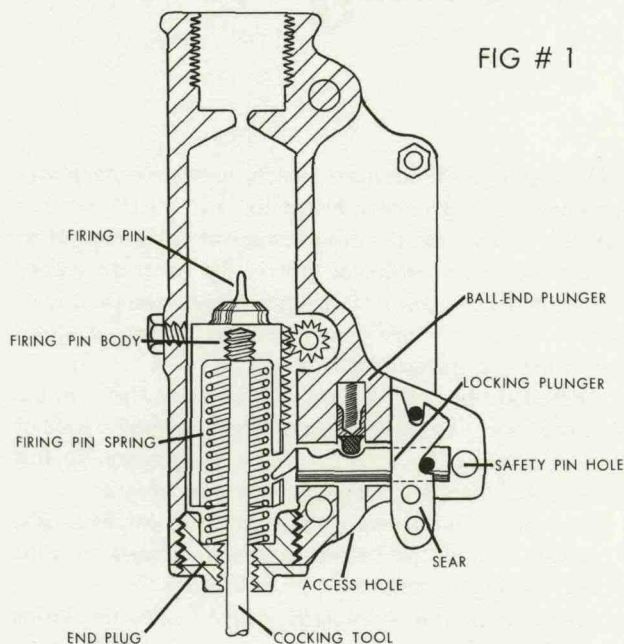
## CORRECT ASSEMBLY (Fig 1)

The position of the locking plunger is controlled by a spring loaded ball-end plunger which engages the detents

in the upper surface of the locking plunger. The locking plunger must be in the outboard position to allow the sear to be inserted and it must be pushed fully home to secure the sear before the drogue gun can be cocked. This action compresses the ball-end plunger and allows it to ride from one detent position to the other.

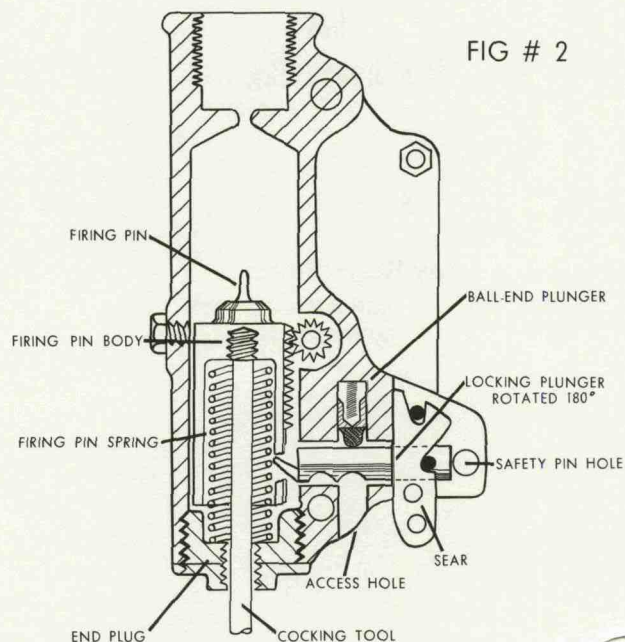
It is possible to set the drogue gun in this dangerous condition. And it can fire accidentally if it were jarred by involves incorrect assembly and incorrect cocking procedures — but you have to work at it to get it this way, using either three hands or a bench vise.

It requires the locking plunger to be rotated 180

rees which negates the positive locking action of end plunger. It also requires the drogue gun to be cocked with the locking plunger in the disengaged position initially and then pushed into engagement with the firing pin when the spring is fully compressed. The unit can be cocked in this fashion and may hold for a while but the firing pin will eventually push the locking plunger out of engagement and the drogue gun will fire unexpectedly.

It is not easy to achieve this hazardous condition and it is impossible to attain when the correct cocking procedure is used. The locking plunger can be rotated once it is correctly installed, anytime the sear is removed, but it will snag the ball-end plunger if an attempt is made to insert it incorrectly on assembly.

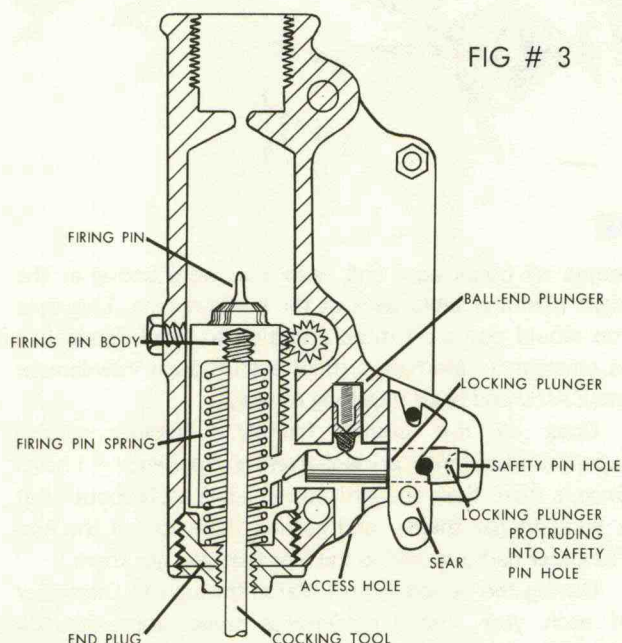
FIG # 3

The mating surfaces of both the locking plunger and the firing pin are chamfered to ensure positive

engagement. This can be checked as the drogue gun is being cocked by noting that the locking plunger appears in the safety pin hole and then snaps back to engage the firing pin. These actions will preclude the possibility of hair trigger cocking. Note that only the tip of the locking plunger is engaged with the lip of the slot in the firing pin and that they can slip out of engagement, if jarred, allowing the drogue gun to fire. In this condition, it will not be possible to install the ground safety pin because the locking plunger will be protruding into the hole for the safety pin. Again, it's easy to recognize and can be avoided by using the proper procedure for cocking the drogue gun. When the firing pin is pulled to its full extent of travel, there should be approximately 1/8 inch of overrun after the drogue gun cocks before the firing pin bottoms out. If this is checked when the mechanism is being cocked, the locking plunger should snap into engagement and thus eliminate the risk of hair trigger cocking.
