**UNITED STATES AIR FORCE**  
**AIRCRAFT ACCIDENT INVESTIGATION**  
**BOARD REPORT**

**F-16CM, T/N 91-0413**

**DATE OF ACCIDENT: 4 April 2018**

**SUMMARY OF FACTS AND STATEMENT OF OPINION**  
**F-16CM, T/N 91-0413**  
**4 April 2018**

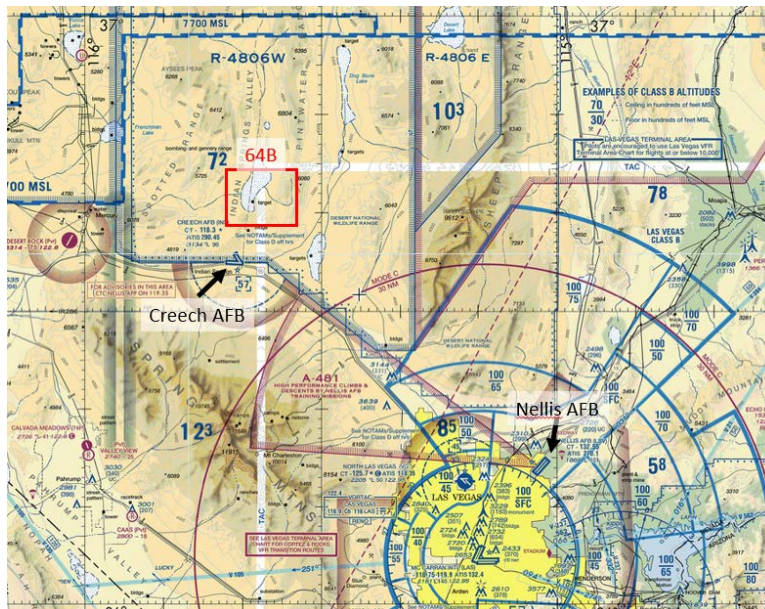
Figure 2: South NTTR (Tab Z-3)

The MF departed Nellis AFB at approximately 0950L (Tab U-4). The Diamond Formation coordinated with Nellis Tower for a Diamond Loop on takeoff while TB5 and TB6 took off as single ship aircraft (Tabs BB-26 and DD-7). The Diamond Loop is an aerial demonstration maneuver where the Diamond Formation performs a loop immediately after takeoff and was executed IAW the 57 WG Supplement to Air Combat Command Instruction (ACCI) 11-USAFAADS Volume 3, *Operational Procedures-Thunderbirds*, 3 January 2018 (Tabs Z-6 and BB-26 to BB-27). The MF then proceeded toward the northwest and entered the NTTR (approximately 12 miles north of Creech AFB as depicted in *Figure 2*) at approximately 0956L (Tabs K-7, Q-5, Z-3, Z-6 and DD-7).

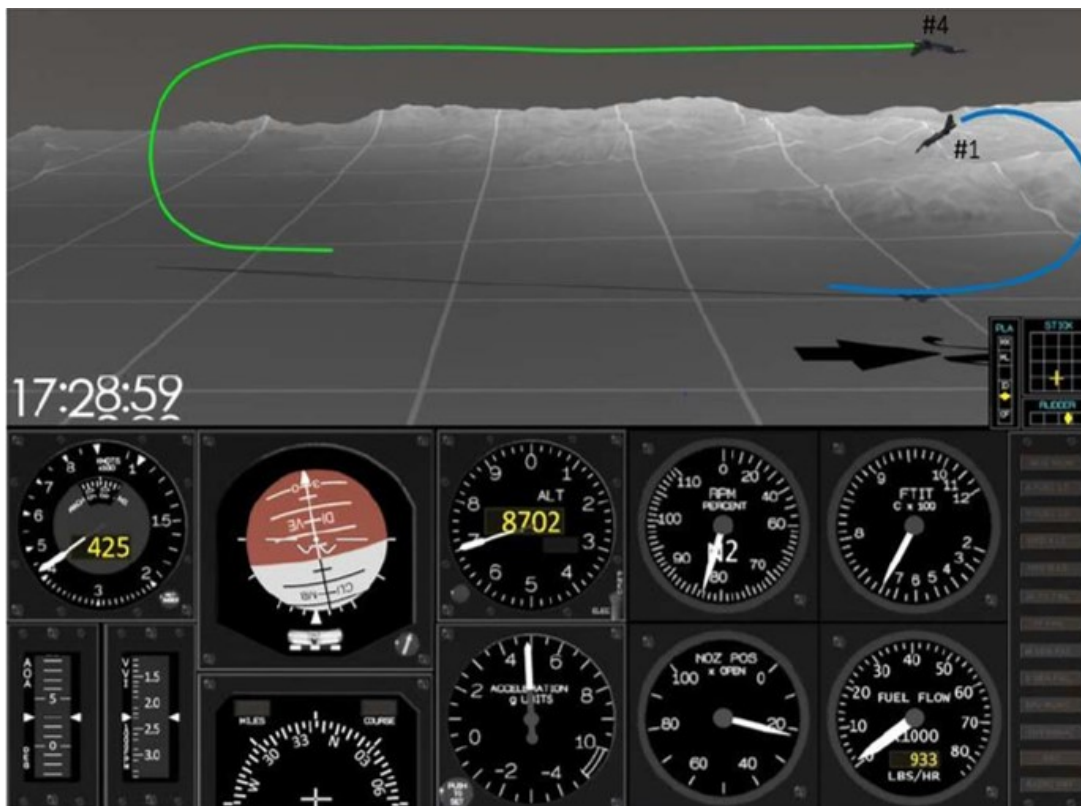
Figure 7: Beginning of Split-S Maneuver with TB1's Approximate Flight Path for Reference (Tab DD-5).

At 1028:56L, TB1 made the prescribed radio call as he reached his maximum altitude during his Half Cuban Eight (Tabs N-4 and BB-38). Two seconds later at 1028:58L, the MP selected idle engine power and pushed forward on the control stick to attain -2.06 G's, with a resulting 2,250 feet per minute climb at five degrees nose high (Tab DD-7). One second later, the MP began his Split-S maneuver as depicted in *Figure 7* by pulling the nose of the MA down towards TB1 (Tabs

V-13.11 and DD-5). The MP continued this maneuver and achieved a maximum of +8.56 G's at 1029:03L (Tab DD-7).

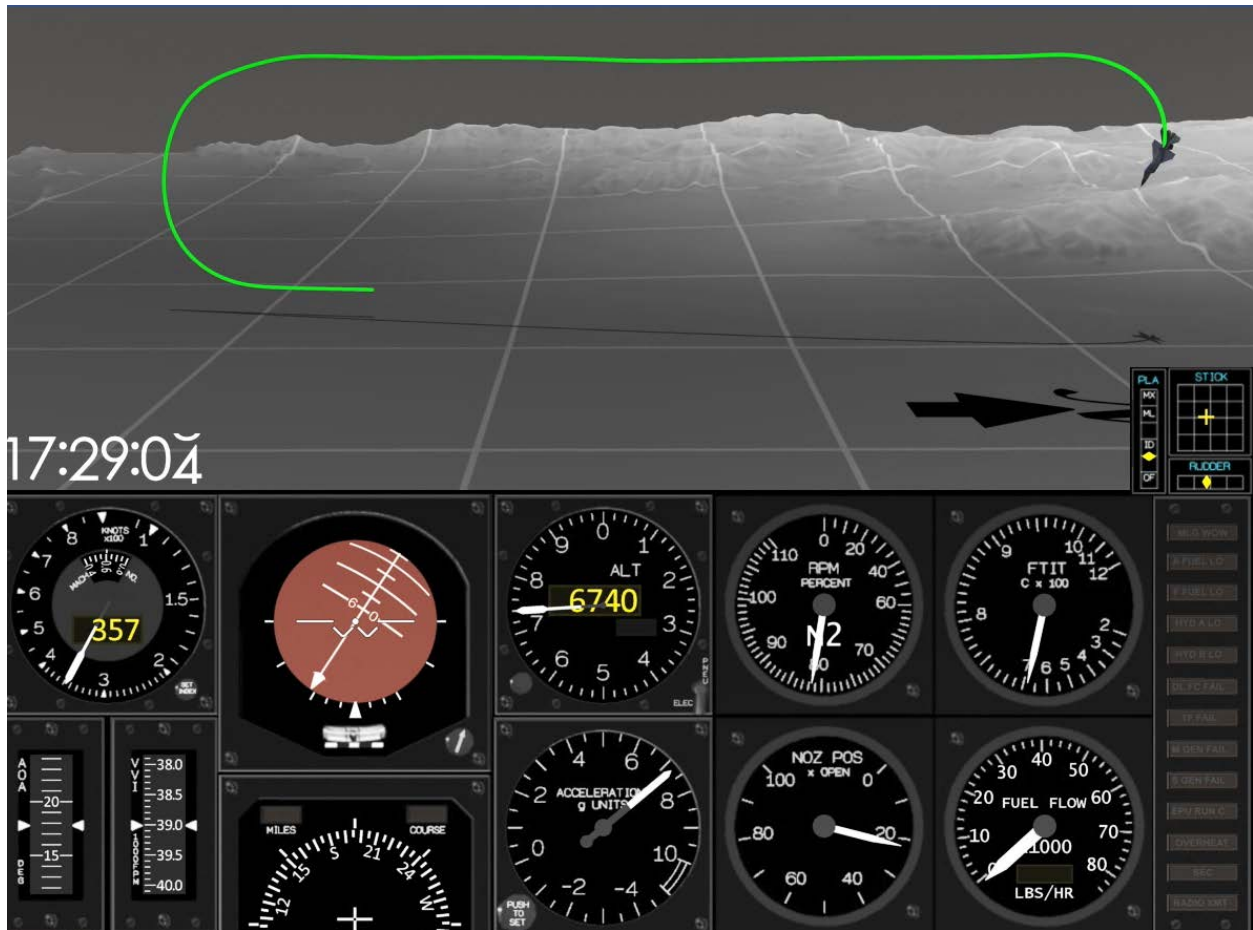
Figure 8: Deliberate Flight Control Inputs Stop (Tab Z-9).

Based on the DAS data, the MP stopped providing deliberate flight control inputs at 1029:04L, as depicted in *Figure 8* (Tabs Z-9 and DD-8). This left the aircraft 68 degrees nose low, 30 degrees left bank, accelerating through 356 KCAS, and rapidly descending through 6,556 feet MSL, with a 38,500 feet per minute descent rate (Tab DD-8). This descent continued until 1029:08L, when the MP began to increase engine power and pulled back on the control stick at 1029:09L (Tab DD-8). At that point, the MA was at 415 KCAS, 3,452 feet MSL (406 feet AGL), 60 degrees nose low, and 65 degrees left bank (Tab DD-8). Based on F-16 dive recovery procedures, once the aircraft descended below 2,300 feet AGL at that dive angle, a safe recovery above the ground was not possible (Tab DD-6 to DD-7).

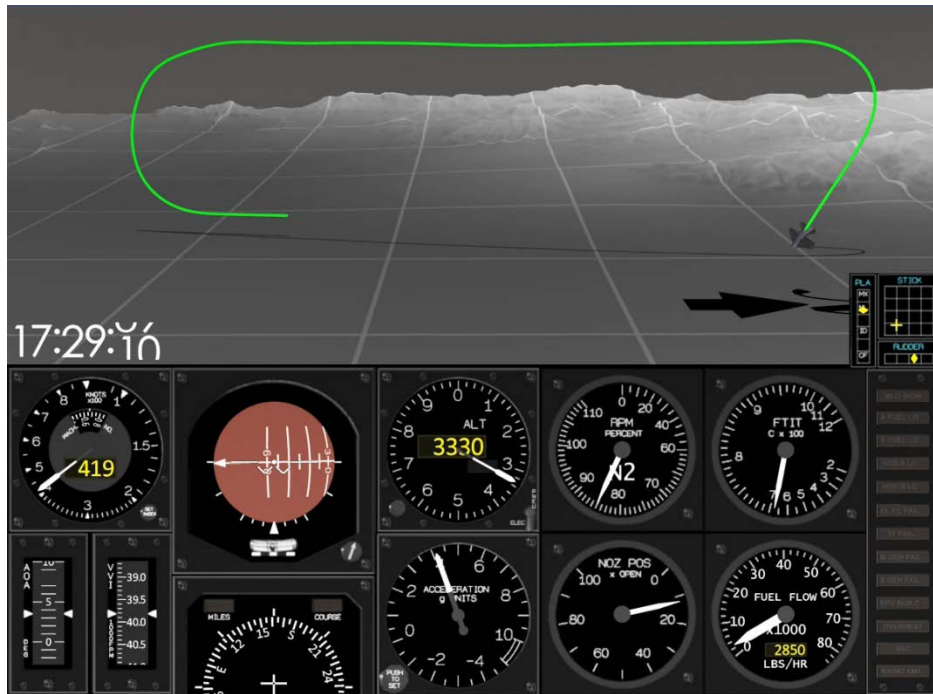
Figure 9: Last Recorded Data recorded approximately .343 seconds before impact (Tab Z-10).

At 1029:10L, the MA impacted the ground at 419 KCAS, 57 degrees nose low, 89 degrees left bank, and a descent rate of 39,750 feet per minute with maximum control stick input and high engine power setting, as depicted in *Figure 9* (Tabs U-4 and Z-10). The RSO made the radio call “4, recover” just as the MA impacted the ground (Tabs Z-11 and V-13.12). Both the RSO and TB6 called “Knock it off” on the radio to cease demonstration maneuvers (Tabs N-4, V-2.13, V-14.15 and DD-8). The MA impact resulted in the MP’s fatal injuries (Tab X-4).

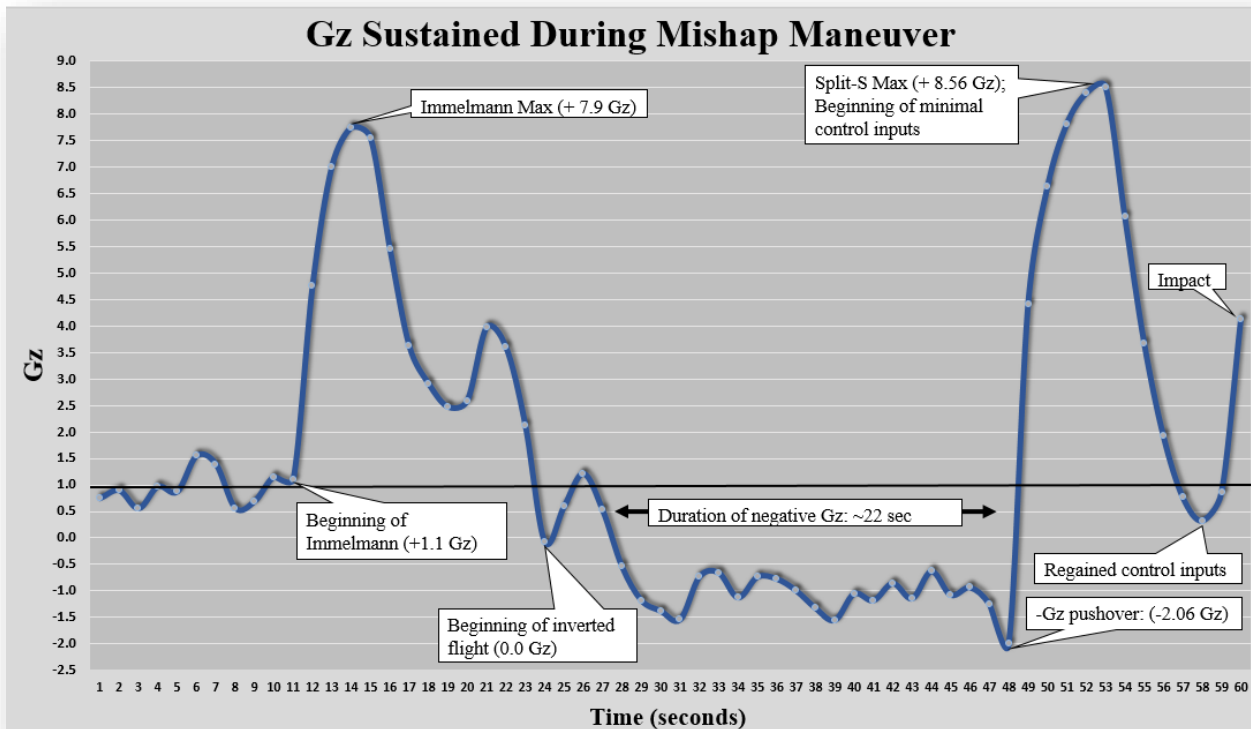
Figure 11. Data Extracted by Medical Member from Mishap Data (Gz terminology represents measurements of G in the z axis, generally) (Tab Z-7)

- a. 1028:22L: Beginning of Immelmann (Max +7.9 G’s)
- b. 1028:36L: Beginning of inverted flight (with 22 sec duration neg G’s)
- c. 1028:56L: -0.90 G’s recorded
- d. 1028:58L: Maximum –G’s: -2.06 G’s
- e. 1028:59L: +3.61 G’s (5.67 G’s/sec)
- f. 1029:00L: +6.23 G’s (2.62 G’s/sec)
- g. 1029:01L: +7.75 G’s (1.52 G’s/sec)
- h. 1029:02L: +8.34 G’s (0.58 G’s/sec)
- i. 1029:03L: Max +G’s: +8.56 G’s (0.21 G’s/sec)
- j. 1029:04L: Beginning of period of no deliberate flight control inputs
- k. 1029:09L: Beginning of renewed flight control inputs
- l. 1029:10L: Impact
