UNITED STATES AIR FORCE
GROUND ACCIDENT INVESTIGATION
BOARD REPORT

CONFINED SPACE MISHAP, SEWAGE CLEARING PROJECT

**380th EXPEDITIONARY CIVIL ENGINEER SQUADRON,
380th AIR EXPEDITIONARY WING**

DATE OF ACCIDENT: 8 JULY 2018

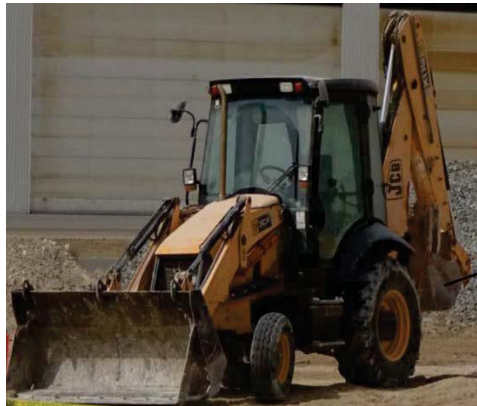
Figure 4 (Tab Z-3)
Backhoe used at mishap site

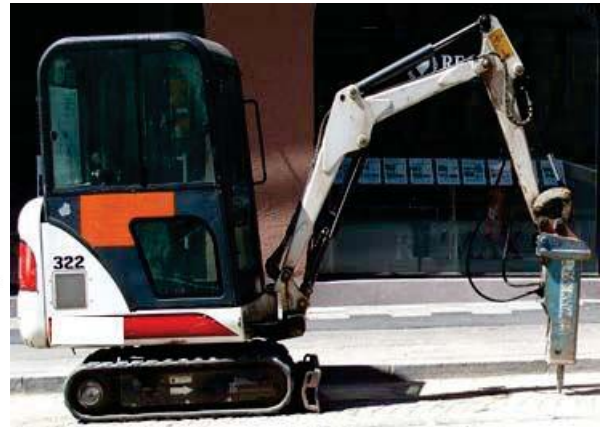
There were two separate crews working in the immediate area of the mishap (Tab R-61 to R-62). One crew was the pavement and equipment team consisting of two individuals, Mishap Witnesses 4 and 5 (MW4 and MW5) (Tab R-61). Their role was to locate one of the manholes, clear the surrounding area of rock and concrete, and make the manhole accessible for the sewage clearing effort (Tab R-61). MW4 and MW5 were using two machines that day (Tab R-61). MW4 was driving a backhoe (Figure 4), while MW5 was on a skid steer (referred to by the brand name “Bobcat”) that had a jackhammer attachment on it (Figure 5) (Tab R-61).

Figure 5 (Tab Z-4)
Example skid steer with jackhammer attachment.
Photo credit: High Contrast

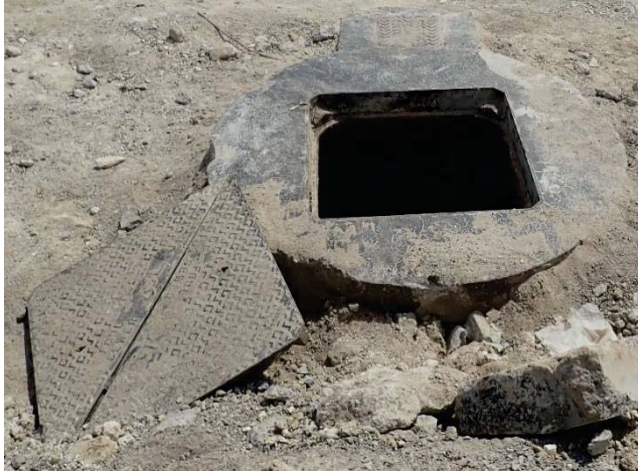
At approximately 1330L, the 4-person WFSM team arrived at the jobsite to continue sewage line clearing efforts (Tab R-5 and R-68). The MA and MW2 removed a metal outer cover (Figure 6) from the manhole and discovered there was a second square manhole cover made of fiberglass (Figure 7), designed to prevent sand and dirt from getting into the manhole (Tab R-5 and R-28). The WFSM team attempted to remove the fiberglass cover unsuccessfully and eventually had MW4 use the small bucket on the backhoe to remove it (Tab R-62). MW4 broke a handle off the cover on his first attempt to remove it and then used the small bucket to push the cover (Tab R-62 and R-78). MW4 was able to dislodge the cover; however, it fell to the bottom of the manhole (Figures 8 and 9) (Tab R-41 and R-62). There was a noticeable smell when the cover was removed (Tab R-14, R-63, and R-80).

Figure 6 (Tab Z-4)
Example metal manhole cover and manhole opening

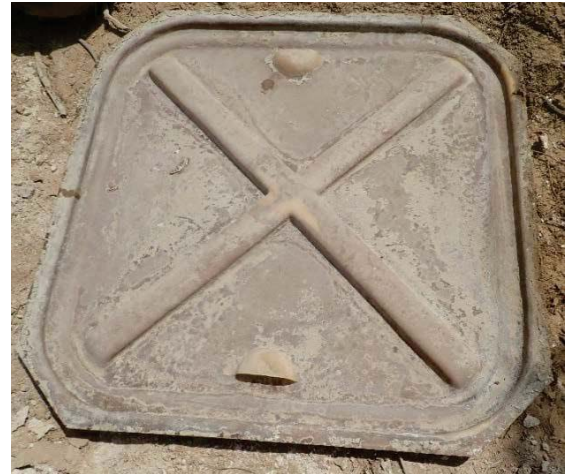
Figure 7 (Tab Z-5)
Example fiberglass manhole cover

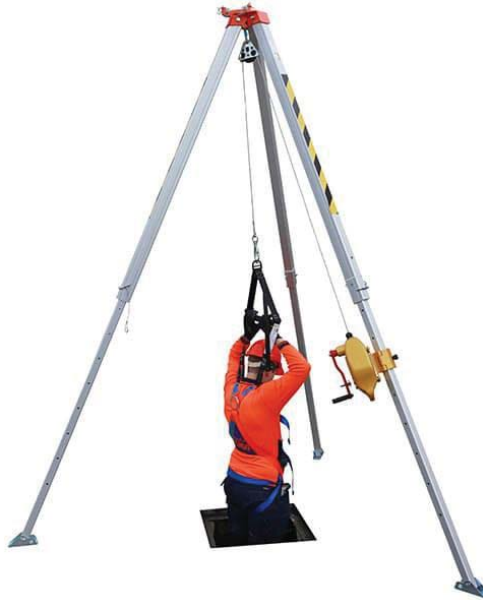
Figure 11 (Tab Z-7)
Example of confined space rescue tripod

Firefighters extracted the MA from the manhole at 1419:57L (Tab N-7). A pulse was still absent and CPR was initiated (Tab R-127). Firefighters and medical personnel placed the MA on a stretcher and put him into an ambulance (Tab R-127). The MA was in the manhole for approximately 20 minutes total, 11 of which were without emergency responders (Table 1) (Tab N-5 to N-7). Physical conditions in the manhole necessitated firefighters using a confined space rescue tripod and pulley system to extract the MA (Tab V-9.5 and V-11.5).
