# TAC ATTACK

MAY 1969  
Vol. 9 No. 5

Lightning strike

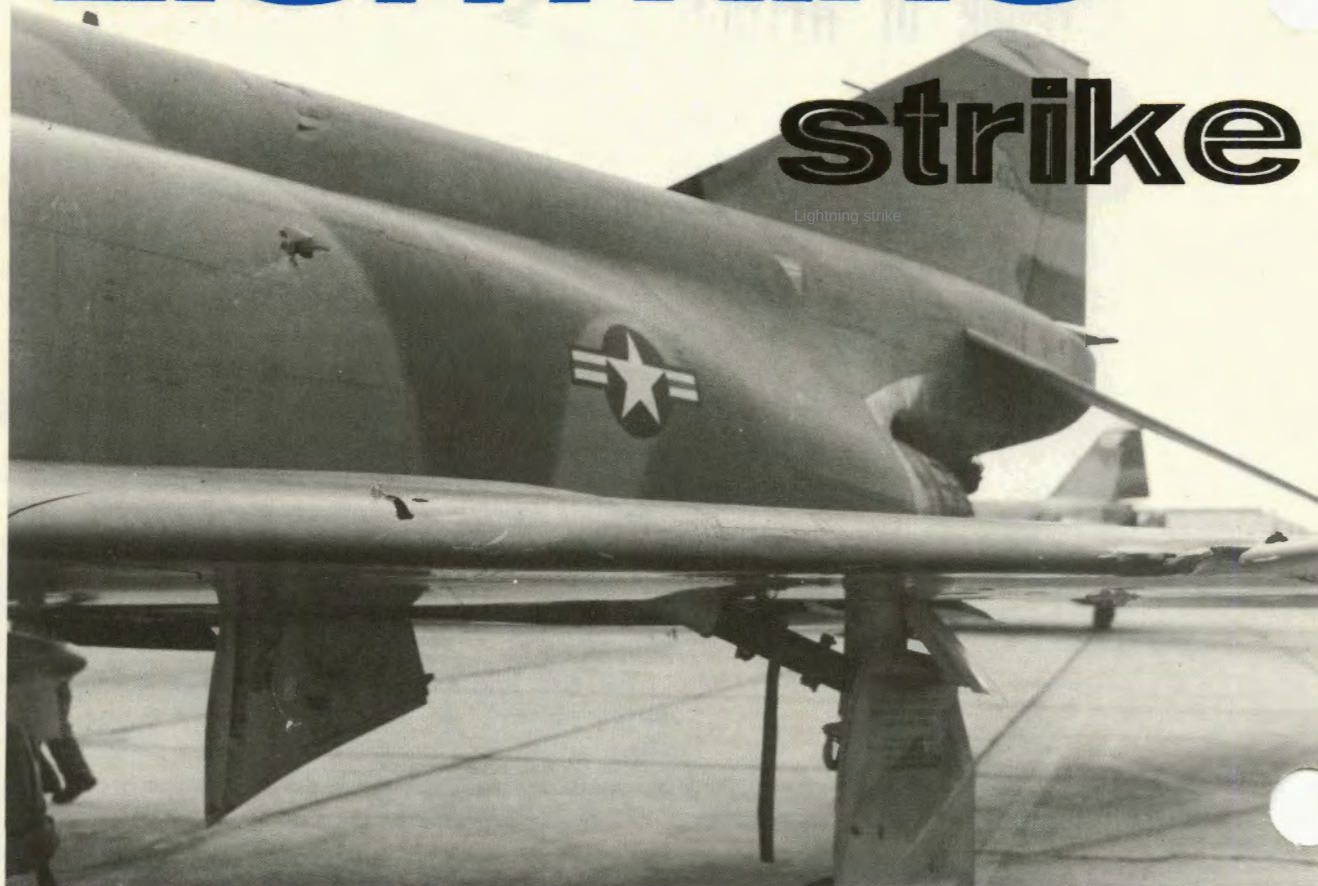
It was the middle of last summer. An RF-4 crew consisting of a pilot and navigator were enroute to their second target on a photo test mission. While circumnavigating a thunderstorm about 190 miles west of home, they took a lightning strike. The pilot estimated that they were two to three miles from the cloud at the time, thunderstorm activity was very light as estimated by weather — three to fifteen percent coverage.

Damage to the aircraft was quite extensive. The lightning strike caused the left external tank to jettison, and then explode while still very close to the aircraft. There was no evidence of forceful separation of the external tank. The damage report included: left center leading edge flap dented and 6-inch hole torn in it; left aileron flap dented and torn; left wing-fold strips torn; left inboard landing gear door dented and punctured; left cartridge starter door punctured; left engine bay door punctured; left wing skin punctured; left pneumatic starter door torn; panel 48 and adjacent skin punctured and torn; skin below ram air turbine punctured and three adjacent ribs cracked; skin aft of panel 47 punctured and torn; right external tank punctured and hole blown in aft end; and casting and hinge adjacent to doors 78 and 138 cracked. Four bolts from the left external tank seam joint were found imbedded in the left gear door and a piece from the seam flange of the left external tank was found imbedded in the left engine starter access door. Including 350 man-hours, all of this came to a hair over nine grand. We were lucky — it only cost us money this time.

The primary cause was, "Weather factor, in that the lightning strike caused the left external fuel tank to jettison and explode." Recommendations by the investigating officer were two: "That the F-4 system support manager initiate an aggressive program to lessen the apparent susceptibility of the F-4 aircraft to lightning strikes or develop a system to rapidly dissipate the electrical charge prior to damaging the aircraft and aircraft systems; and that all rated personnel be briefed on the hazards of summer thunderstorm activity" . . . consider yourself briefed.

With respect to recommendation number one, TAC headquarters requested OOAMA and ASD to make an engineering study to determine if there is a possibility of lessening the susceptibility of the F-4 aircraft to lightning strikes. OOAMA, last September established engineering study number 334E to investigate lightning problems encountered by F/RF-4 aircraft. In February of this year, the project manager reported the study showed that F/RF-4 aircraft were no more susceptible to lightning strikes than any other aircraft.

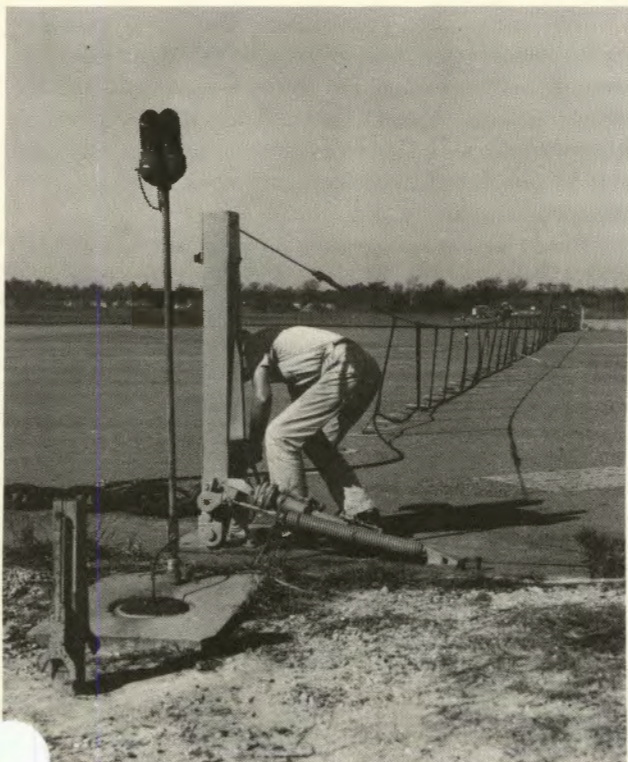
**MA-1A is the oldest Air Force barrier system in use. It and its modified brothers have saved many birds, and with good maintenance can save many more.**

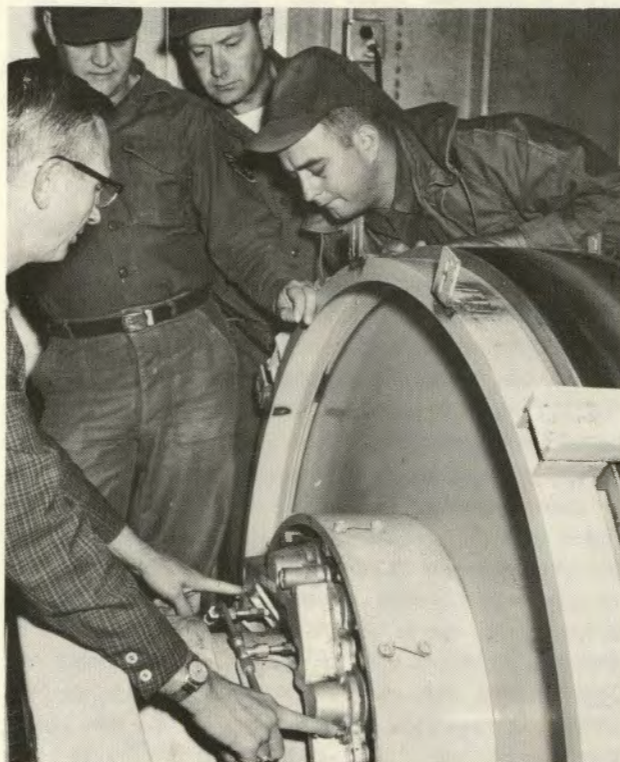
**Specialists learn the nitty-gritties of maintaining BAK-12 barrier brakes at their own base, from ATC Technical Training Center instructor, Mr. L.E. Schoffit.**

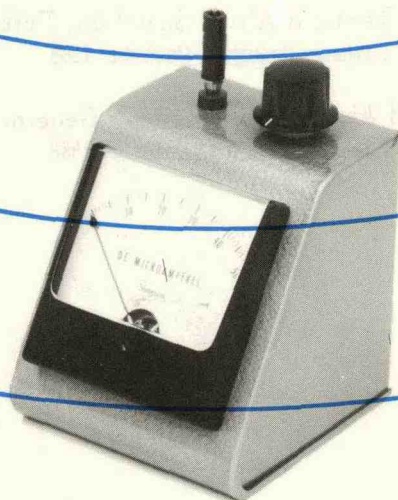
The snooper is not expected to become a supply item but units can easily build as many as required for about 30 dollars each. Assemble the parts itemized in Figure 2 according to circuitry shown in Figure 3. When assembled, tune the snooper to the desired frequency by adjusting condenser, C<sub>1</sub>. Then you're ready to save a lot of time recovering the next squawking beacon. ➔

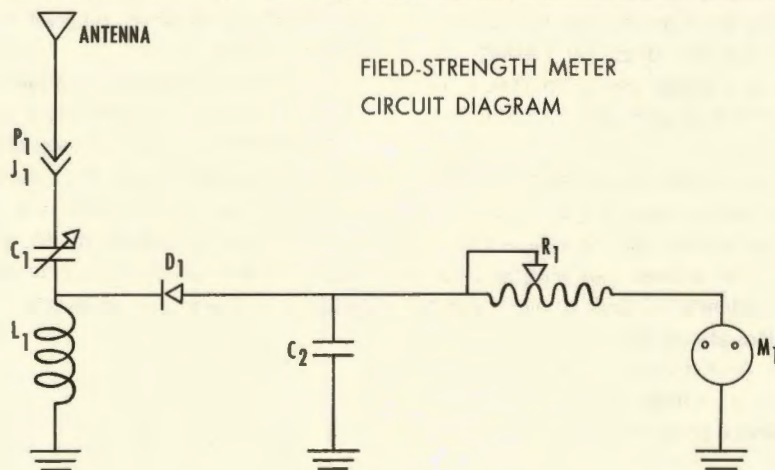
Figure 3

the high side. The signal strength to the meter is then reduced by turning the only moving part, a potentiometer. With this simple method, the snooper will lead directly to a chute with a run-away beacon.
