# TAC ATTACK

FEBRUARY 1970

TACTICAL AIR COMMAND

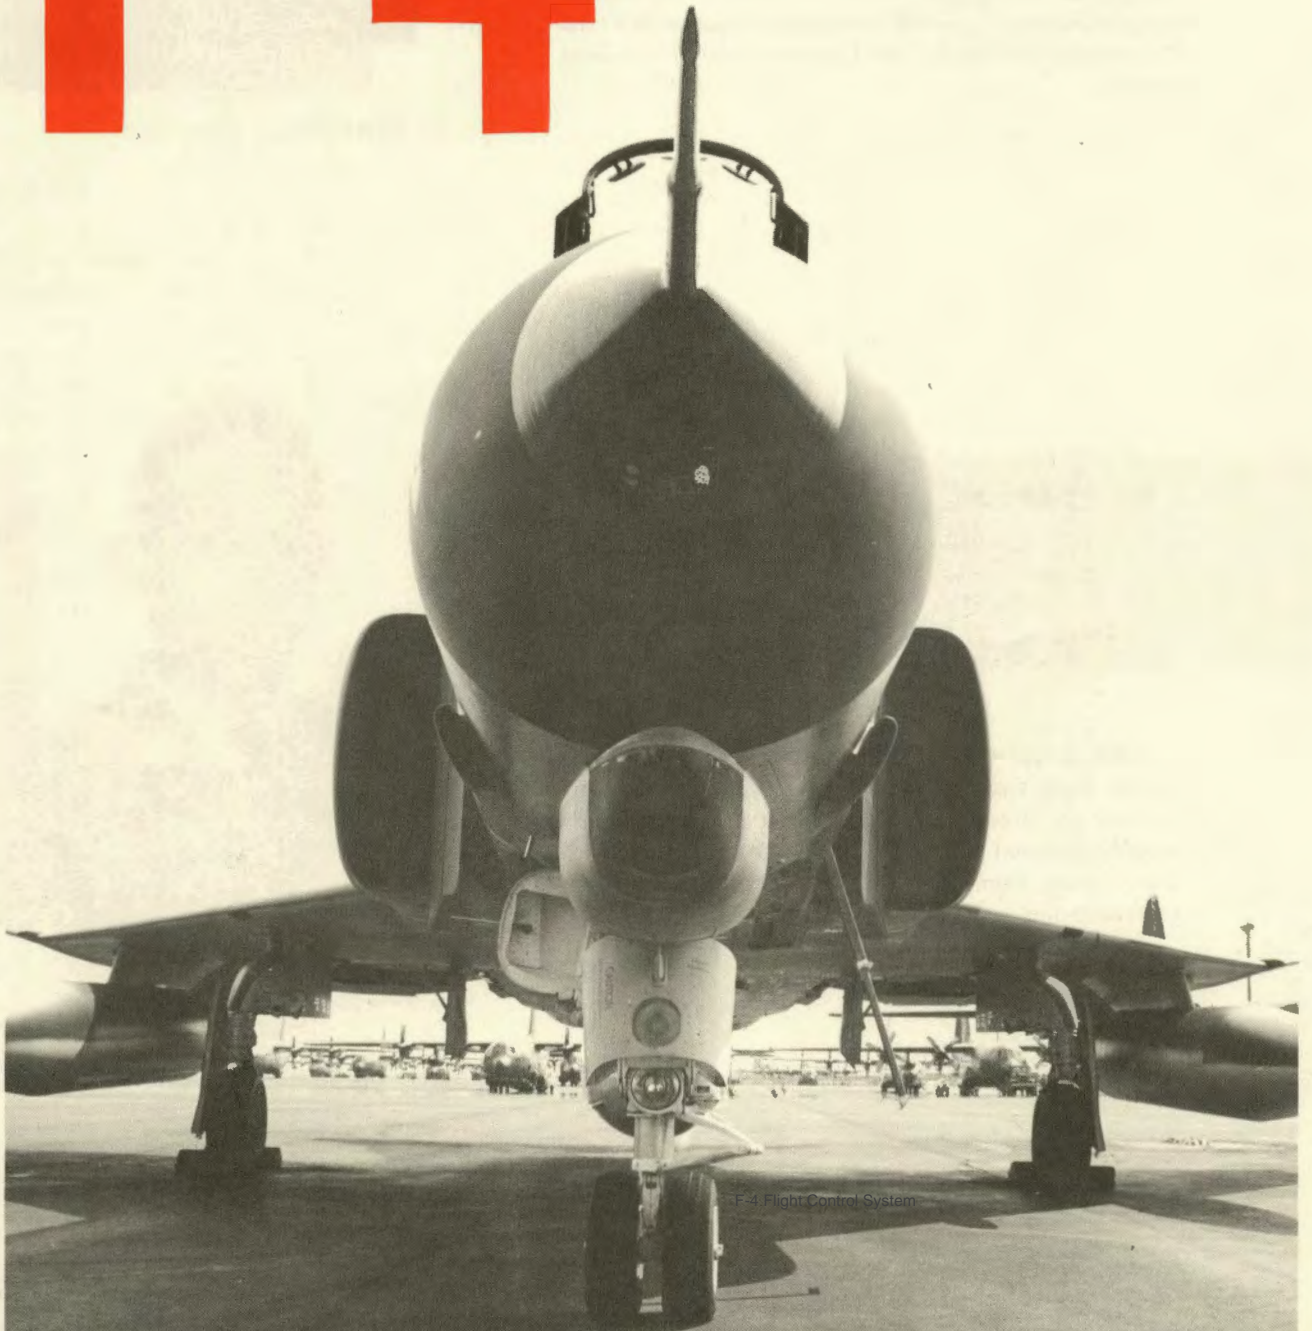
# F-4 FLIGHT CONTROL SYSTEM.

F-4 Flight Control System

The bellows, which are pressurized from the fin-mounted total pressure (airspeed) pickup, exert an aft stick force that increases with indicated airspeed. This force opposes the bobweight force and makes the stick "stiffer" at higher speeds. The difference between the magnitude of these two forces represents the "feel" force transmitted back through the control system to us at the stick. When flying in a condition we wish to maintain, we operate the trim switch to get rid of any stick forces. What we are doing is running a trim actuator on the
