TAC ATTACK

NAY 1972

Tactical Air Command

CURRENT INTEREST

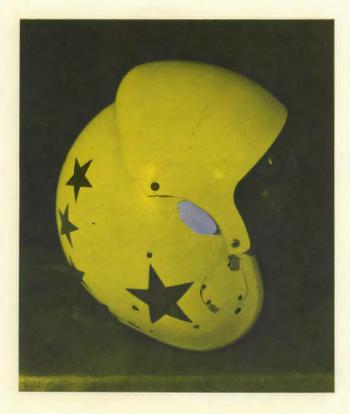
Check the thumb actuated visor

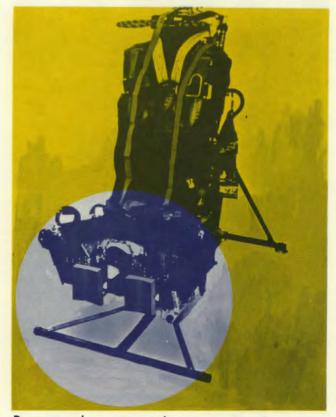
Proposed seat with magnetic leg restraints

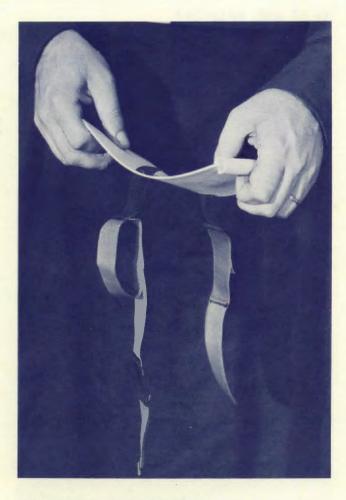
FLEXIBLE KNEEBOARD

A simplified clipboard (kneeboard) is on the way. As shown in the illustration, it's made of a durable yet flexible plastic board attached to the leg with velcro tape. The letdown book, maps, AF Form 70, or any other piece of material you care to put on it is held down by another piece of velcro attached to a transparent piece of plastic. You'll notice there is no light mounted on it. (They never seem to work when you need them anyway!) It's just a simple, small, inexpensive device to do the job. This one, even if it comes loose in flight, won't bind the stick or throttle, won't hurt you if it hits you, and won't come apart when you eject.

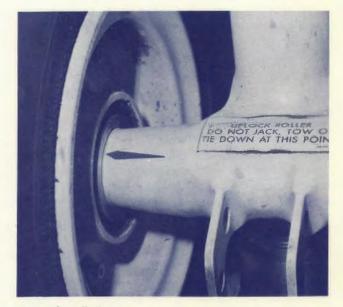
correct installation

The first photo gives a good view of what the wheel should look like when it is correctly installed. The wheel fits snugly over the race and up to the painted forging of the main part of the gear.

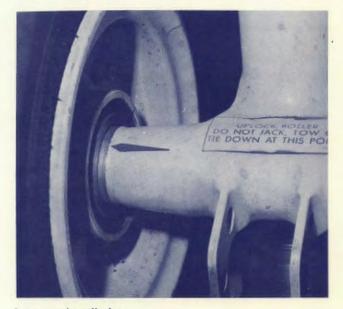
incorrect installation

The second photo indicates how the wheel will look when it has been installed incorrectly. It is obvious that the wheel is not fully seated over the race and part of the race is visible. An aircraft with a nose gear that looks like this should not be flown or taxied.
