TAC ATTACK

SEPTEMBER 1976

LOW LEVEL
WIND SHEAR...Page 4

LOW LEVEL WIND SHEAR	4
OVERCONTROL	10
F-5	16
ANATOMY OF A TCTO	20
FOD - A MANAGEMENT PROBLEM	24

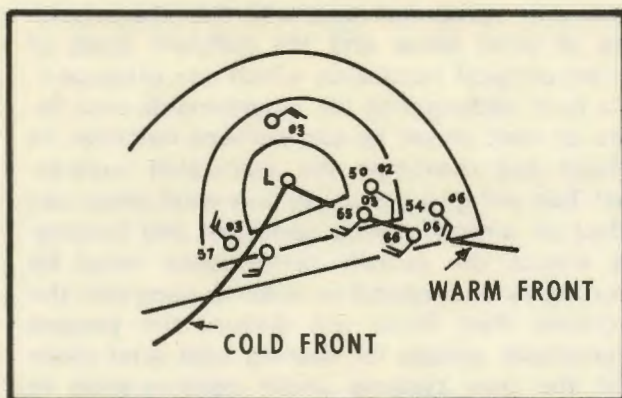
A front (warm or cold) will contain significant wind shear if it meets one, or both, of the following criteria: (1) the temperature differential across the front at the surface is 10 degrees F (5 degrees C) or higher (Figure 1), (2) the front is moving at 30 knots or faster (Figure 2).

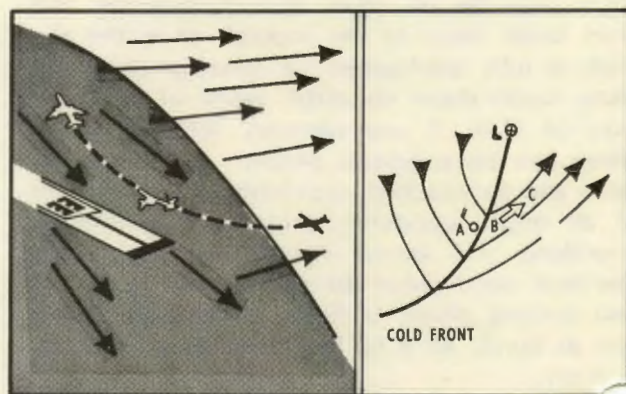
If a pilot carefully studies a surface weather map, he can determine the direction of the wind above and below a frontal system. For example, the cold front in Figure 3 meets the low-level wind shear criteria. The surface winds at Airport A are below the front. To determine the wind di-

rection above the front, interpret the isobars in the warm sector immediately ahead of the cold front. In the example, the winds below the front are from 320 degrees and the winds above the front are shown by the arrow BC, or from 220 degrees. Therefore, an aircraft flying an approach to runway 33 (depicted in the picture) would be transitioning from a 110 degree left quartering tail wind to a head wind. Of course, the aircraft would experience a sudden increase in IAS and lift which would initially tend to make it rise high on the glide path.

An approach to a northeast runway under the conditions in Figure 3 creates another problem. The wind above the front, being a direct tail wind, produces high ground speed. This approach would require a high rate of descent and the IAS would have a tendency to increase even with the throttles in idle. As the aircraft penetrates the frontal surface in a direct left crosswind, the IAS will increase even more, causing a corresponding increase in lift with the aircraft having a tendency to rise high on the glide path.

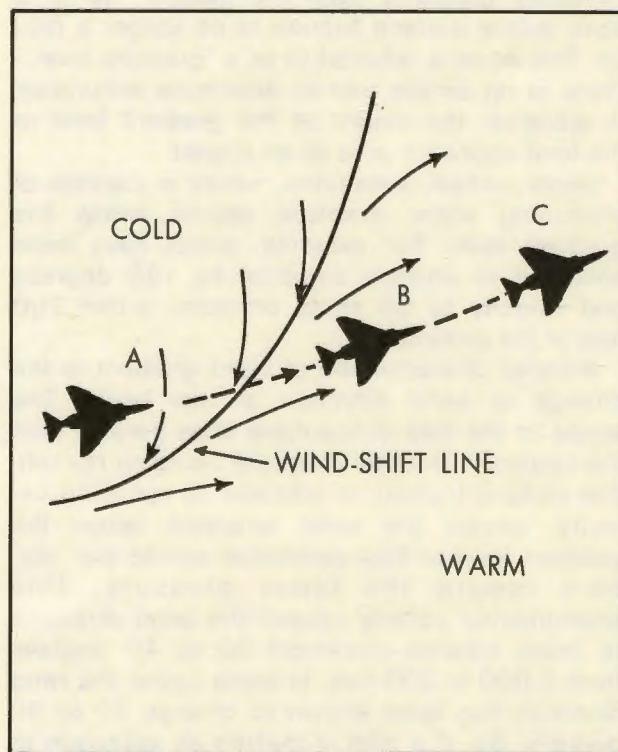
Horizontal shear occurs when the flight path of an airplane passes through a wind-shift line. Figure 4 illustrates a wind-shift line that might be found locally along a cold front. The aircraft is leaving the cold side of the front where there is a northerly wind and penetrating into the warm area which has a southwesterly wind.

Figure 5 is a profile view of an aircraft flying through a wind-shift line and depicts how the shear temporarily affects the plane's airspeed and ground speed. The IAS at point B would instantly drop to 150 knots because the net change along the flight path is 50 knots (+10 to -40).

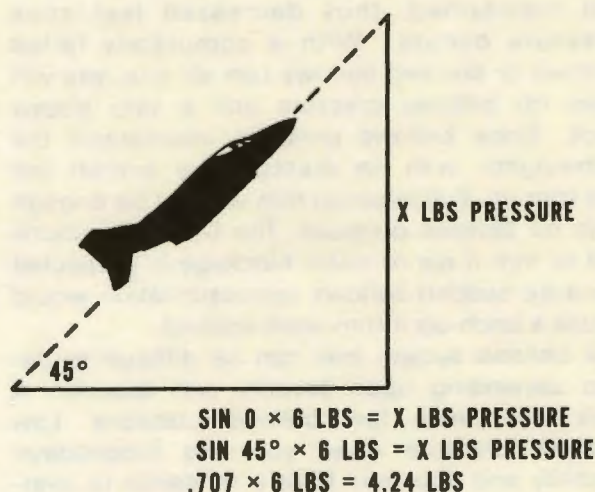
diagram 1

To calculate the amount of stick force supplied by the overbalance weight, you must add the pitch angle to the angle of attack. Then, take the sine of the resulting angle times 6 pounds (see diagram 1). In an unloaded 45-degree climb, the overbalance weight provides 4.24 pounds of stick pressure.

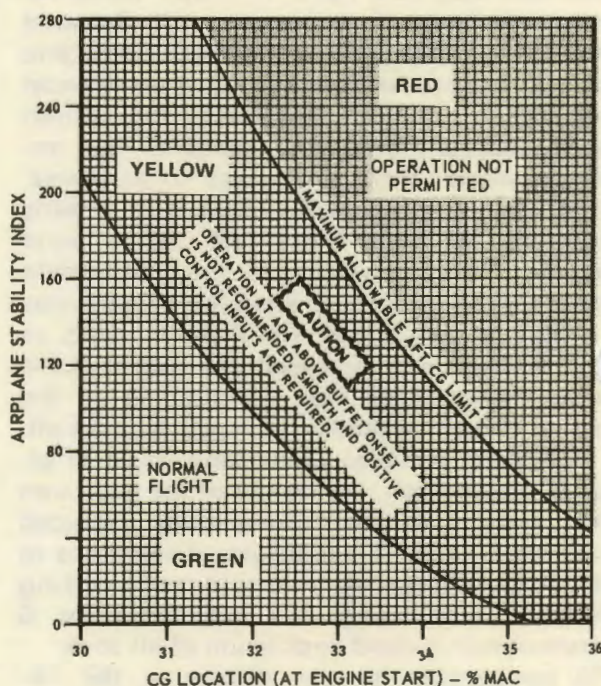
diagram 2

condition is another area that will decrease longitudinal stability. Since most fighter pilots are not weight and balance specialists, it is wise to have the C.G. for your normal loads and configurations precomputed and posted in your flight planning room. It is then a simple matter to add up the stability index number and go to the aft C.G. limits chart in the Dash-1 and see if you are in the normal (green) or caution (yellow) area (see diagram 2). You should never fall in

the prohibited (red) area. If you have a heavy load and happen to fall in the caution area, smooth and positive control inputs are required.

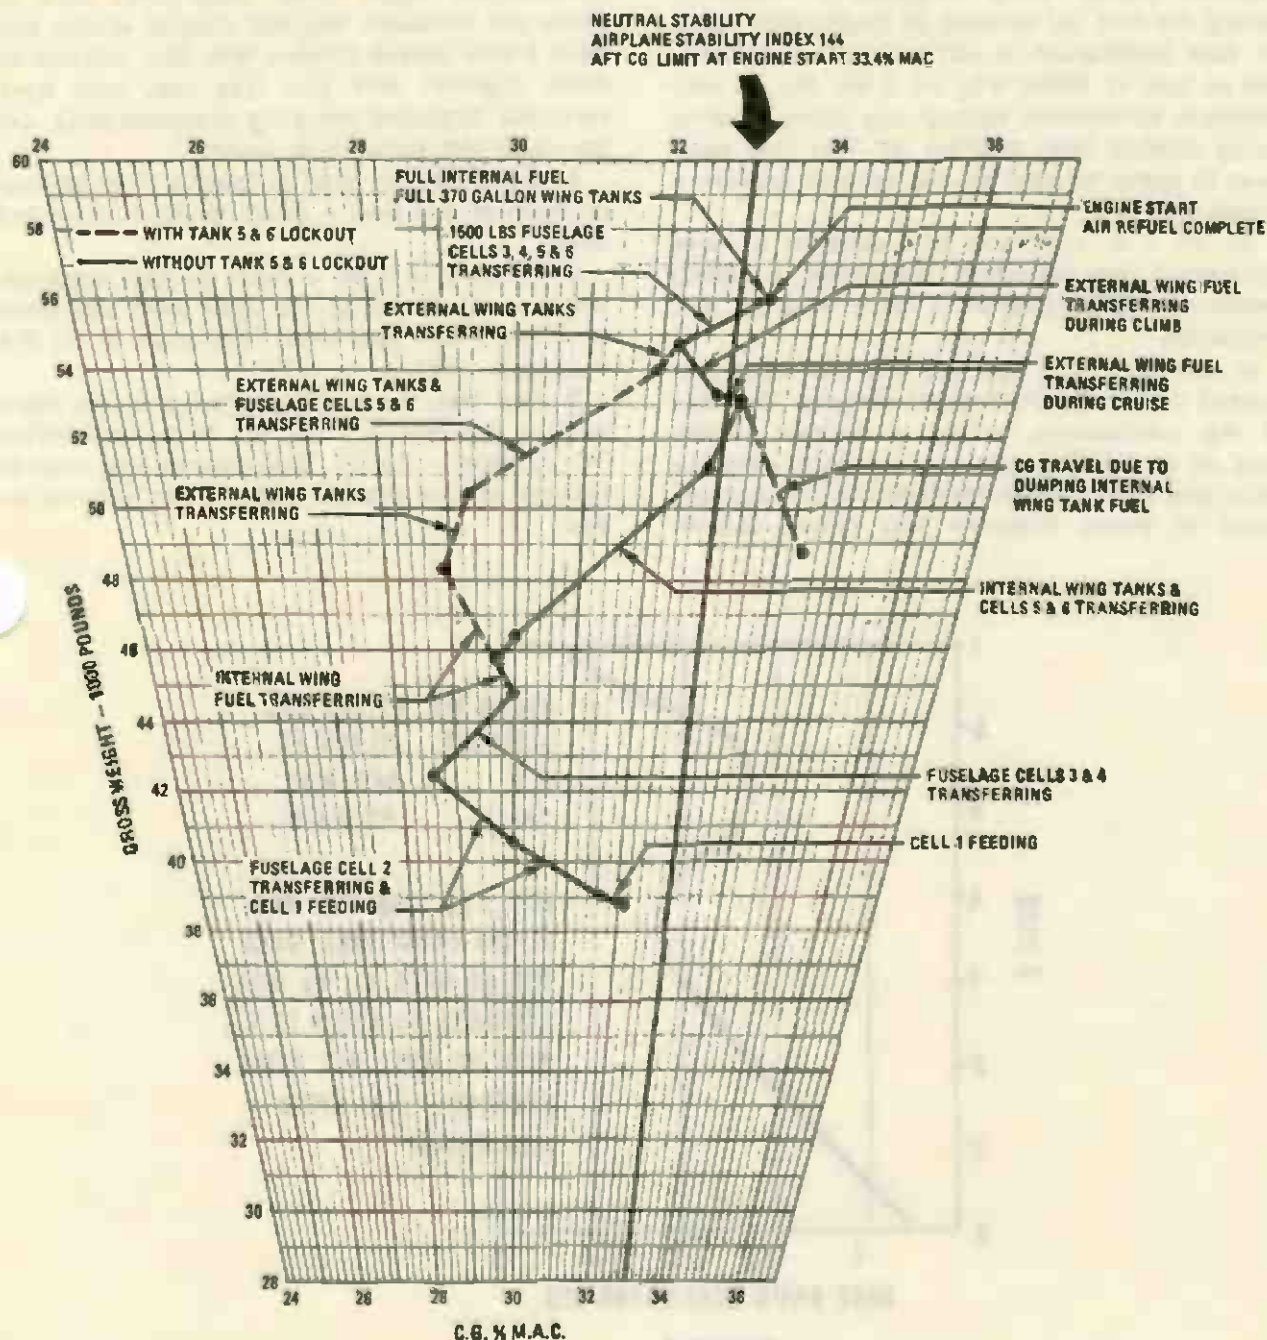
diagram 3

Your worst aft C.G. condition for each mission will normally be at engine start or after air refueling, unless you dump your internal wing fuel. If you dump your internal wing fuel while the fuselage is still full, your C.G. can shift aft as much as 1.4 percent. During normal fuel transfer, your C.G. does not change very much until the external tanks go dry and the internal wings start feeding. As the internal wings an

cells 5 and 6 feed, the C.G. shifts forward rapidly (see diagram 3).

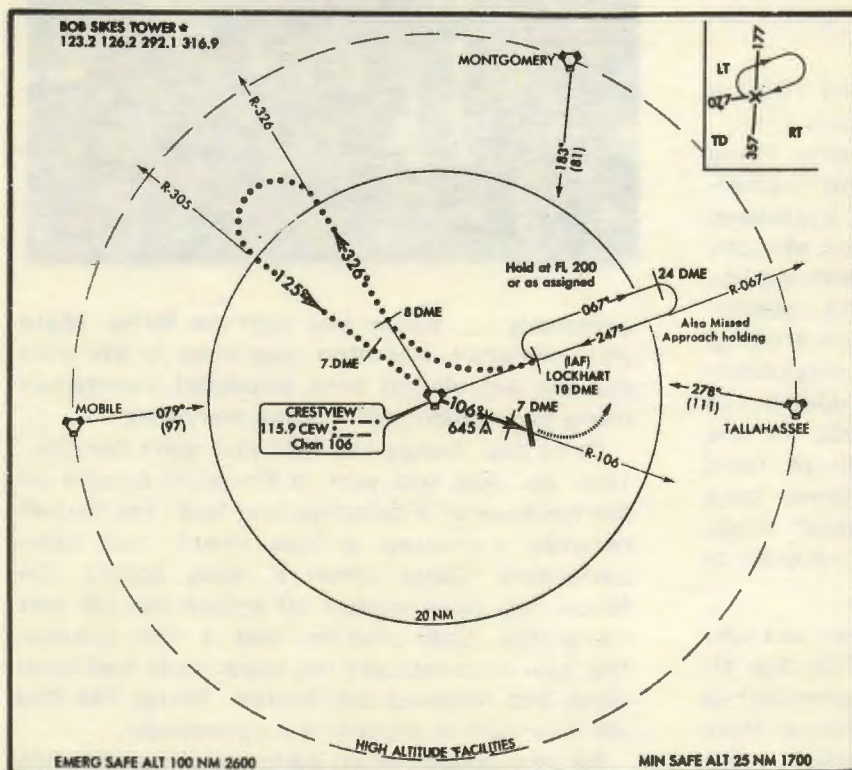
QUESTION: Am I required to initiate a turn at the IAF (Lockhart) to intercept the 326°

radial as depicted in the Hi-TACAN approach to Bob Sikes airport?

ANSWER: No, not necessarily. Remember that approach depictions are designed for use by all types of aircraft. Air-

speeds and angles of bank peculiar to individual aircraft may require that published flight path depictions be modified slightly to allow for the turn

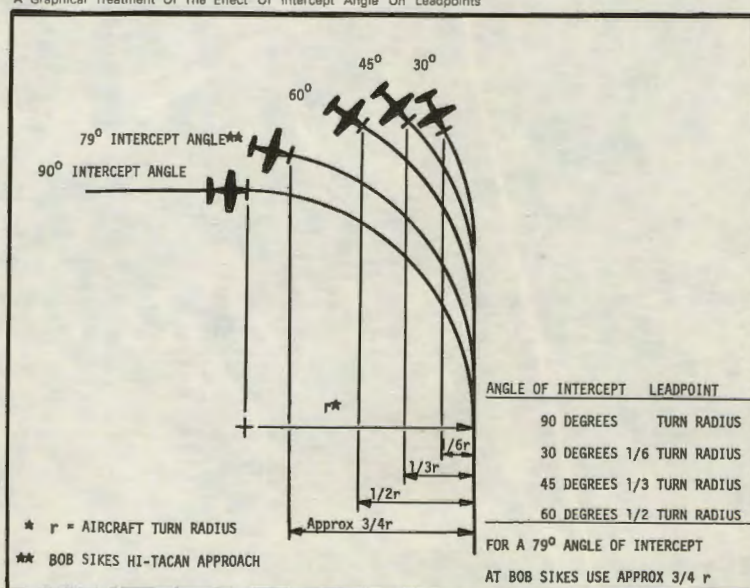
A Graphical Treatment Of The Effect Of Intercept Angle On Leadpoints

In the example above, start-turn point = (3+4) - 2 = 5 DME.

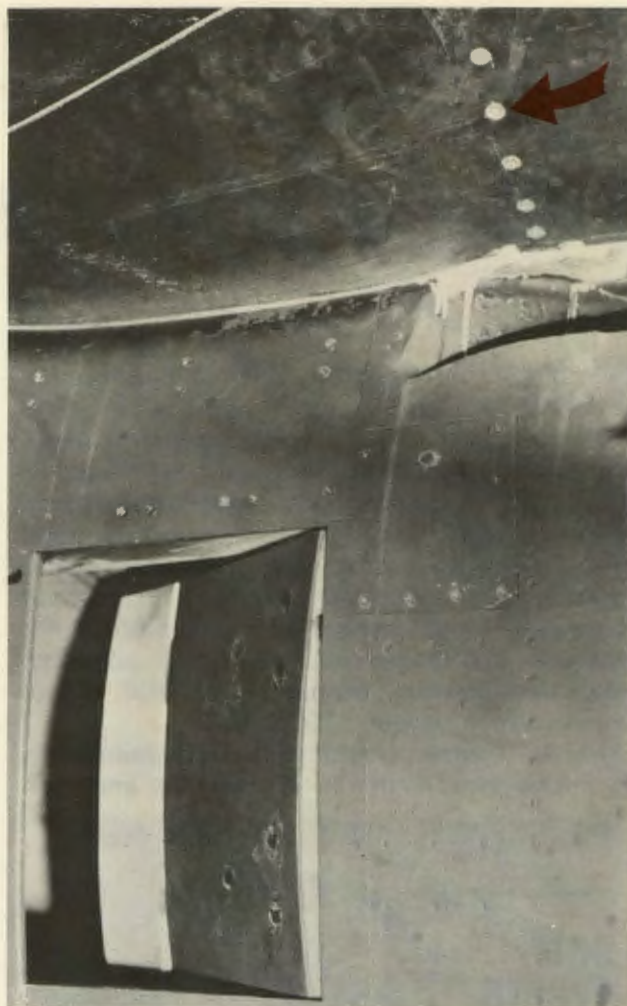
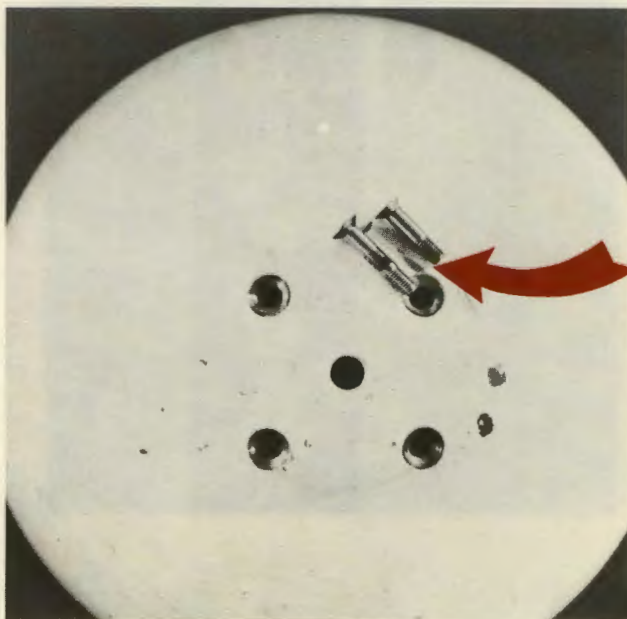
What's "grip-length"? It is really bolt length, and is measured from the top of the head to the

beginning of the bevel just prior to the threads - in sixteenths of an inch (photo 3). The mechanic's problem is how to determine which bolt has the proper grip length for the holes. To compound the problem, the proper size bolts do not have their grip length stamped on the head of each bolt. A special tool is required to determine the exact length. In a survey of mechanics of all grades, 95 percent could not measure the length of these bolts correctly. Why? No previous training. This skill is not taught in tech school, FTD, or OJT.

During an F-111 engine run in May of this year, the number two engine sustained foreign object damage (FOD) costing \$165,000. The origin of the foreign object was not difficult to trace ... a fastening bolt was missing from the aft lower glove fairing cover (panel 3328) located just above the engine blow-in door (photo 1). The nose cone of the heavily damaged engine had the imprint of a bolt 4/16 inches shorter than the one required for the empty hole (photo 2).

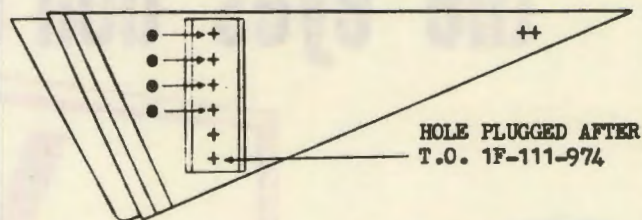
- 3327 (12B5880) - AFT LOWER GLOVE FAIRING COVER (LH)
- 3328 (12B5880) - AFT LOWER GLOVE FAIRING COVER (RH)

- + 64228V4-12 BOLT (8) - PRIOR TO T.O. 1F-111-974
- 64228V4-14 BOLT (4) - AFTER T.O. 1F-111-974
- + 64228V4-12 BOLT (3) - AFTER T.O. 1F-111-974

During the investigation, the six remaining fasteners in the panel were removed. Four of these bolts were also too short ... but only by 2/16 inches. It was discovered that the wrong bolts could be installed and their threads would engage the self-locking nut plate. They could also be torqued to the proper value. However, they would not secure the panel. A one-time, fleetwide inspection revealed nearly all F-111s to have some incorrectly sized bolts installed in panel 3328. How could this happen? The reasons were tech order deficiencies and conflicts, not understanding "grip-length," and training inadequacies.

TO 1F-111F-2-2-1, which was used during panel installation, was in conflict with the parts list tech order on the type of bolt required. TO 1F-111F-2-2-1 listed bolts which had inadequate thread length required to ensure proper engagement of the self-locking nut plate. TO 1F-111F-4-1, the parts list tech order, did not list this type of bolt, making it an unacceptable substitute.
