# TAC ATTACK

JANUARY 1983

VOLUME 23 NUMBER 1

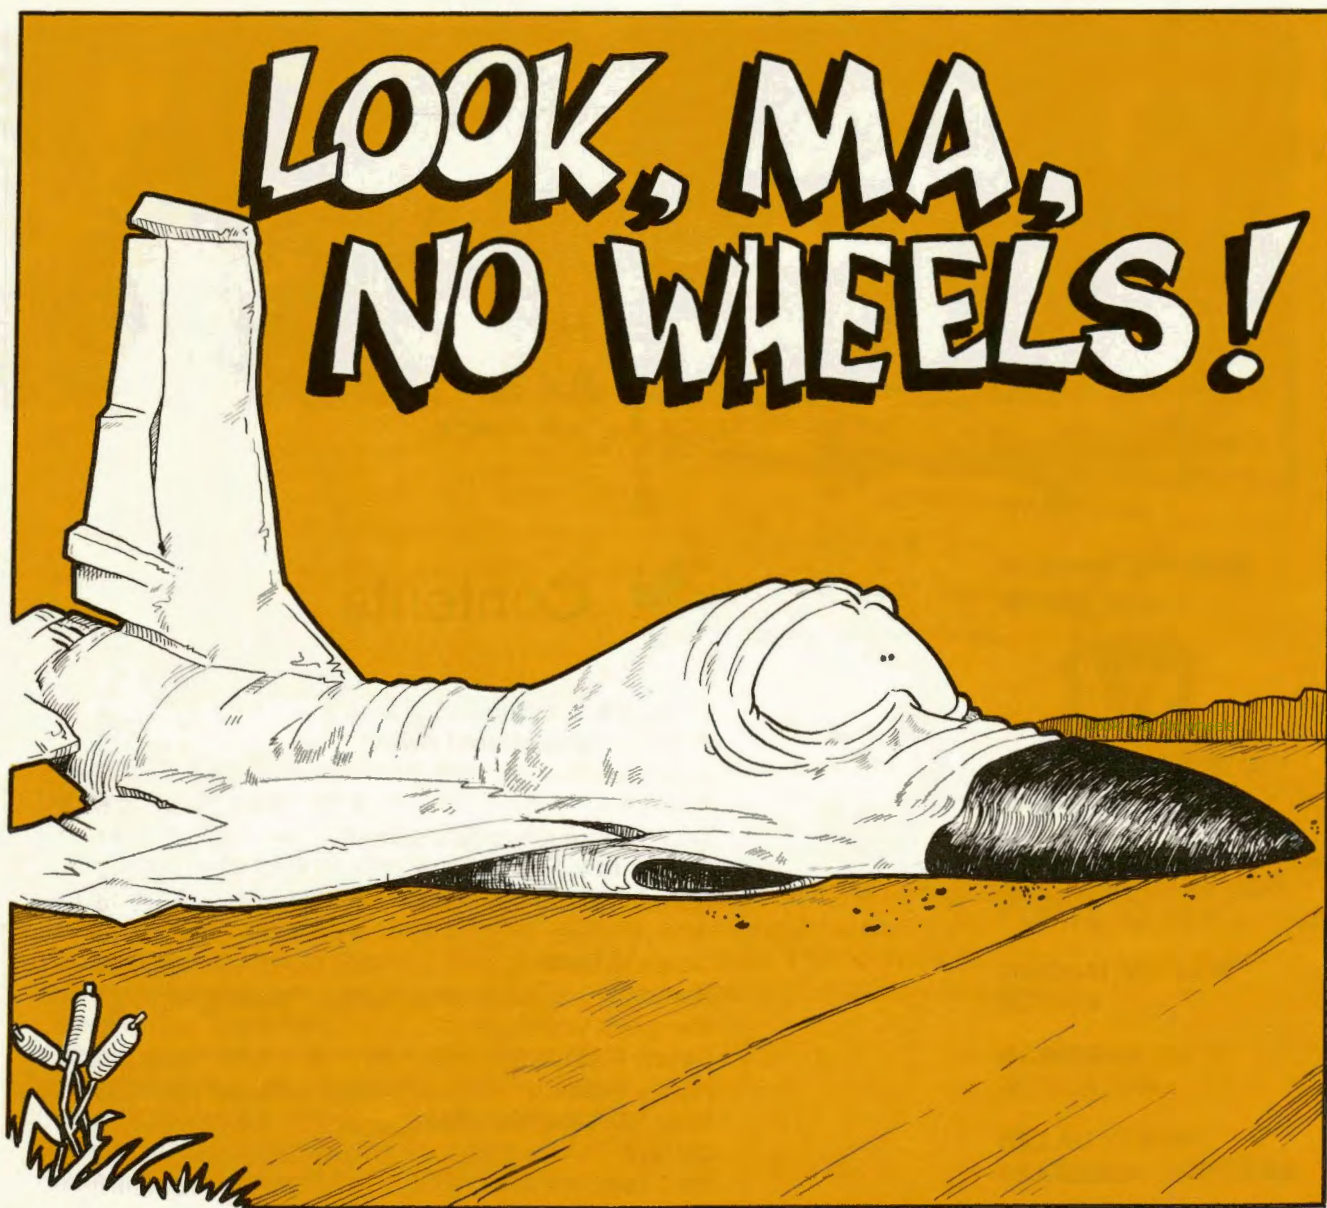
An F-16 was flying an ILS approach to a cross-country base. The pilot was concentrating on flying precise course and glideslope. When he touched down, the pilot thought everything was normal. But as he slid to a stop on the centerline fuel tank and tower called that he was on fire, the pilot realized something was wrong.

The landing gear weren't down.

Fortunately, the pilot wasn't injured, and the damage to the airplane was relatively minor. The centerline tank was destroyed, but the aircraft itself only suffered scraped ventral fins.

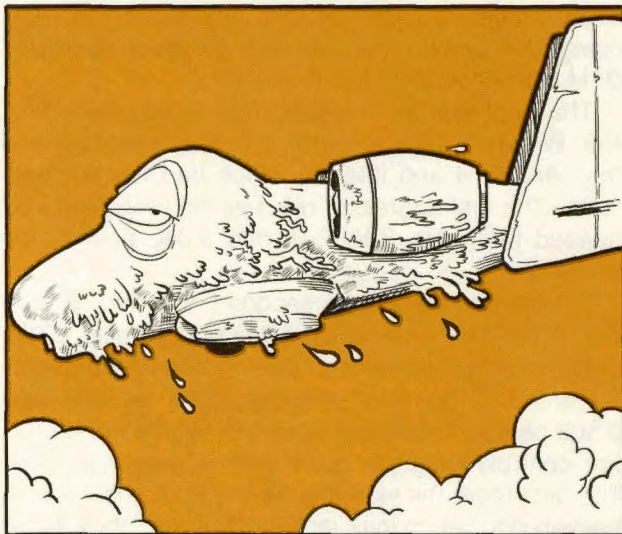
After all the airplanes landed, the three A-10s were found to be saturated with JP-4. The fuel had entered avionics bays and come in contact with unsealed electronic components. The potential for fire or explosion was high.

The cause of the fuel spray was an improperly installed part on the tanker's nozzle assembly, which had recently been rebuilt. But that wasn't the cause of the hazard. The hazard came about because the A-10 pilots decided to continue refueling despite the spray.

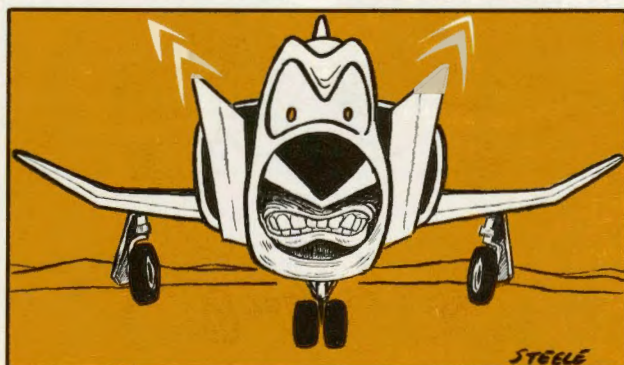
the ramps stayed out. They remained extended and the duct temperature light stayed on until both engines were shut down.

Troubleshooting of the variramp system showed the problem was in the central air data computer (CADC) test receptacle plug. The plug is one of four plugs below the left canopy sill in the rear cockpit. The upper two plugs are attitude reference and bombing computer set (ARBCS) test plugs; the bottom plugs are CADC test plugs. The bottom right plug was about three-quarters of the way off its mount. A loose plug would cause a momentary interruption of CADC power, which would cause the ramps to extend.
