Just When You Thought You Knew	
Everything About F-4 Canopy Stalls	4
Aircrew of Distinction	7
TACTips	8
Safety Awards	11
Weapons Words	12
Motorcycles and Hearing	15
F-100	16
The Great Storms—Hurricanes	18
Chock Talk	21
The Case of the Missing Cotter Pin	24
Down to Earth	26
"Lose Sight, Lose"	29
Letters	30
TAC Tally	31

MAY 1983

#### By Maj Mike Lichty, TAC Flight Safety With Technical Assistance from Bobby Moore, HQ TAC MCAIR Field Service Engineer

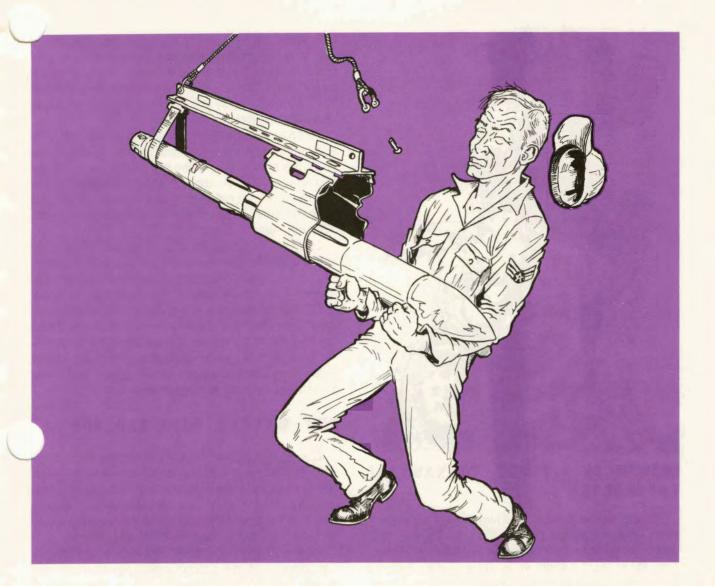
drive over to the trailer and reverse the task just accomplished. The two crewmembers assigned to steady the AIM-7 in its sling were sidestepping toward the empty trailer. The jammer driver stopped to change direction and the missile gently swayed. Suddenly, the forward end of the missile bar ejected violently from the clevis, and the missile heeded its command from gravity. The crewmember steadying the nose grappled momentarily with all the weight slamming into his forearms. He groaned with pain and frustration as he desperately tried to prevent the inevitable. Gasping, he lunged backward at the same time he retrieved his arms. The Sparrow, with its aft end still dangling in the sling, crashed against be pavement. The perfectly formed porcelain dome

over shattered to reveal a smashed seeker and numerous wire bundles.

Shocked, the crew stared disbelievingly at the missile. Baffled, they stepped forward to inspect the broken missile and sling. It was immediately apparent that the clevis pin had come out. But how? It's supposed to be held secure by a small but strong cotter pin.

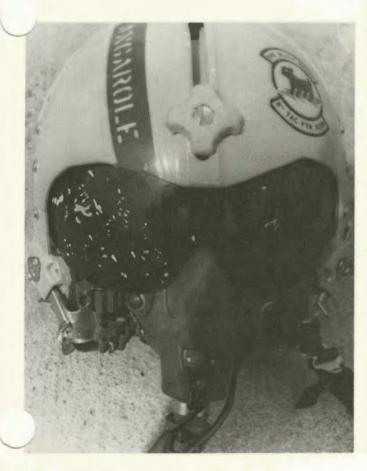
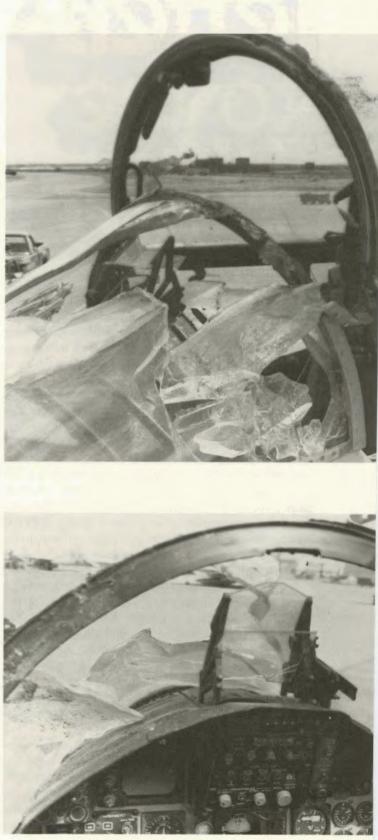
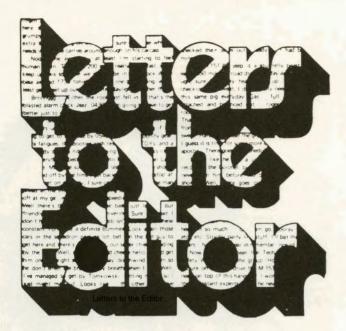
Everybody who thinks Eagle jets are immune to birdstrikes, step forward. Not so fast. This Eagle hit a hawk while flying a low-altitude proficiency sortie. Airspeed was 430 knots. Fortunately, this Eagle driver had his visor down. As you can see, that action probably saved his eyesight. After he landed, there were bits of bird bones and plexiglass in his clothes. "Lose sight, lose fight," they say. In this case, we would have said "lose sight, lose everything."

Use your visor. 'Nuff said.
