# TAC ATTACK

JULY 1983

# GET THE FACTS ST

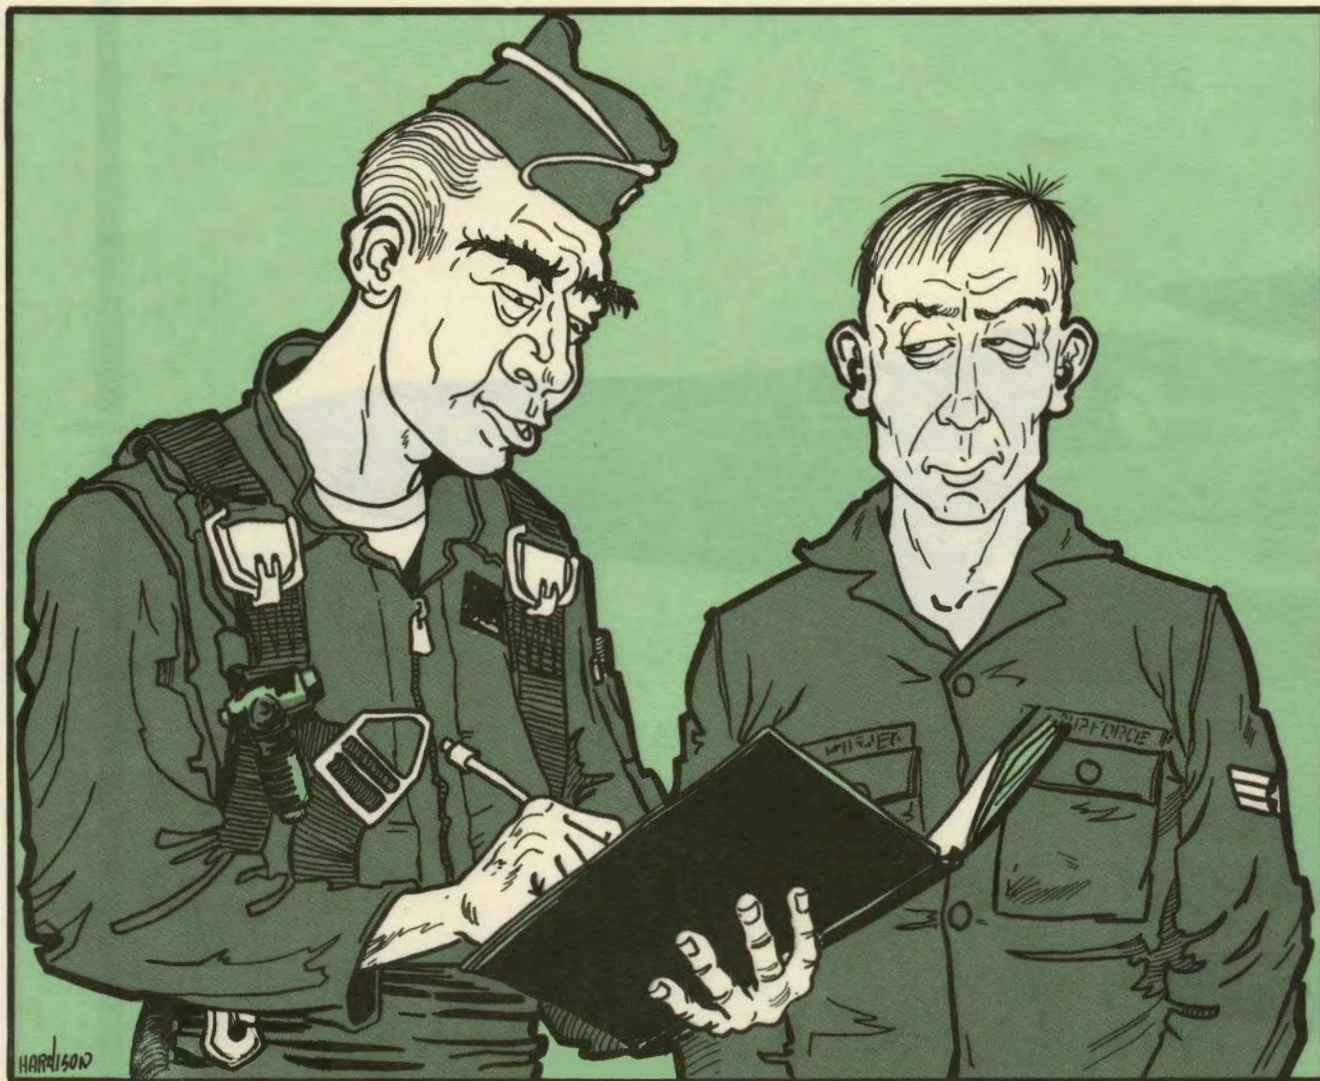
# HYDRAULIC LEAKS: Is the

Just picture yourself as a crew chief on the flight line, helping an aircraft commander preflight for an early morning sortie. During the walkaround, the pilot notices hydraulic fluid leaking from a fitting. You are asked by the pilot, "Is the aircraft safe to fly?" You then respond, "Sure, I saw that leak during my preflight inspection, it's only a static leak."

uals that the leak is within limits? Can you effectively and positively determine the exact problem without applying full aircraft hydraulic operational pressure? The answer is no. No technical order will tell you that an aircraft is safe to fly with fluid leaking from a hydraulic fitting.

“Smoking/Reefing”—an incorrect maintenance practice used to tighten “B” nuts that are leaking. This is usually done without a torque wrench and with pressure on the system.

If a leak is discovered from a tube assembly when pressure is on the system, you should never torque, as this will tend to cut the flare without adding any appreciable torque to the fitting. This means tighten fittings without pressure applied and follow tech data to maintain proper torque.

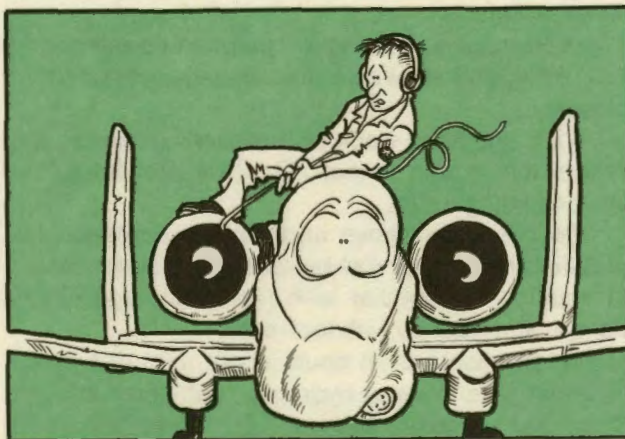
The engine mechanic began to adjust the T-5 amplifier on top of the right engine. Suddenly his communications cord was pulled from his earphones; the cord was sucked into the right engine, ripping the other end of the cord out of the ground communications receptacle.

The ground safety observer quickly signaled the aircraft mechanic in the cockpit to shut down both engines. The mechanic did shut them down, but it was too late. The comm cord knocked out nine sets of engine fan blades.

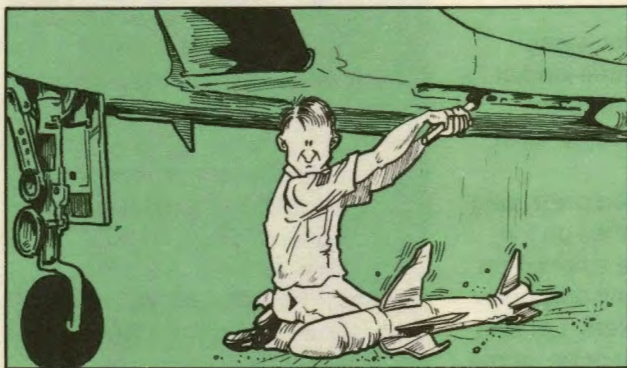
The number 2 man was slightly delayed. By the time he got to the airplane, the number 3 man had already armed three of the AIM-7s. So the number 2 man started to work on one of the armed missiles. Since the missile was armed, the release/lock mechanism was not protected by a safety pin. The load crew chief saw that the number 2 man was working on an armed missile; he warned him of the danger but didn't stop the operation. When the number 2 man tried to extend the umbilical, he actually inserted his ratchet into the release/lock mechanism by mistake. He rotated the ratchet, and the missile crashed to the ground.

The drive socket for the release/lock mechanism looks like and is located near the umbilical extension/retraction drive. It can be easily misidentified. However, if the safety pin were installed, the mechanism could not have been actuated. That's why the sequence of steps in the tech order is to first connect the umbilicals, then arm the missiles.

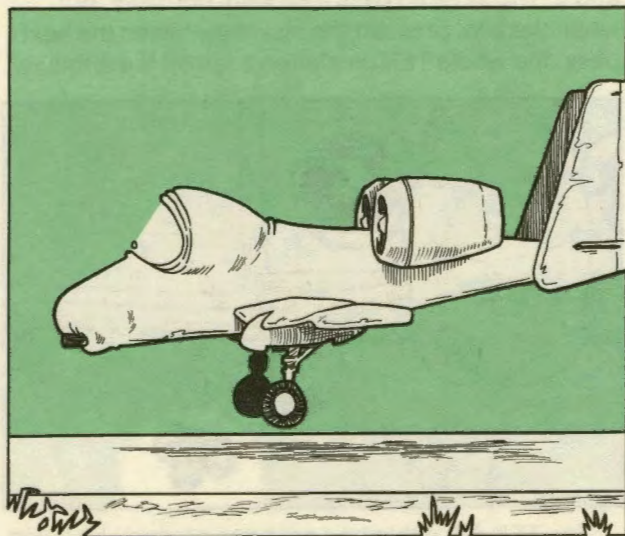
## Gun Gas Residue Overheats Engine

An A-10 on a surface-attack training mission was on its third hot strafe pass when the Right Engine Hot light and the Master Caution light both lit up. The pilot immediately started to climb. Seeing that the engine temperature was 1,100 degrees Celsius, he pulled the throttle to idle. At idle the temperature dropped to 1,000 degrees, and the rpm fell to 56 percent. The low rpm triggered the automatic start cycle for the right engine, so the pilot shut down the right engine. He landed at a nearby emergency field.

Borescope inspection of the engine later showed no damage but did reveal a large accumulation of gun gas residue on the compressor blades.

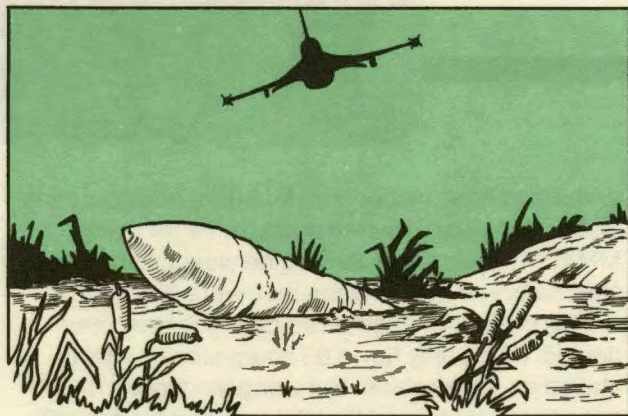
the pilot pressed the pickle button prior to the release cue. The centerline tank immediately fell off the airplane. It hit in some mud flats on the gunnery range. The airplane returned to base with no damage.

When the weapons release system was tested on the ground, troubleshooters discovered a firing voltage on the aft breech of the centerline pylon MAU-12 whenever one of the other stations was selected, Master Arm was set to Arm, and the pickle button was pressed. With the pylon removed, the aircraft system checked out fine.

The pylon was taken to the shop and tested on the 75500 weapons tester; it failed. The wires to two pins at the fuselage-pylon disconnect were reversed. These reversed wires allowed the current to flow to the aft breech, bypassing the normal routing, as soon as power was available—that is, when any station was selected, Master Arm was armed, and the pickle button was pressed.

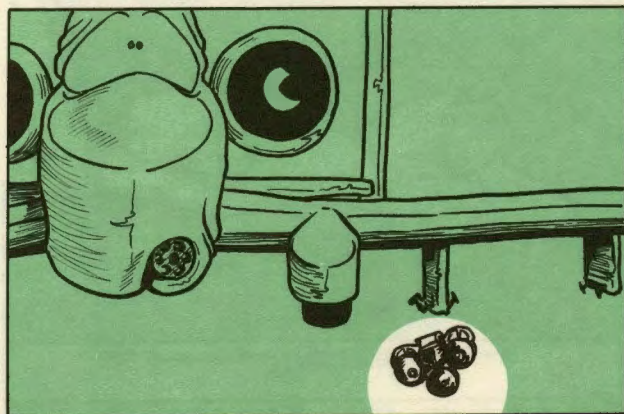
## Another A-10 Loses a TER

An A-10 was on a weapons delivery mission with 12 BDU-33 practice bombs. The bombs were loaded on four TER-9/As on stations 3, 4, 8, and 9. Selecting stations 4 and 8 first, the pilot flew six passes and released all the bombs on those stations. Then he switched off stations 4 and 8 and selected stations 3 and 9. The seventh pass also went normally. But when the pilot pressed the pickle button on the next pass, the whole TER on station 3 fell off the airplane.

The TER-9/A cable had not been properly installed to the cable attachment on the station 3 pylon. When the pilot hit the pickle button, the current was misdirected, causing the weapons release system to sense a single store and release the TER.
