JULY 1961

# ATTACK

TAC Attack July 1961 TAC Eval Pow-Wow

# TACTICAL AIR COMMAND ATTACK

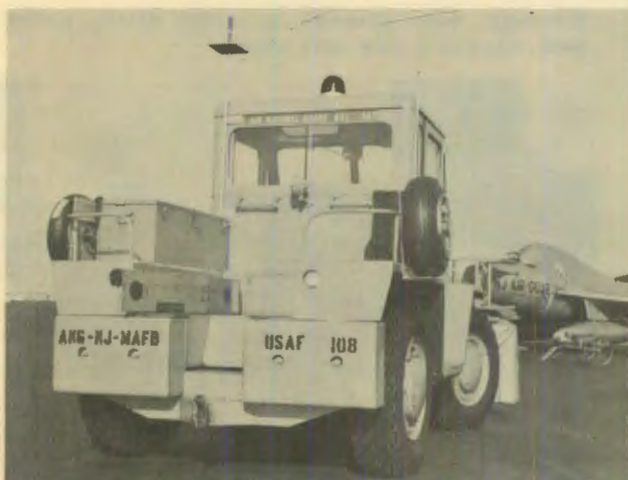
Rear view of the Coleman showing the ramp, additional spare wheels, tool kit, and radio installation.

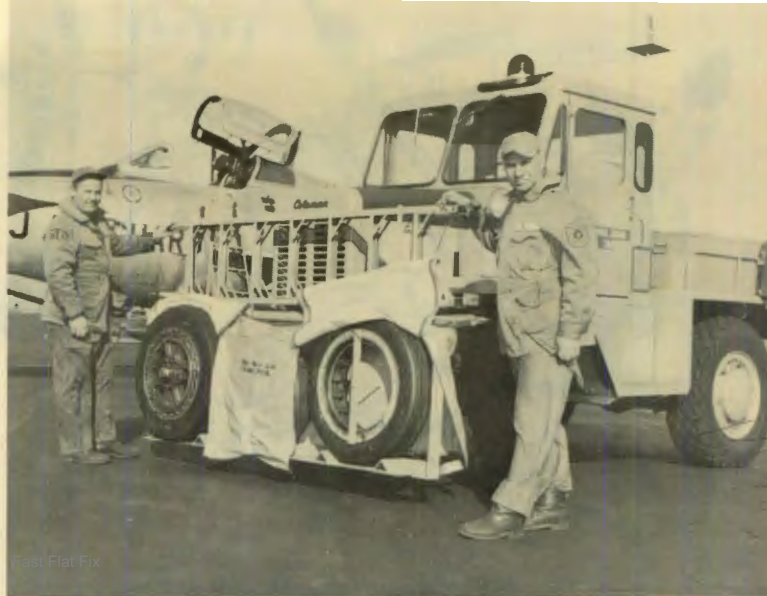
Fast Flat Fix

S/Sgt Wesley Ward and M/Sgt D'Angelo of the 108th show the neat method used to hold spare wheels, ladder, and tow bar to the front of the Coleman tug. Sgt Ward helped in the design and built the rack while Sgt D'Angelo, as hangar chief, is the man responsible for retrieving sick birds.

The last time the 141st Tactical Fighter Squadron received a call to retrieve a bird with a flat tire on the active, it took exactly seven minutes from the time of the call to the time the aircraft was towed off the runway with two round tires.
