JUNE 1961

TAC Attack June 1961 Bum Steer

TACTICAL AIR COMMAND ATTACK

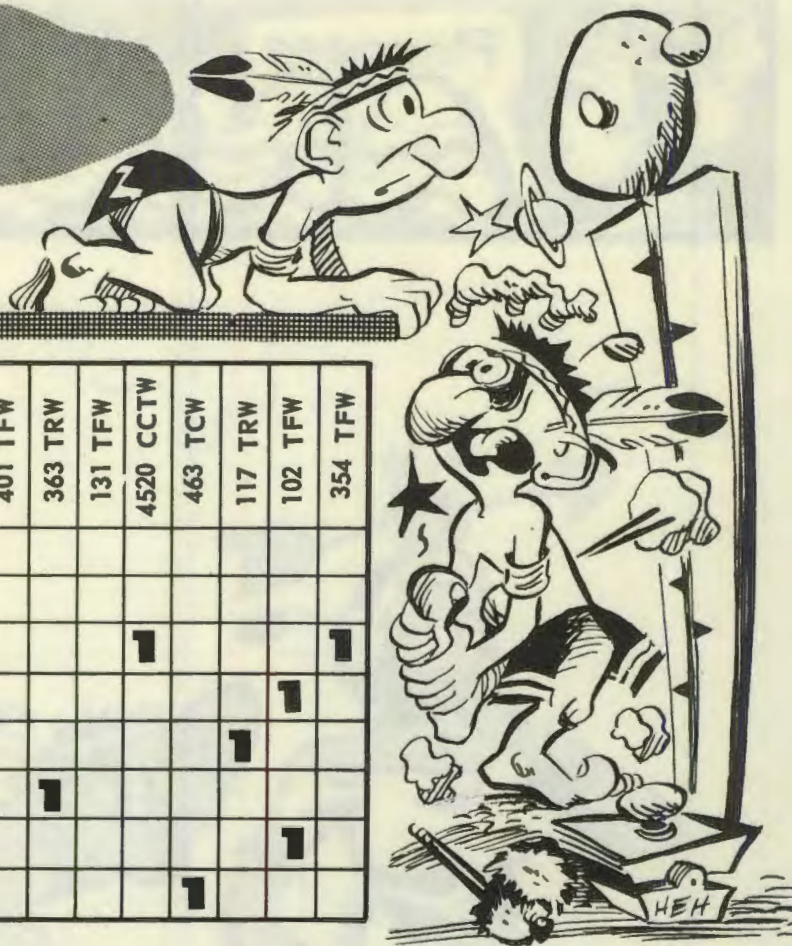
TAC TALLY

APR. MAJ. ACDTS.	4510 CCTW	433 TCW	464 TCW	31 TFW	479 TFW	140 TFW	27 TFW	474 TFW	4505 ARW	127 TRW	401 TFW	363 TRW	131 TFW	4520 CCTW	463 TCW	117 TRW	102 TFW	354 TFW
F-105																		
F-104																		
F-100							1							1				1
F-86																	1	
F-84	2															1		
B-66											1							
T-33	1																1	
CONV.															1

MAJOR ACCIDENT RATE 1 JAN. - 30 APR.

TYPE	1961	1960
F-105	0	42.8
F-104	27.5	60.9
RF-101	0	0
F-100	19.4	22.6
F-84	67.7	0
T-33	3.8	6.9
B-66	50.9	0
KB-50	16.5	0
C-130	4.9	0
C-123	10.0	0
ALL	13.1	11.8

The old cliché "April Showers" has been literally fulfilled this year only with aircraft instead of rain. TAC experienced eight aircraft accidents in April compared with only three in April 1960. This brings the total for this year to 26 . . . Only 23 occurred during the same period of last year; consequently the rate this year is slightly higher. But, statistics are valuable primarily to show trends and indicate areas of weakness. We should think more about what these accidents cost us in dollars, lives and ability to accomplish the mission. This year through April, aircraft accidents have cost TAC more than 15 million dollars. More than enough to buy fully equipped Cadillacs for 2,500 people. Seventeen aircraft were destroyed . . . that is nearly a squadron and even more important is the tragic loss of lives associated with these aircraft accidents. TAC experienced 14 aircrew fatalities, of these seven were pilots. Accident prevention is everyone's business so let's all make a concerted effort to conserve what is left of our inventory and to make 1961 TAC's best aircraft accident prevention year.
