MARCH 1961

# ATTACK

# TACTICAL AIR COMMAND ATTACK

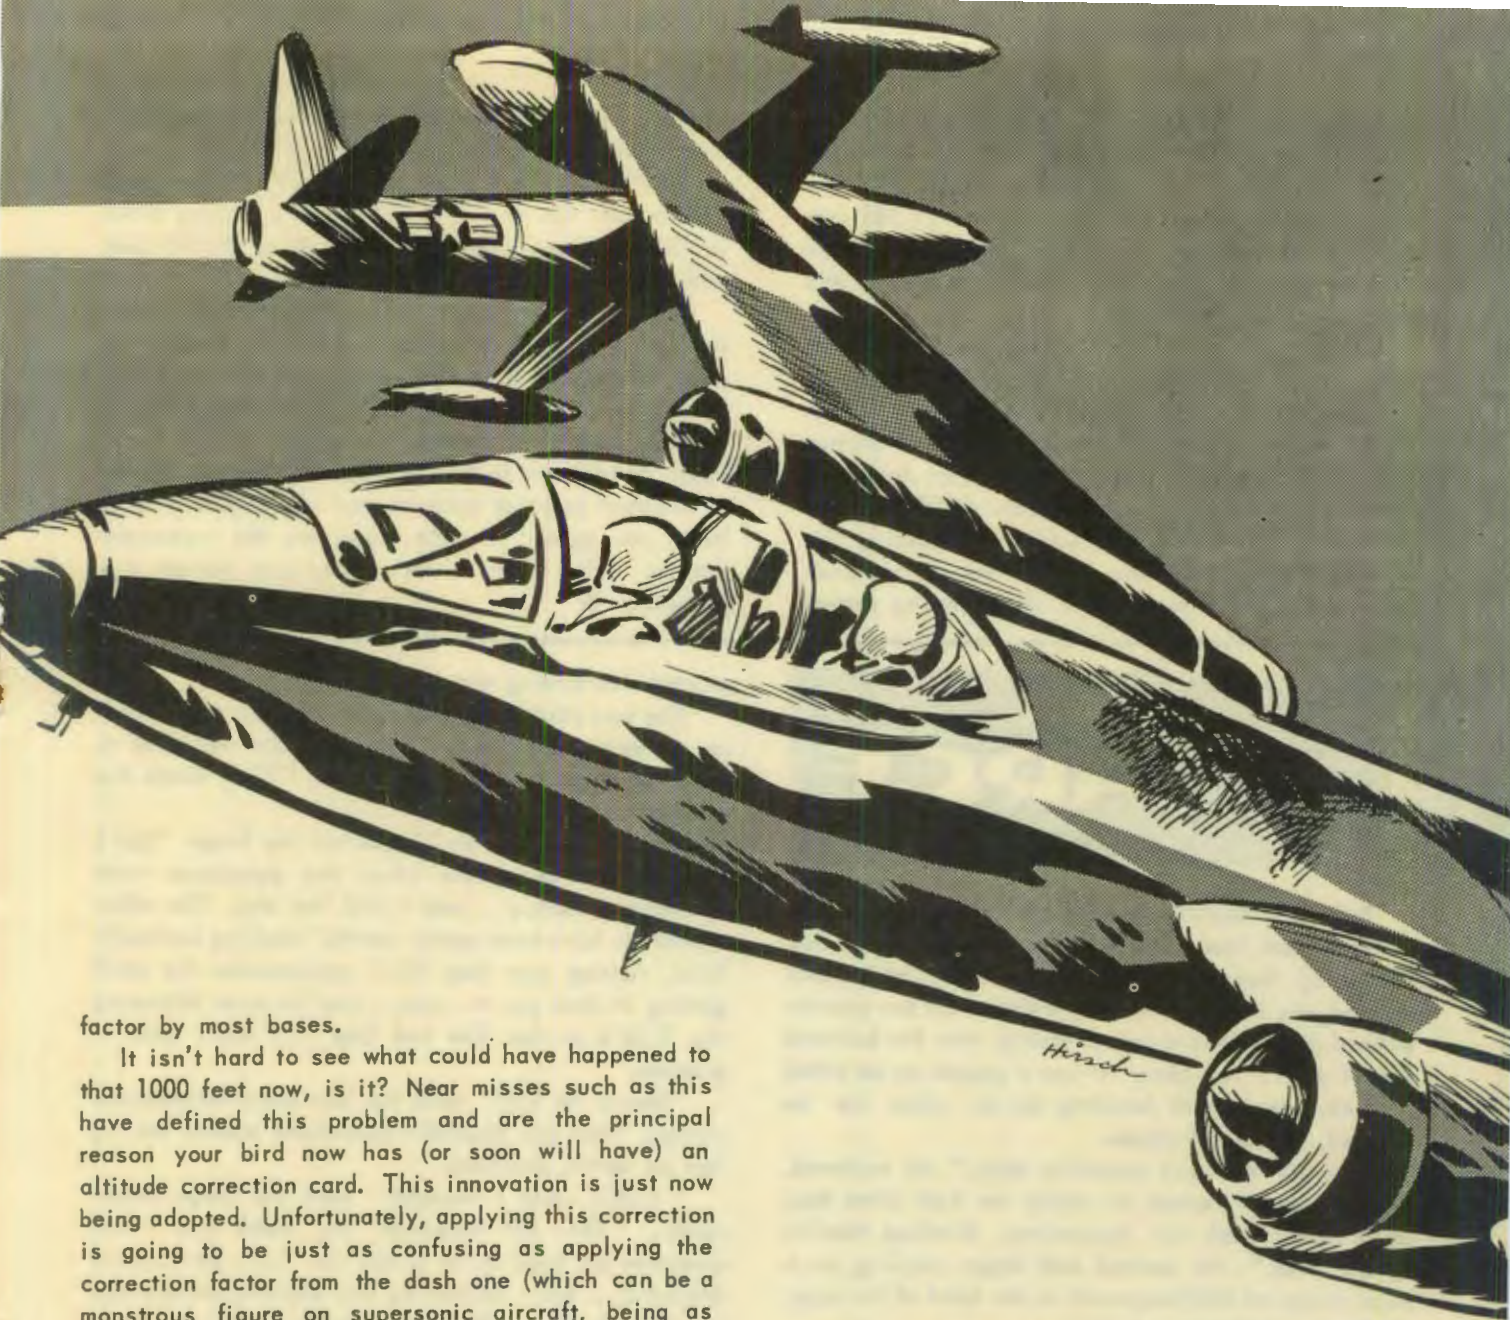
Were the altimeters within tolerance? First, just how close is this tolerance? A trip to the base instrument shop supplied the answers. There, we found a technician checking two altimeters using a low pressure chamber attached to a mercury barometer with a vernier scale. By exhausting air from the chamber he was able to run it up to a synthetic altitude of 80,000 feet, checking this altitude on the mercury barometer. By comparing the readings with those of the altimeter being checked, he was able to enter a correction factor on a form. This factor will eventually find its way into the cockpit.

At 35,000 feet one of the altimeters being tested was within 20 feet; the other was about 425 feet off. A reject? Not on your life. T.O. 5F3-4-2-3 permits an error of plus or minus 450 feet! A letter from MAAMA dated 17 Nov 60, requiring bases to test all altimeters and make up correction cards specifies a tolerance of plus or minus 250 feet for altitudes above 30,000 feet. Unfortunately, very few altimeters are meeting this requirement and to keep from grounding the fleet, the T.O. is being used as the limiting

It isn't hard to see what could have happened to that 1000 feet now, is it? Near misses such as this have defined this problem and are the principal reason your bird now has (or soon will have) an altitude correction card. This innovation is just now being adopted. Unfortunately, applying this correction is going to be just as confusing as applying the correction factor from the dash one (which can be a monstrous figure on supersonic aircraft, being as much as 6000 feet at certain speeds and configurations on one machine).

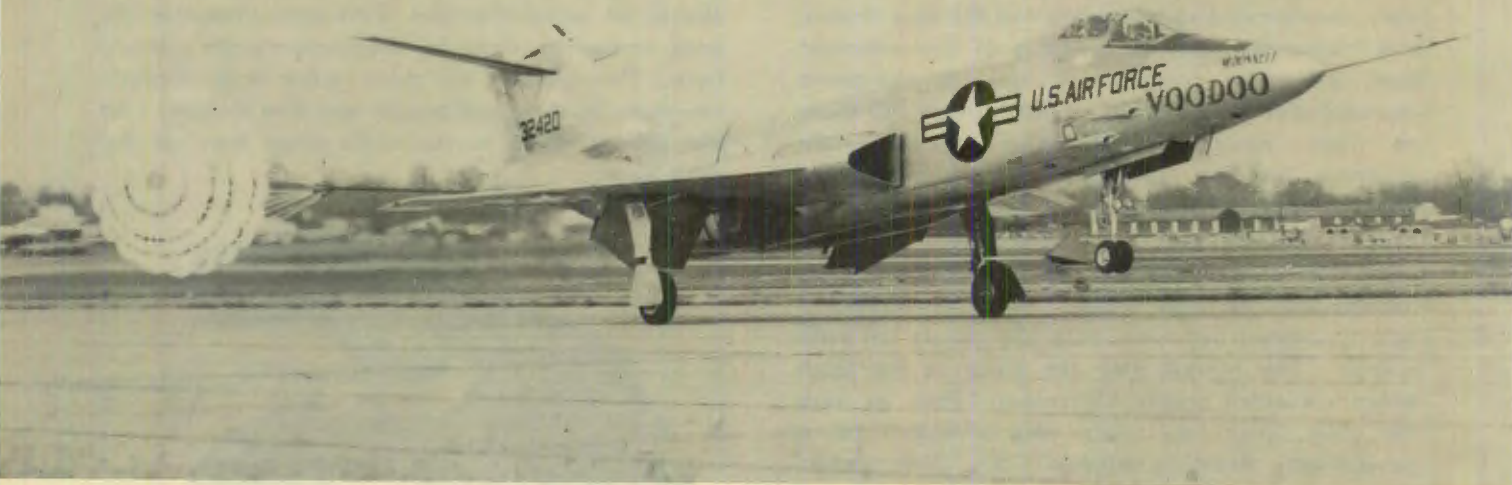
# GIVE THE BIRD A BRAKE!

**H**IGH PERFORMANCE AIRCRAFT have forced us to make a lot of changes in the way we have been flying traffic patterns during the past decade. We've had to abandon the bank and yank, seat-of-the-pants affair in favor of a more comfortable pattern with power on approaches held to closely (?) calculated speeds. Despite this, our barriers are not exactly getting rusty from disuse and we still get reports on an occasional unscheduled trip into the boon docks.

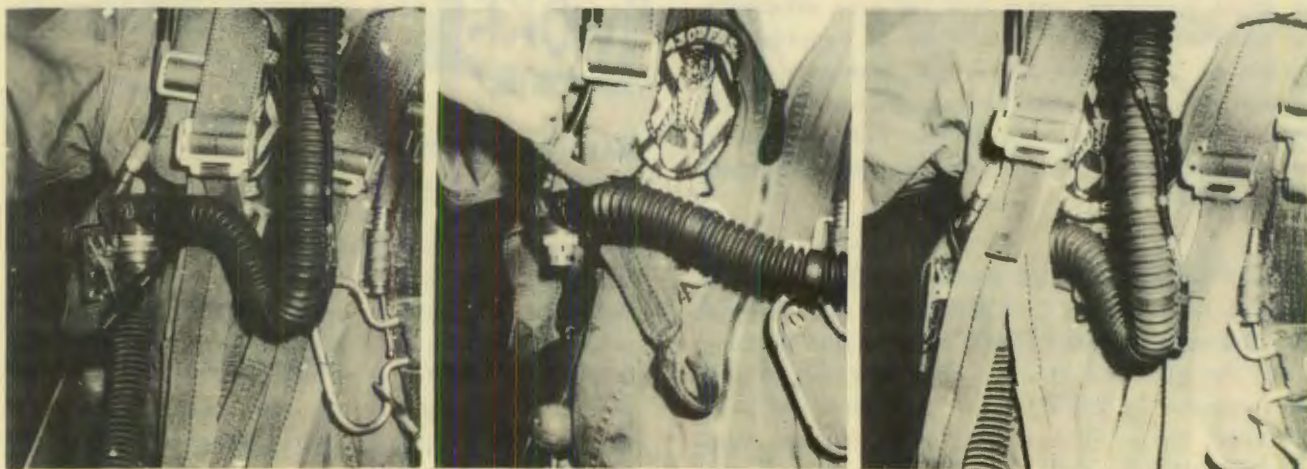
at Cannon AFB and found that others had experienced similar difficulties. His solution to the problem was to run the shoulder harness over the hose instead of under it. The photos tell the story. In the photo on the left, the shoulder harness is placed under the oxygen hose. The center photo indicates the shoulder harness wedged in the T-block as the pilot starts to leave the seat. The right hand photo shows the safer way to place the shoulder harness. Tests performed by pilots at Cannon indicate no binding of the hose with this arrangement. Thanks a lot, Fred; passing on the word should help keep someone from getting some unneeded lumps. ●

**A** few days ago Lieutenant Fred Nelson shut down his F-100 and started to clamber out. As he stood, he was rudely braked to a halt by the right shoulder harness strap. The strap had wedged between the T-block oxygen connector and the attaching plate. Knowing that this would be serious during an ejection, Lieutenant Nelson checked with his fellow pilots in the 430th Squadron
