FEBRUARY 1961

ATTACK

TERMINAL FLIGHT MONITORING

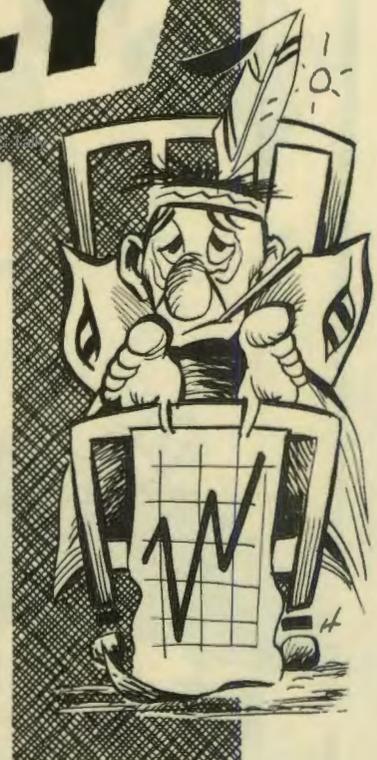
ACCIDENT RATE

1 JAN - 31 DEC 1960

The final tally for 1960 reveals that TAC scored 83 major aircraft accidents to establish a rate of 14.2 for the year. This represents a very favorable reduction from the 1959 total of 107 accidents and rate of 16.2. A review of 1960 accidents indicates approximately 60 per cent resulted from personnel error and that the majority of these resulted from errors in judgment and technique on the part of the pilot. Therefore, this area will be the most fertile for further aircraft accident prevention efforts in 1961 and much can be accomplished through proper exercise of the old standby--Safety through Supervision. Personal interest of supervisors in initial checkout followed by close monitoring of individual performance should help reduce the frequency of pilot factor accidents. A typical example of the type accident we are referring to is reviewed in this issue in the article "Sunday Driver." Perhaps a little closer supervision of this pilot would have revealed a tendency or obsession to fly low, and corrective action taken then may have prevented the accident. Taking more stringent disciplinary action and giving widespread publicity of the consequences may cause other pilots to think twice before they participate in such foolish endeavors.
