NOVEMBER 1961

ATTACK

VOL. 1 NO. 11

CONTENTS

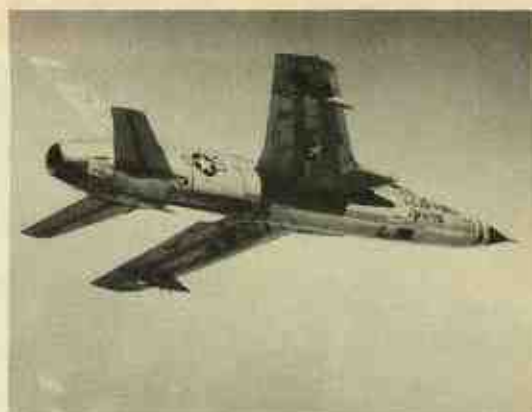
COVER PHOTO

TAC's Big Stick, The Thunderchief

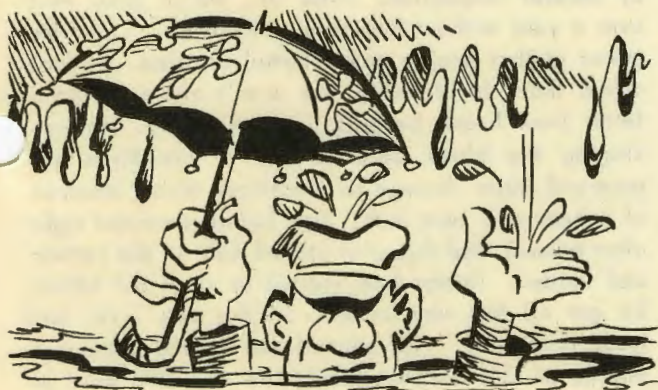
BIG DRIP. Five F-105's have been found with fuel leaks in the teflon plug holder on the forward fuel cell. In each case, fuel was seen drooling from the underside of the aircraft when it was on the ramp. Since all fuel cells in the F-105 have teflon plug holders, there is a possibility that other tanks may be affected as well. Until the problem is completely defined and solved, all hands will have to stay alert and look for leaks during post flight and preflight of this big bird.
