## TAC ATTACK

#### MARCH 1970 VOL, 10 NO. 3

TACTICAL AIR COMMAND

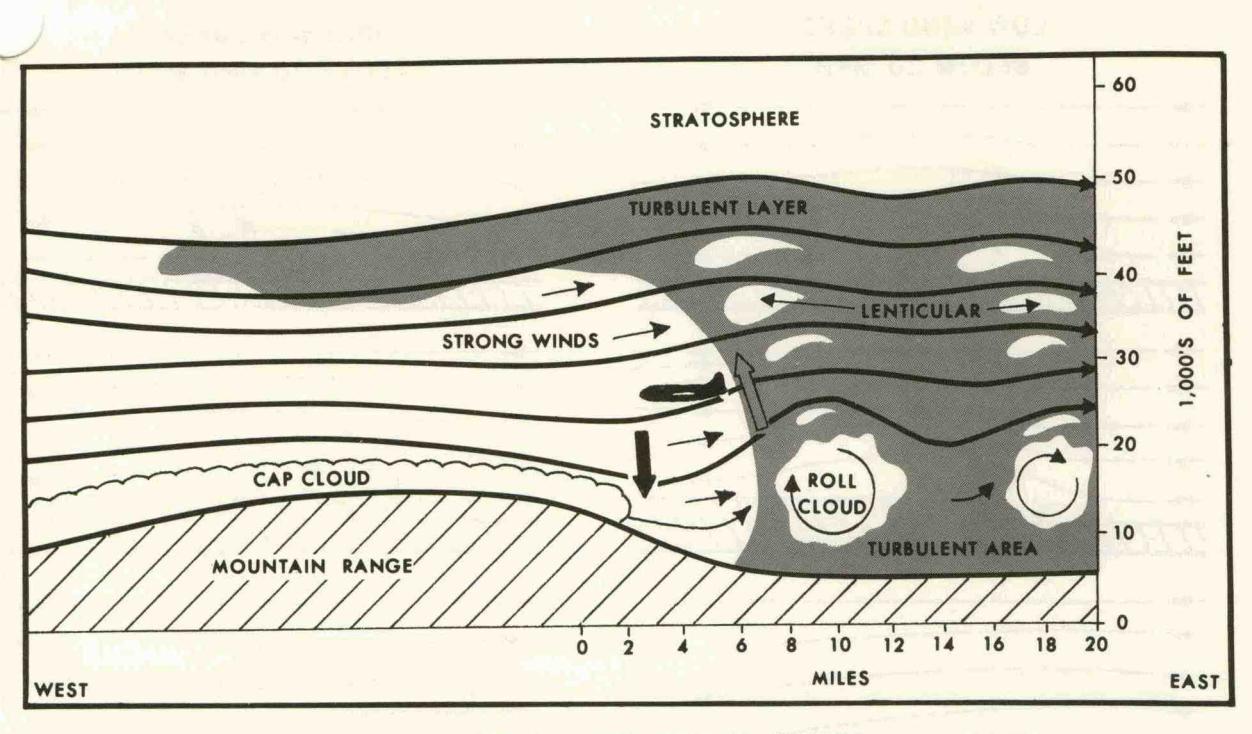
FIGURE 1 - MOUNTAIN WAVE

Grenade smoke follows downslope downdraft off approach end of runway.

Most pilots find mechanical turbulence readily recognizable in its visible extreme, the mountain wave cross-sectioned in Figure 1. They've encountered its familiar cloud forms while flying over mountainous country. Or, if not there, on a weather briefing slide during annual instrument refresher courses. As a result, the distinctive lenticular clouds and that mean roll cloud are respected and given a wide berth when seen or reported. If they don't and wander into one at the level of the pictured airplane, they'll be mechanical turbulence believers before the mountain wave turns them loose...hopefully, with a whole airplane.

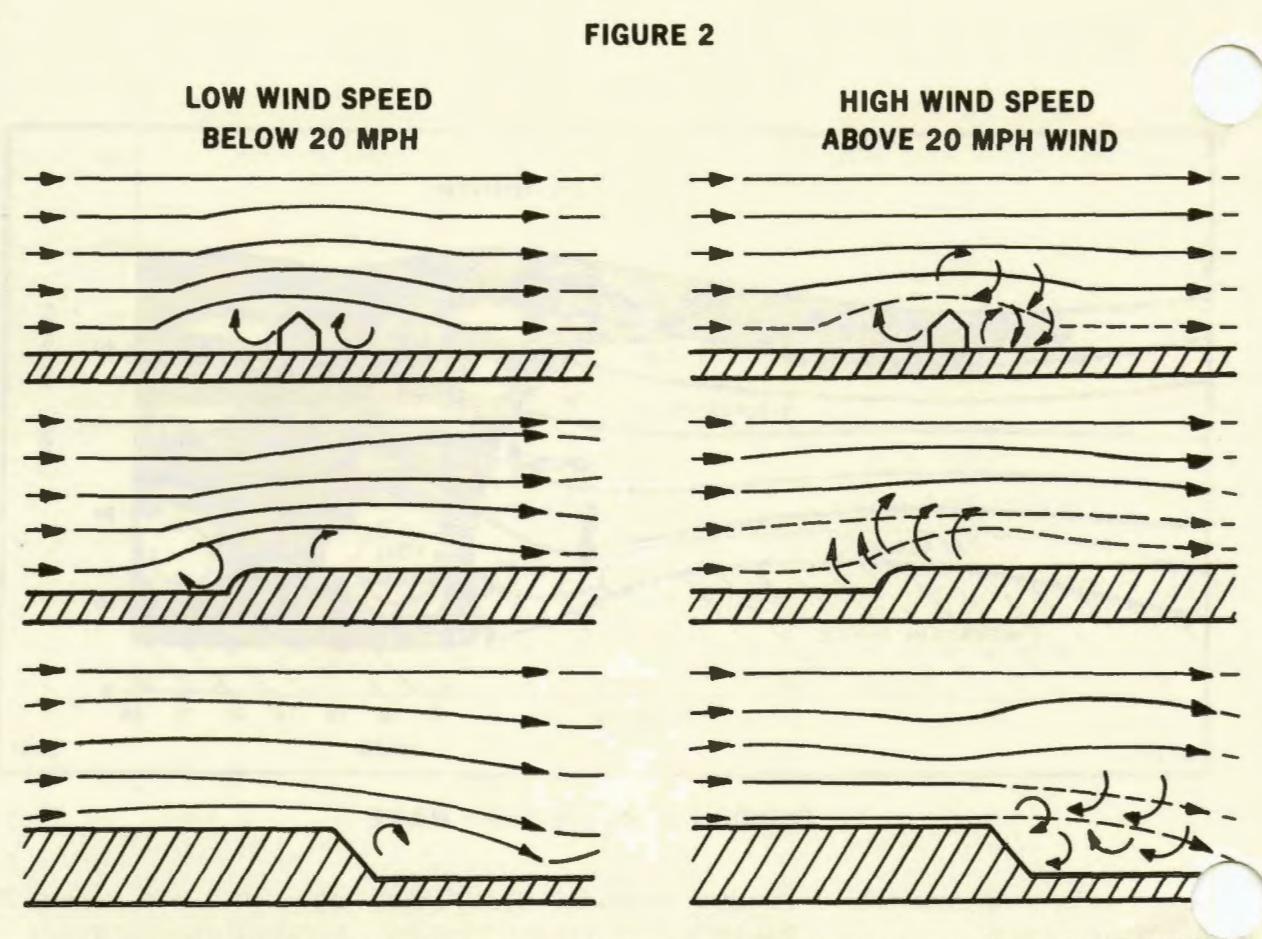
SURFACE OBSTRUCTIONS CAUSE EDDIES AND OTHER IRREGULAR WIND MOVEMENTS

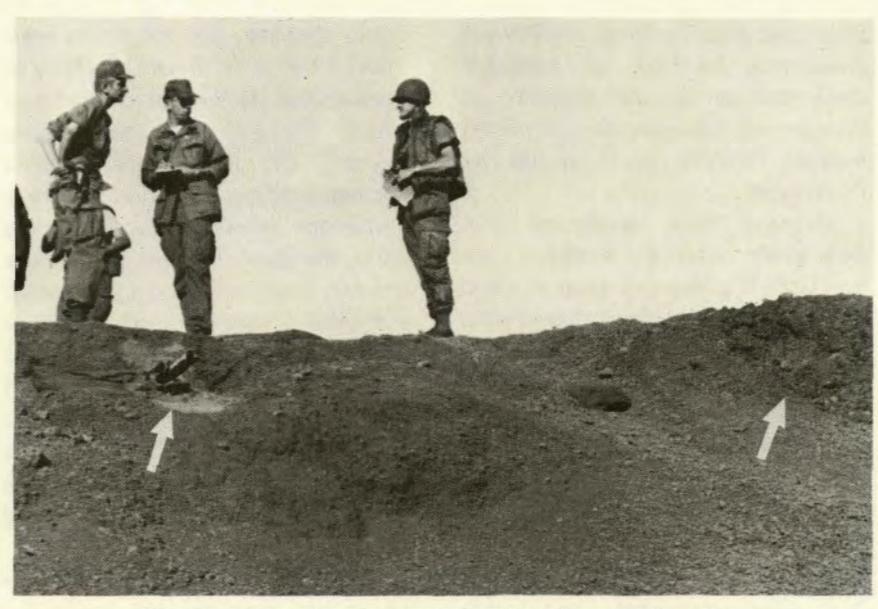
Impact points of main gear below lip of approach end embankment

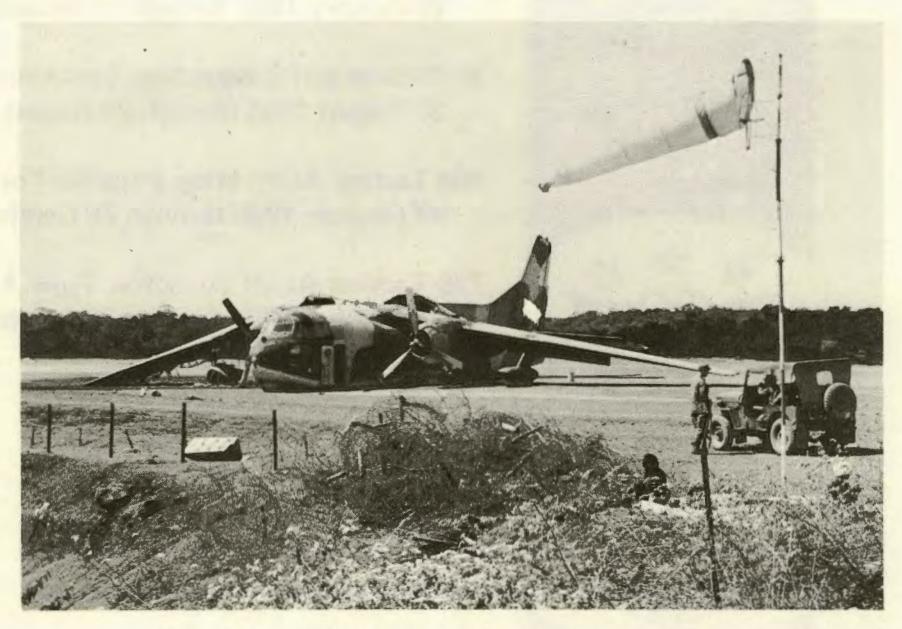
The windsock's lined up with the runway - the airplane's crosswind.

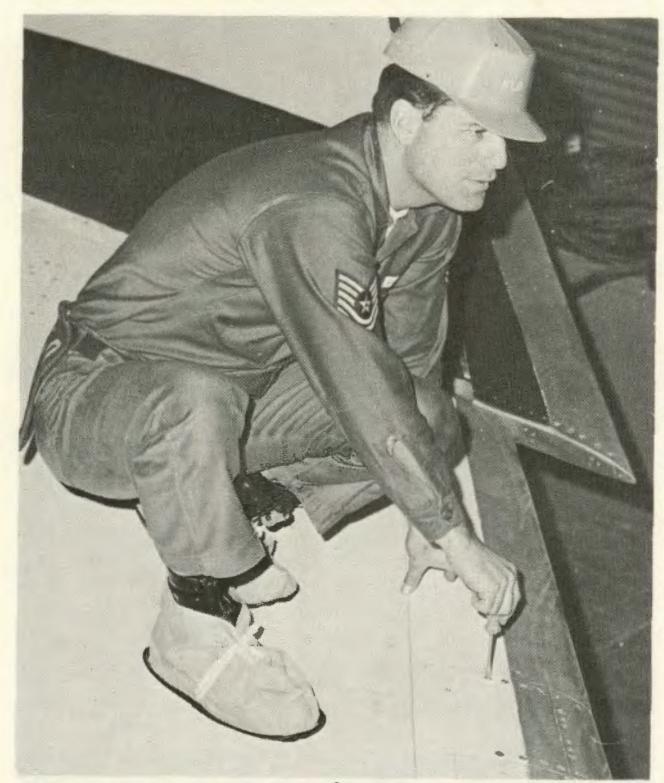
"Booties" prevent damage to unique Thunderbird paint scheme and provide non-skid safety on smooth surfaces.

We keep our unique paint scheme highly polished and waxed. This makes our wings and fuselage areas v slippery. The white surfaces readily pick up black s marks from boots and require many hours of cleaning. To reduce this problem we needed a shoe or boot cover that would not mark the paint and would be non-skid to make the areas safe to work on. Surgical shoe covers proved to be the answer. These "booties" are worn anytime a man is required to work on these surfaces. The non-skid material does not mark the paint and they adhere to any smooth surface better than the standard boot.

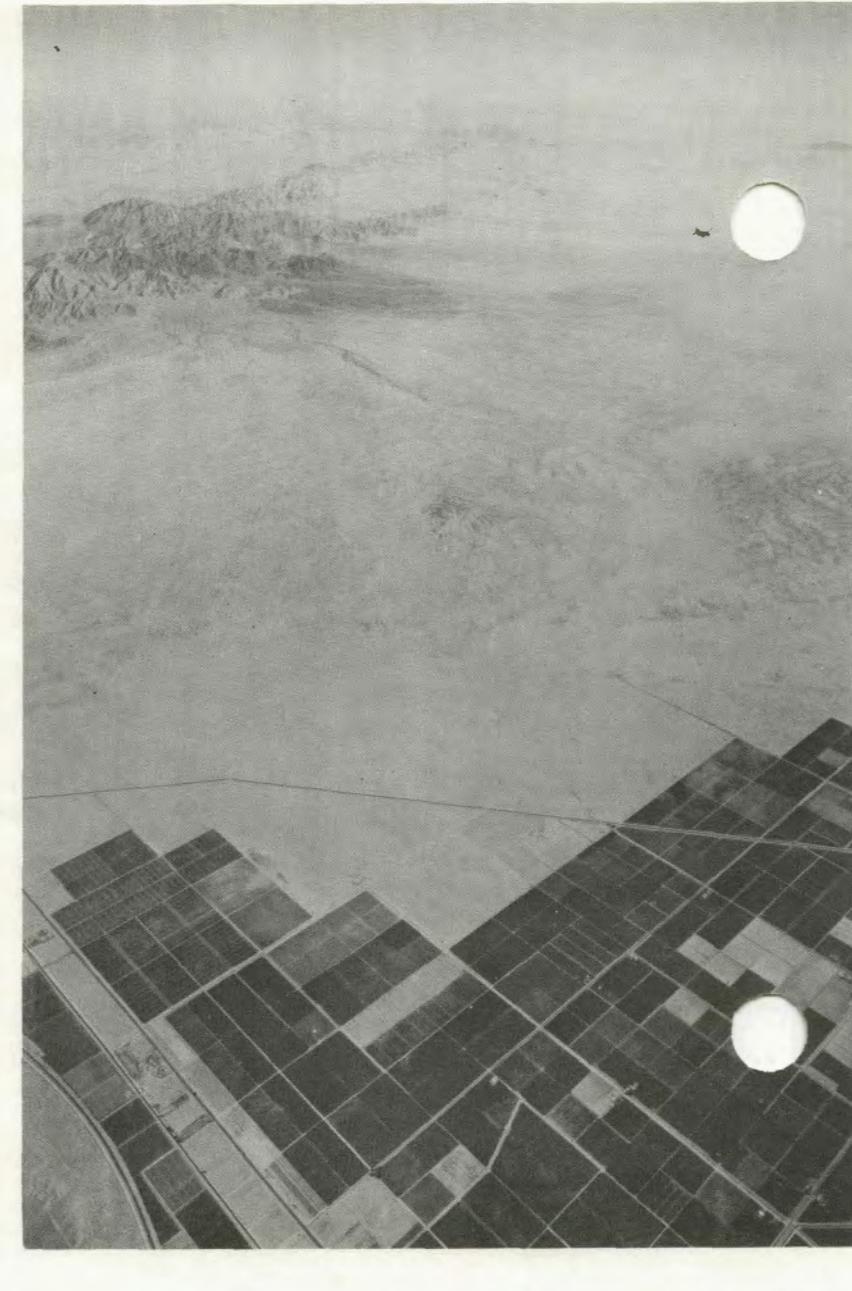
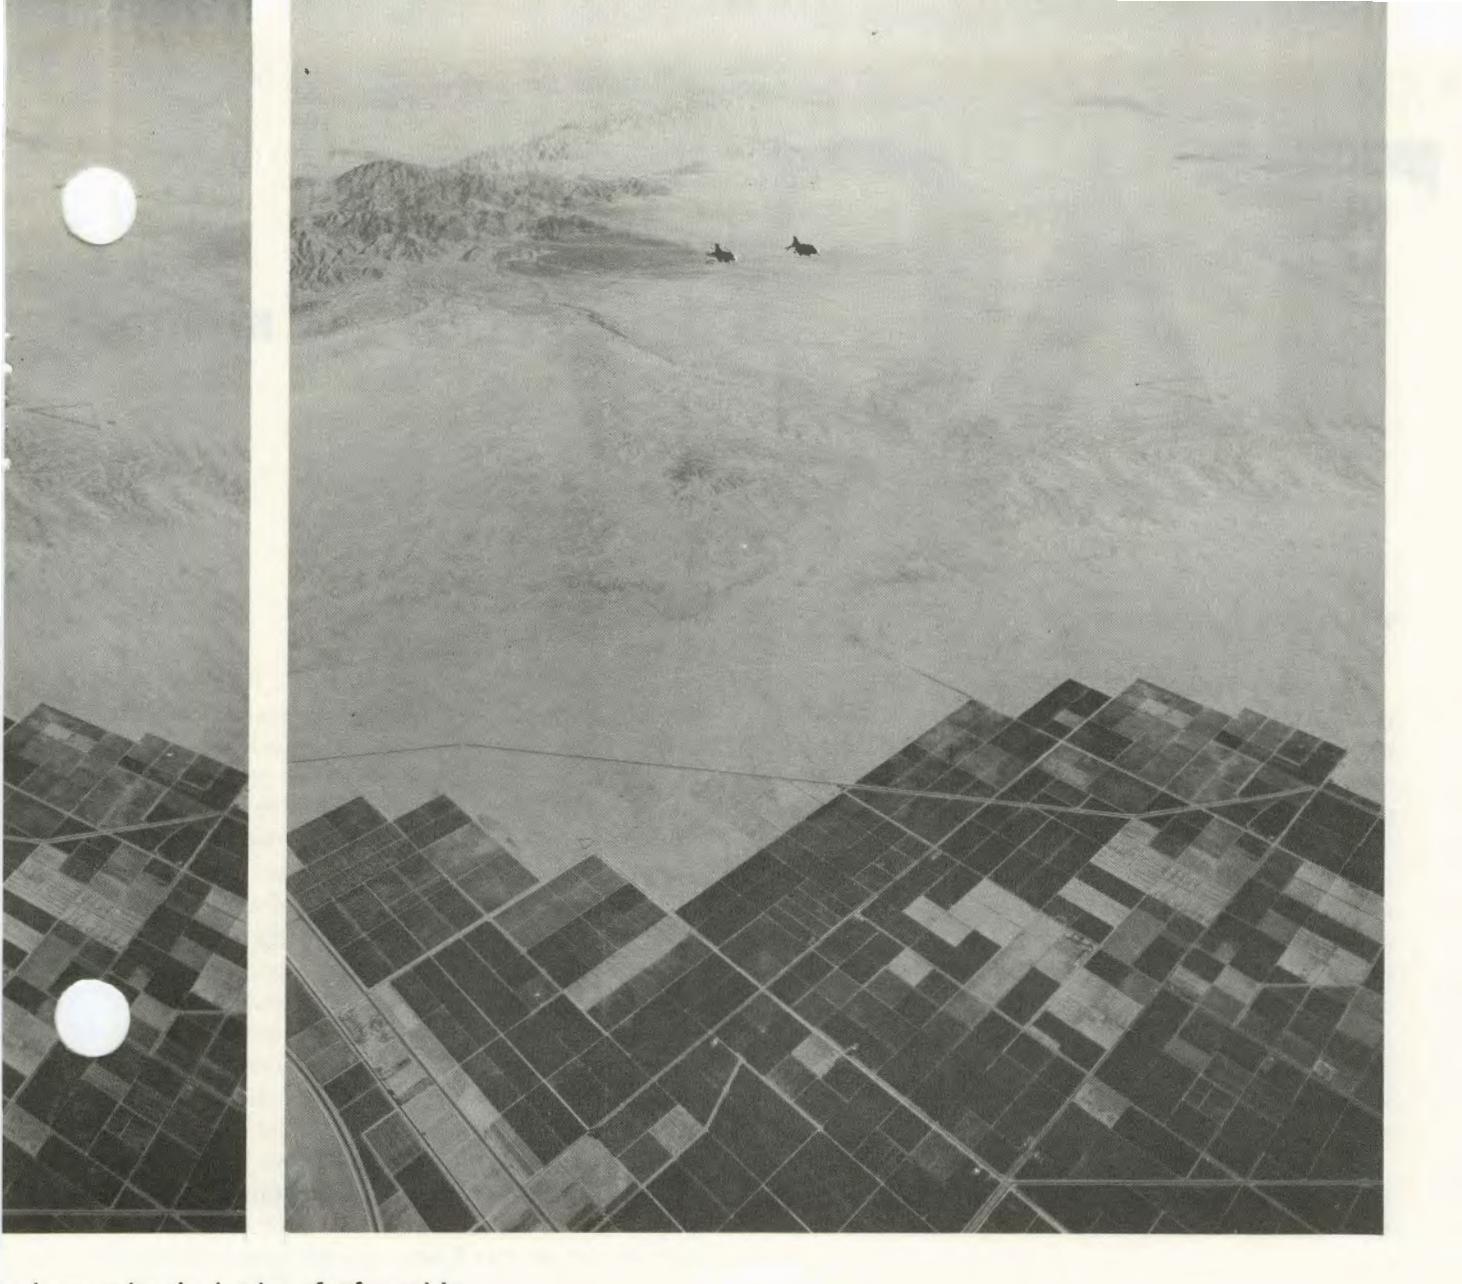
These two photos were taken 1.25 sec RF-84F flight. The flight of F-4s does or following frames. It's obvious that would have taken place less than 1.25

not show up on either the preceding f a midair was destined to occur, it econds following the second photo.

With the extra picture button depressed, a picture is taken every 1.25 seconds. While looking to my left, I saw two objects pass under the left side of my aircraft. I immediately turned to the right to see two Marine F-

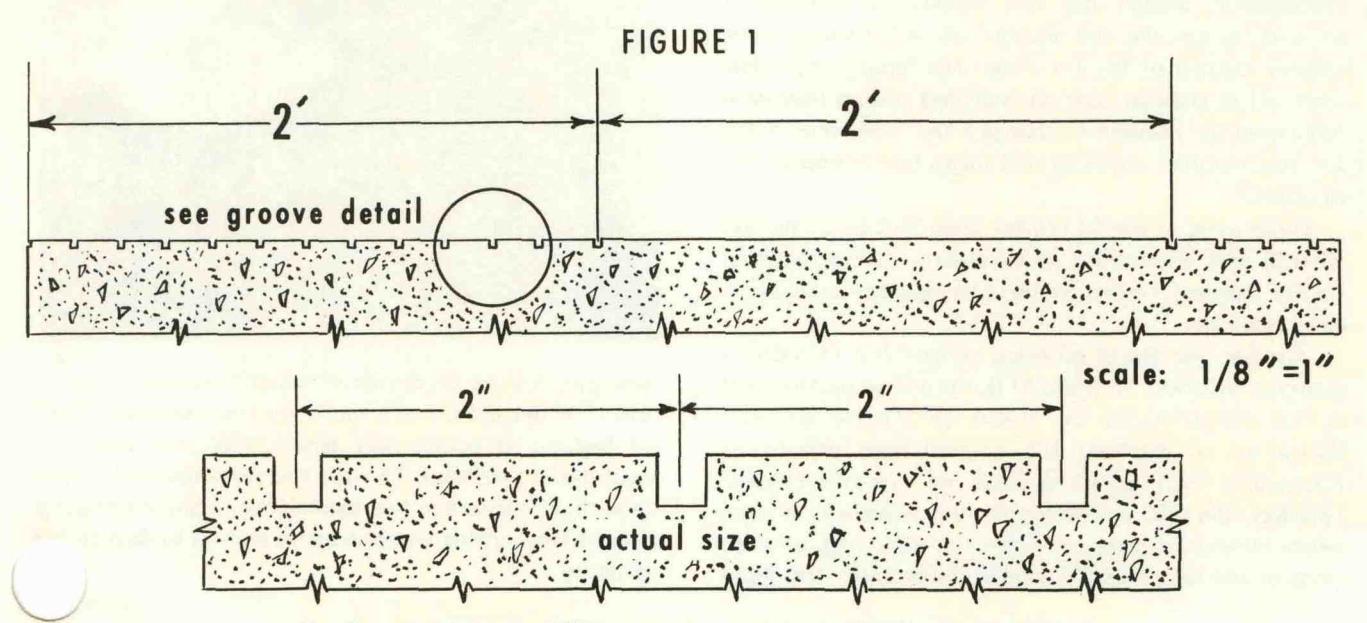
The Seymour Johnson AFB runway is grooved according to this pattern.

The SJ runway (08-26) is 11,758 feet long and 300 feet wide, the result of several revamping projects on the original 150 x 4400 foot strip built in 1942. Ten years ago, the center 75 feet of the 300 foot wide asphalt strip was replaced with portland-cement concrete. The center 70 feet of this concrete strip is the area now grooved, except for 1000 feet on each end which is not. Except for a couple of SEA asphalt strips, the groove pattern used at SJ is new, and untried at any stateside airdrome. The pattern consists of a series of 13 grooves, each one-quarter

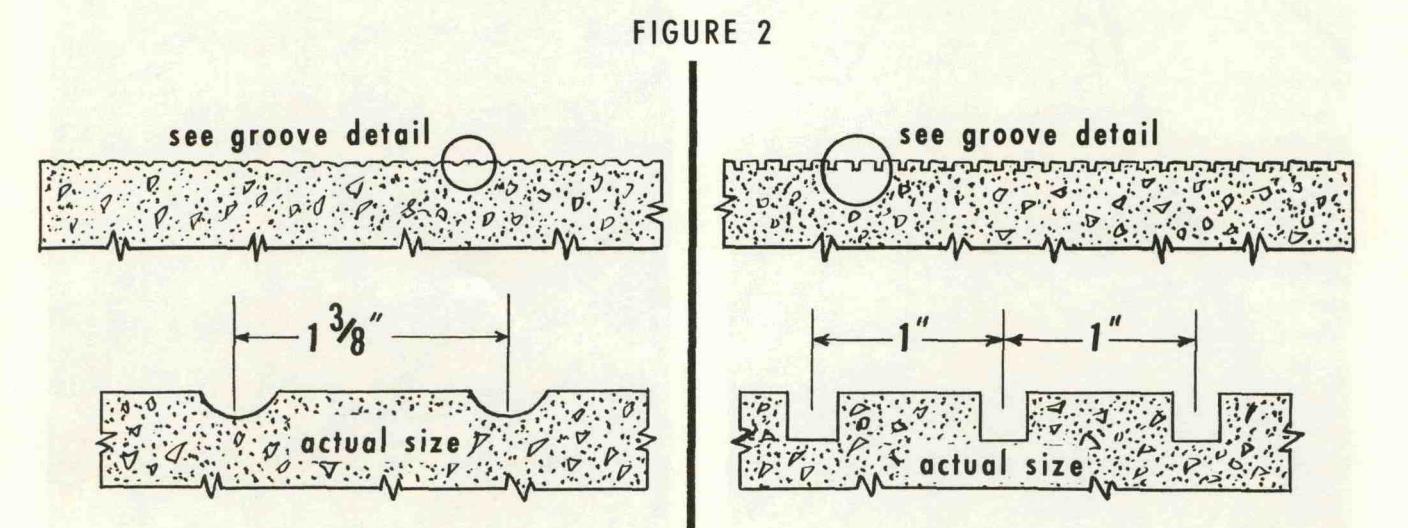
Wet/dry stopping ratio of groove patterns vary. Pattern at New York's Kennedy Airport (left) requires almost 50 percent more runway to stop when wet, while the pattern used at Beale AFB (right) requires only about 15 percent more.

Another Air Force grooving project has recorded a different situation. At Beale AFB, the groove pattern used is one recommended by NASA as offering the best coefficient of friction. It's a continuous pattern of one-quarter inch square grooves on one-inch centers. However, the SAC equipment there is experiencing some severe chevron cutting and some tire shredding, on both retreads and new tires. To combat the problem, the depot

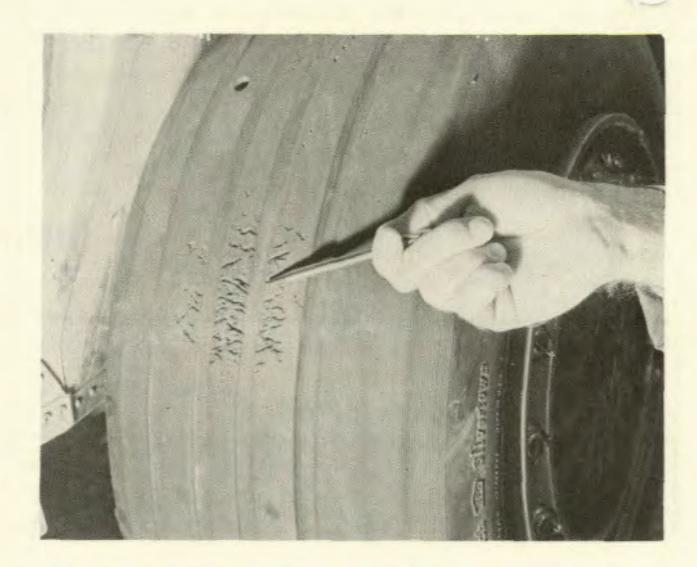
Chevron cutting at Seymour Johnson occurs on center treads of tire indicating a touchdown phenomena instead of braking. It occurs only occasionally and cannot be realistically predicted. This tire was cut when an F-4 came in with an engine bay fire, landing fast, with max braking. The surface cutting was not severe enough to damage tire integrity.

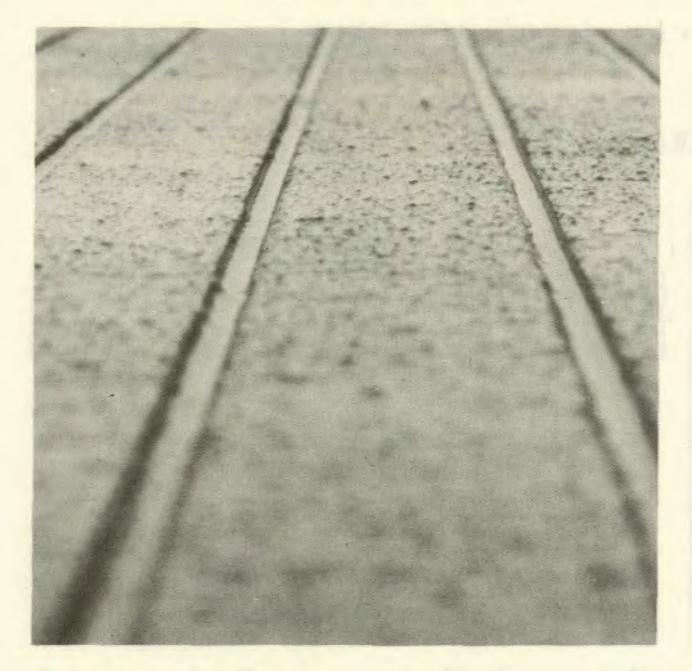
Rainwater landing on grooved runways drains immediately into grooves leaving runway surface texture almost free of skid-causing water buildup.

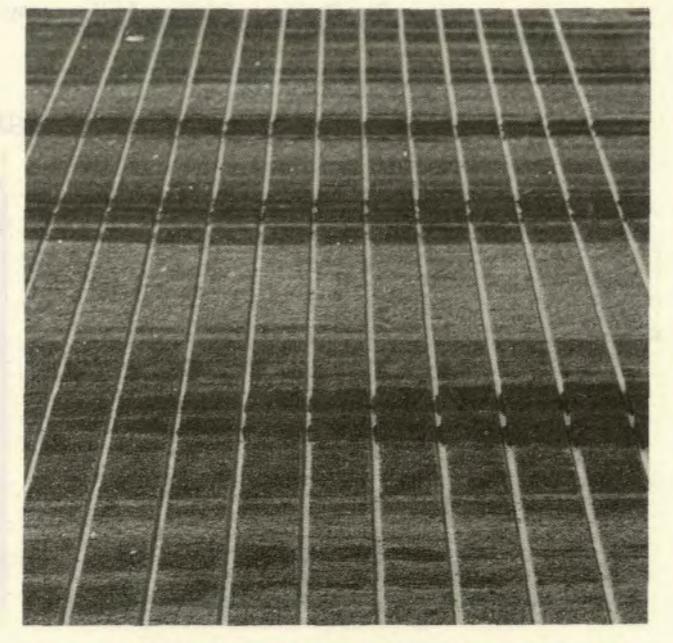
Rubber buildup at touchdown points does not appear to be more severe on grooved runways. To the contrary, draining water in grooves washes away most loose rubber laying in grooves.

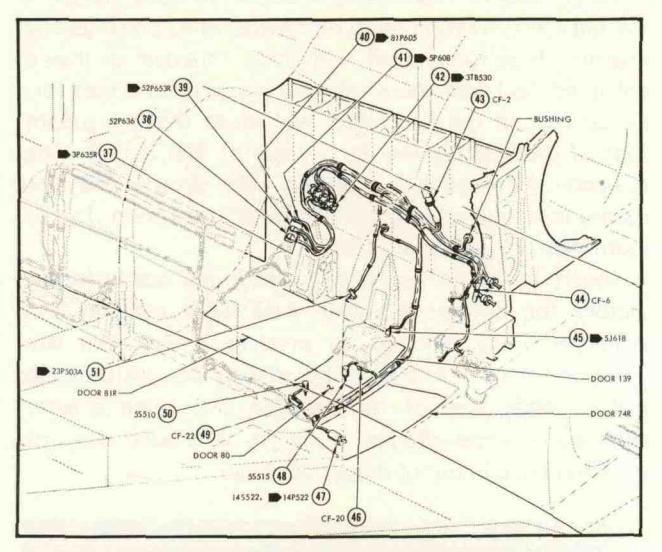
**BEFORE MODIFICATION**

Here's a sample showing a wiring modification in the right hand engine bay. The improvement is obvious.

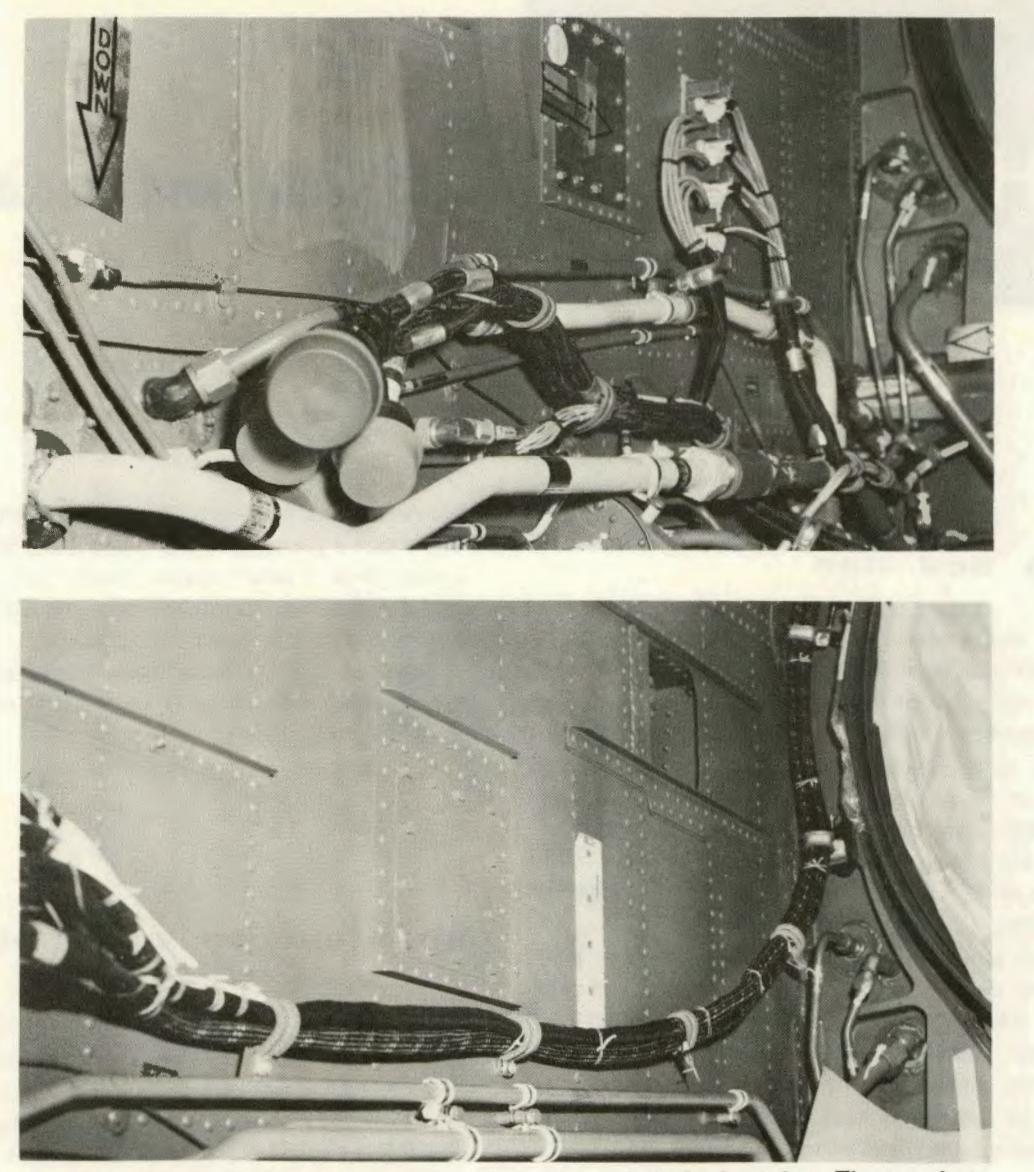
Another example of what has been accomplished in a relatively short time. The top photo shows what was.... the other shows how future production models will look.

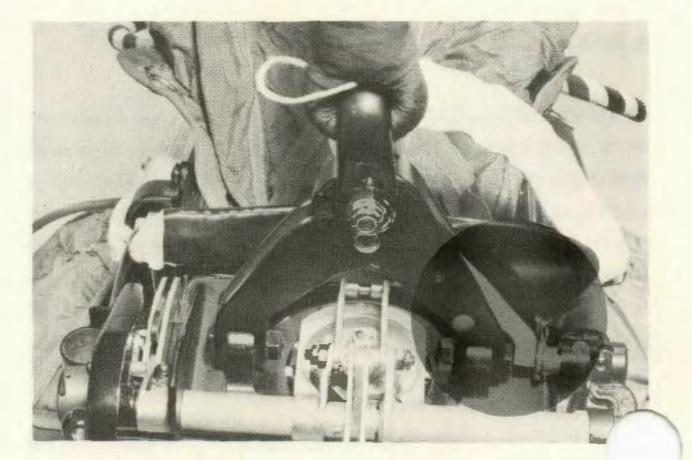
The scissors movable arm is pushing against the plunger and is in the process of opening. While this is going on, the time release mechanism also starts to release the shoulder harness, personnel parachute restraint straps, lap belt, and leg restraint cords to facilitate man-seat separation.

Well, let's take a closer look at the action involved by studying the following "stop action" sequence photographs. Together, they show the instant during the ejection cycle that the scissors action is critical. Ejection has taken place and the drogue chute has deployed and blossomed, pulling the scissors assembly and drogue shackle to its upright position. The time release mechanism has just fired, releasing the plunger from its position against the movable scissors arm where it was keeping the scissors closed. However, the photograph was taken just an instant before the scissors started to open.

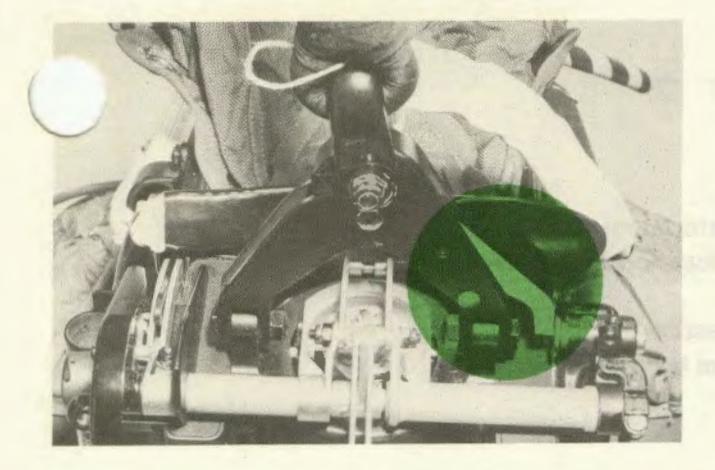
Now the plunger has been pushed out of the way, the scissors has opened completely, and the released shackle is moving quickly away from the seat. In addition, seat-man separation is well on its way.

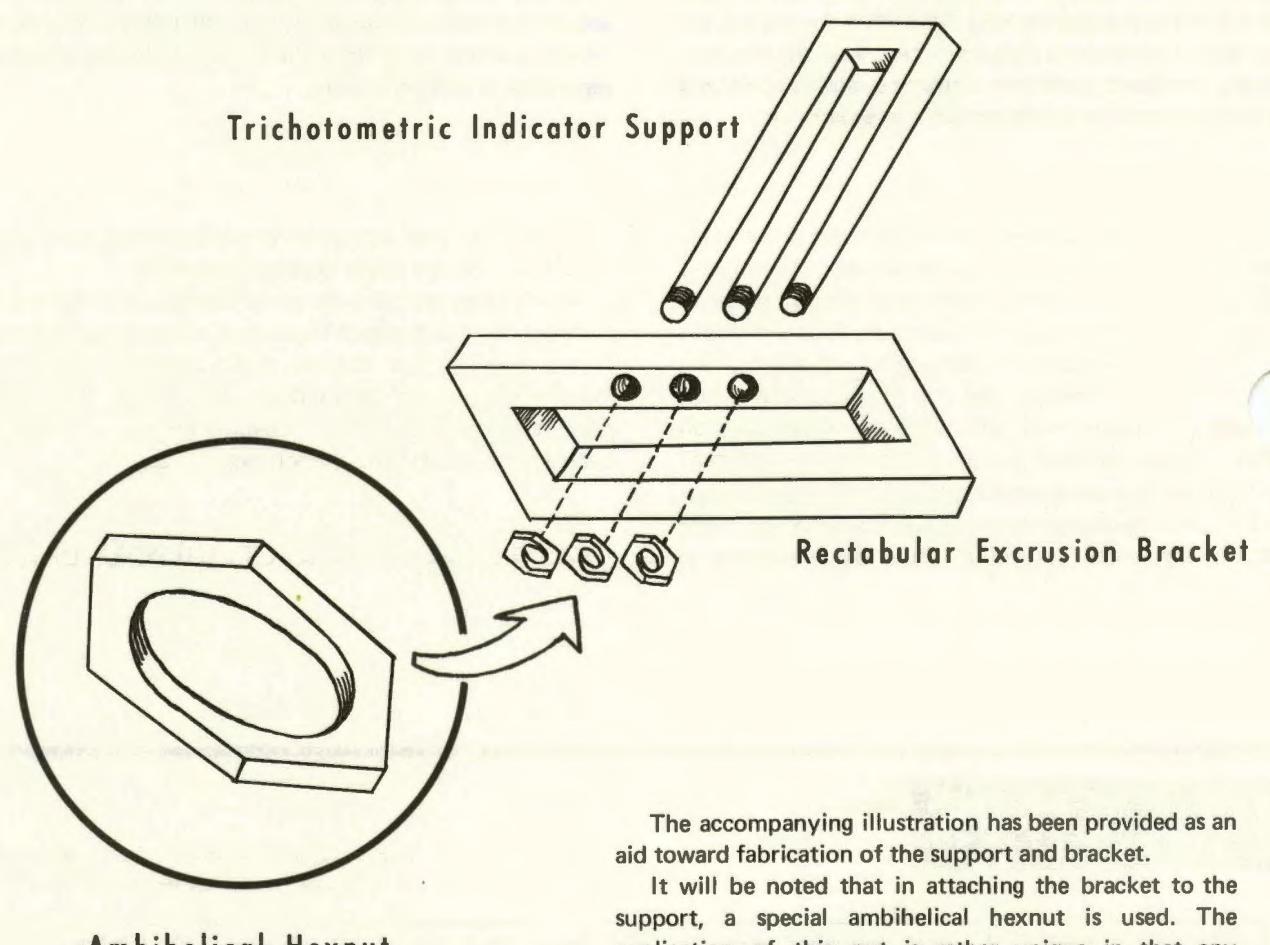
Ambihelical Hexnut

It will be noted that in attaching the bracket to the support, a special ambihelical hexnut is used. The application of this nut is rather unique in that any attempt to remove it in the usual manner only tightens it. Because of this design, the nut must be fully screwed on before it can be screwed off.

A TAC ATTACK reader submitted this as a "better mousetrap." He suggests that it be used in those inaccessible aircraft locations where security of fasteners is vital to airframe integrity.
